## Uniform Mitigation Verification Inspection Form

### Windstorm Mitigation Inspection

**5600-5670 NW 98TH WAY CORAL SPRINGS, FL. 33076**

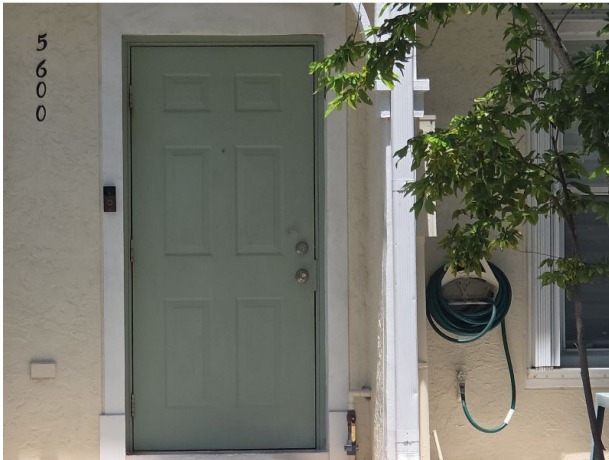
### UNGLAZED OPENINGS

Entry doors are impact rated and approved(NOA #02-0408.04)

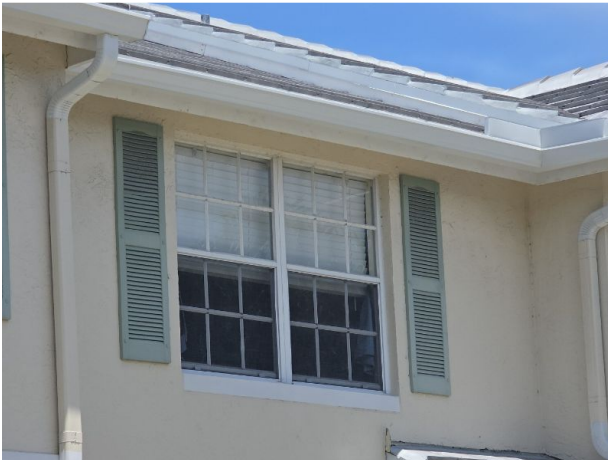
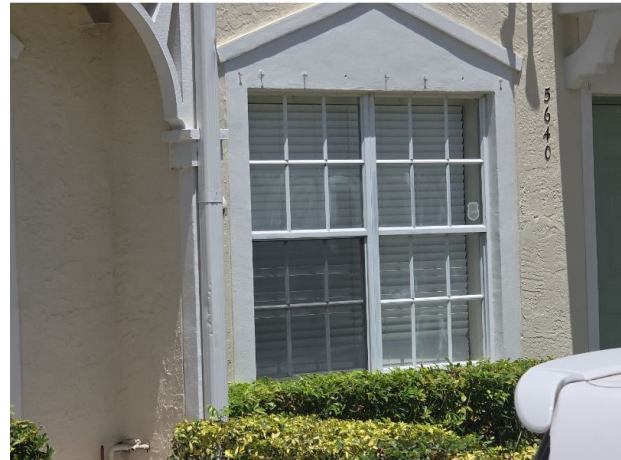
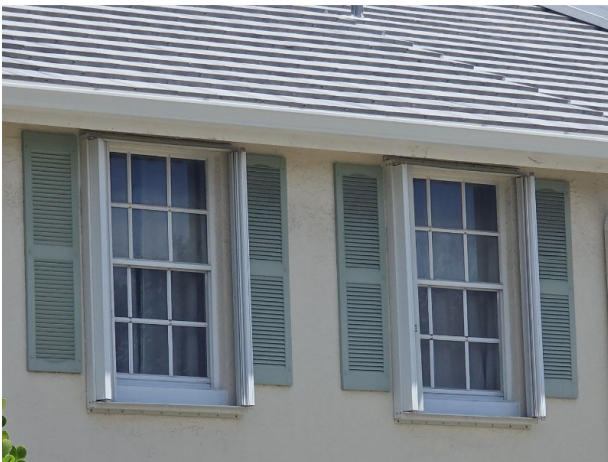
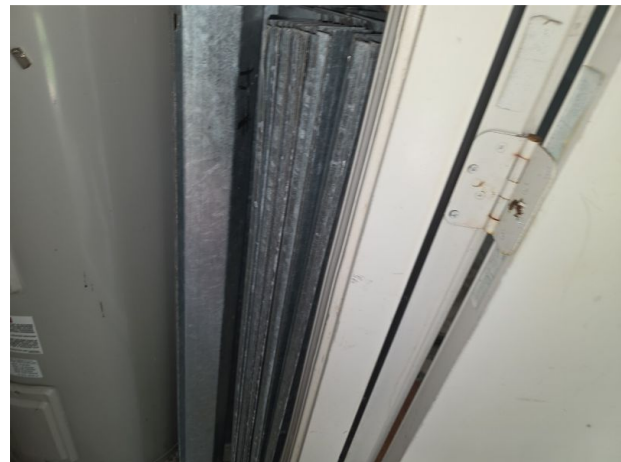
### Glazed Openings

Glazed openings are protected with a combination of approved storm panels and approved accordion shutters.

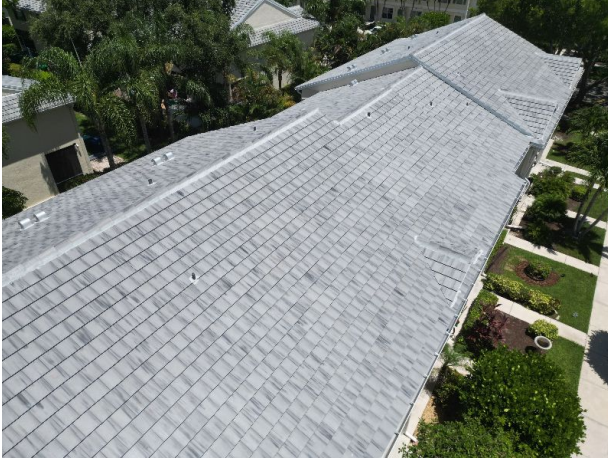
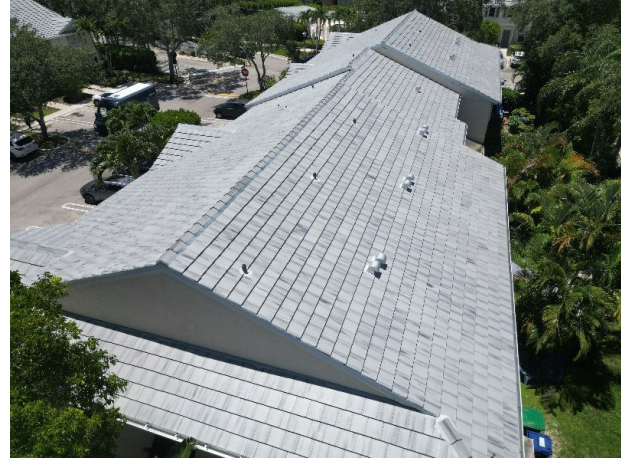
### ROOF COVERING

| 4.1 Roof Covering Type: | Permit Application Date | FBC / MDC Product Approval # | Year of Original Installation or Replacement | No Information Provided for Compliance |
|---|---|---|---|---|
| <input checked="" type="checkbox"/> Concrete/Clay Tile | <b>10/29/2025</b> | <b>25-001231</b> | <b>.</b> | _____ |

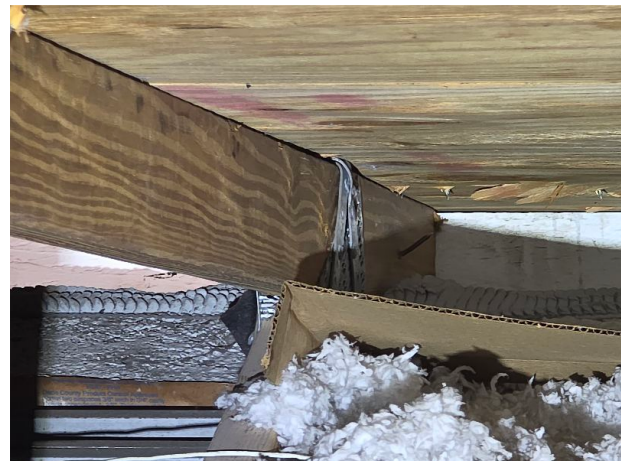
### ROOF TO WALL ATTACHMENT

☒ **D. Double Wraps**

- ☒ Metal Connectors consisting of two (2) separate straps, one on either side of the truss/rafter where each strap wraps over the truss/rafter and is secured with a minimum of two (2) nails on one side, and a minimum of one (1) nail on the opposing side, OR
- ☐ Metal connectors consisting of a single strap that wraps over the truss/rafter, are secured to the side of the wall and/or bottom of the top plate with a minimum of three (3) nails on each side, OR
- ☐ Purpose-made metal connector(s) or structural fastener(s) with a substantiated wind allowable uplift capacity of 891 lbs. or greater installed per the manufacturer's installation specifications (requires site-specific documentation).
