## Uniform Mitigation Verification Inspection Form

### Windstorm Mitigation Inspection

**5601-5671 NW 98TH WAY CORAL SPRINGS, FL. 33076**

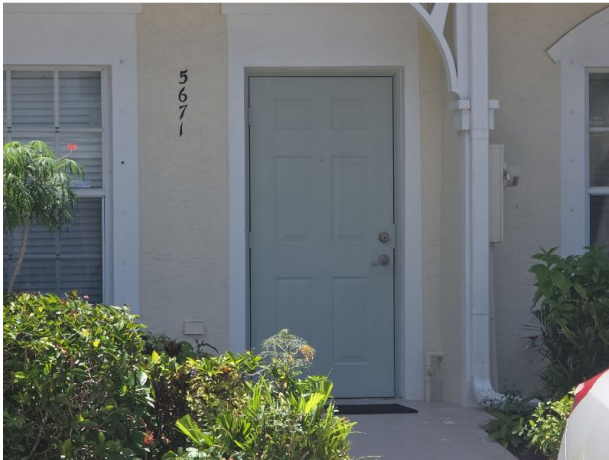
#### UNGLAZED OPENINGS

Entry doors are impact rated and approved(NOA #02-0408.04)

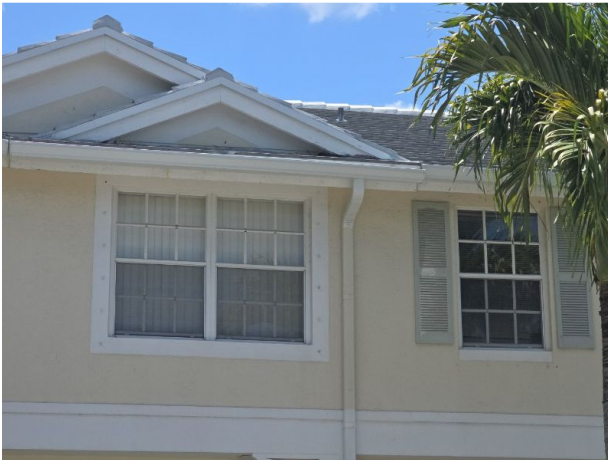
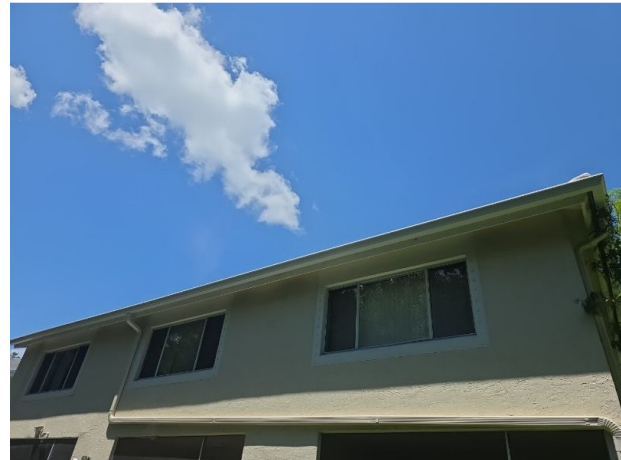
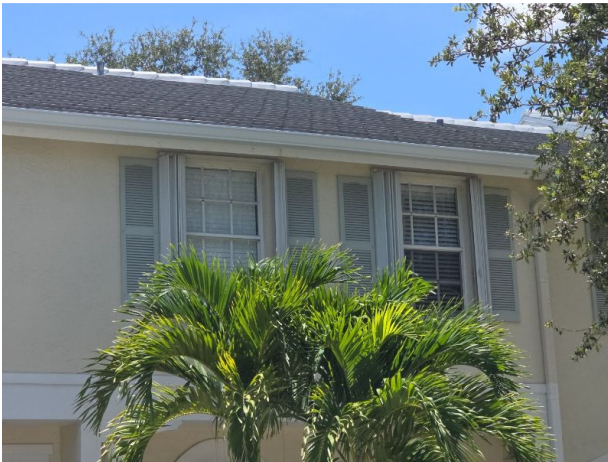
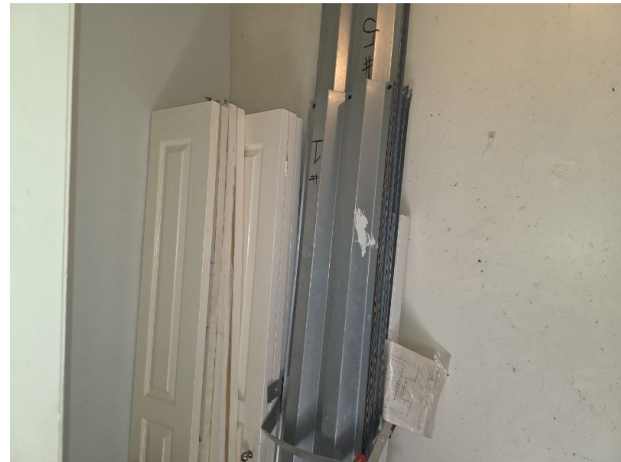
#### GLAZED OPENINGS

Glazed openings are protected with a combination of approved storm panels and approved accordion shutters.

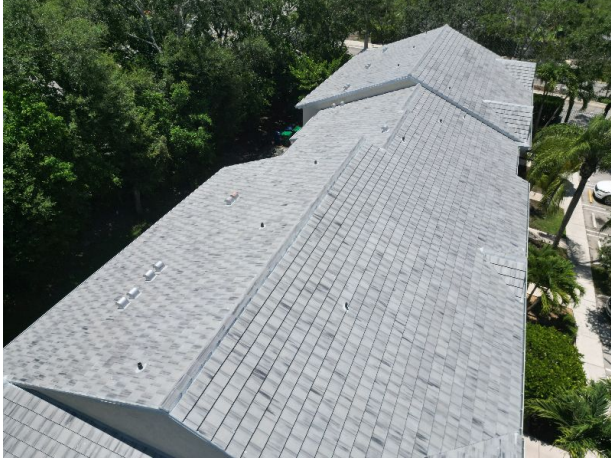
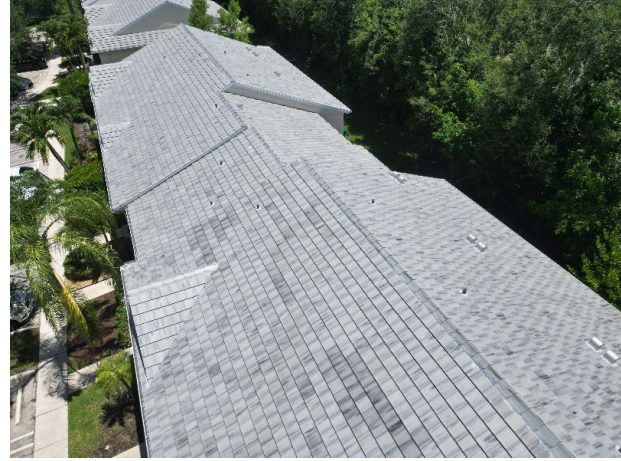
### ROOF COVERING

| 4.1 Roof Covering Type: | Permit Application Date | FBC / MDC Product Approval # | Year of Original Installation or Replacement | No Information Provided for Compliance |
|---|---|---|---|---|
| <input checked="" type="checkbox"/> Concrete/Clay Tile | <b>10/29/2025</b> | <b>25-001235</b> | . | |

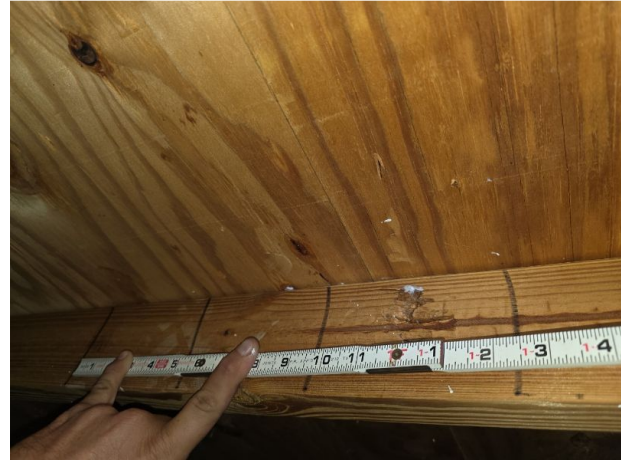
### ROOF TO DECK ATTACHMENT

- ☒ C. Plywood/OSB roof sheathing with a minimum thickness of 7/16" attached to the roof truss/rafter (spaced a maximum of 24" o.c.) by 8d common nails spaced a maximum of 6" in the field. OR Dimensional lumber/Tongue & Groove decking with a minimum of 2 nails per board (or 1 nail per board if each board is equal to or less than 6" in width). OR Any system of screws, nails, adhesives, other deck fastening system or truss/rafter spacing that is shown to have an equivalent or greater resistance than 8d common nails spaced a maximum of 6" in the field (max 24" truss/rafter spacing) or has a mean ultimate uplift resistance of at least 182 psf.

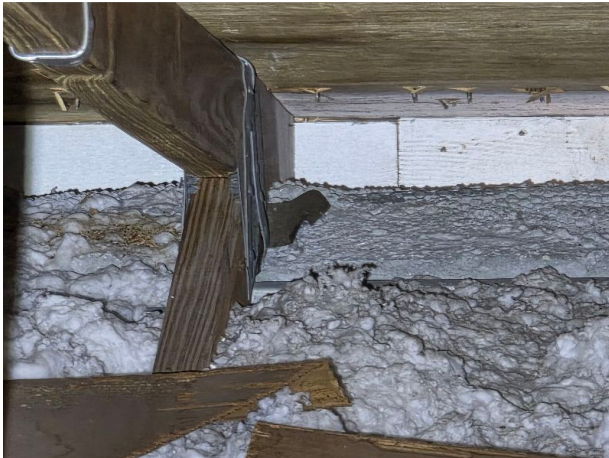
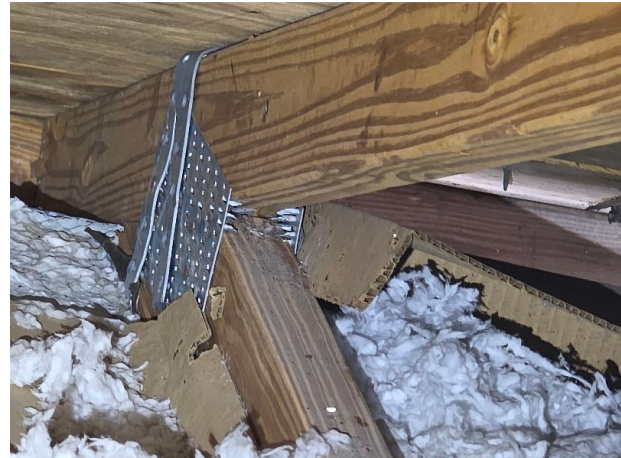
### ROOF TO WALL ATTACHMENT

- ☒ Metal Connectors consisting of two (2) separate straps, one on either side of the truss/rafter where each strap wraps over the truss/rafter and is secured with a minimum of two (2) nails on one side, and a minimum of one (1) nail on the opposing side, OR
- ☐ Metal connectors consisting of a single strap that wraps over the truss/rafter, are secured to the side of the wall and/or bottom of the top plate with a minimum of three (3) nails on each side, OR
- ☐ Purpose-made metal connector(s) or structural fastener(s) with a substantiated wind allowable uplift capacity of 891 lbs. or greater installed per the manufacturer's installation specifications (requires site-specific documentation).
