## Uniform Mitigation Verification Inspection Form

### Windstorm Mitigation Inspection

**5602-5672 NW 99TH WAY CORAL SPRINGS, FL. 33076**

| INSPECTION DATE: <b>6/30/2026</b> | CONTACT PERSON: | Unit / Bldng |

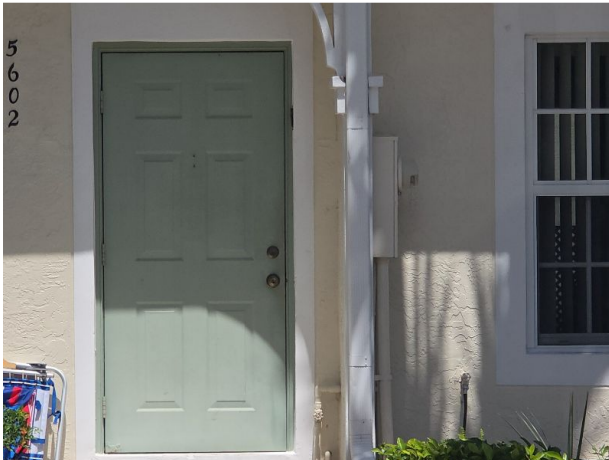
#### UNGLAZED OPENINGS

Entry doors are impact rated and approved(NOA #02-0408.04)

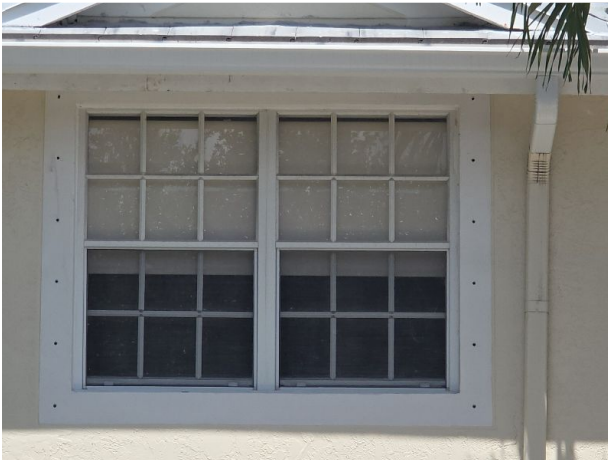
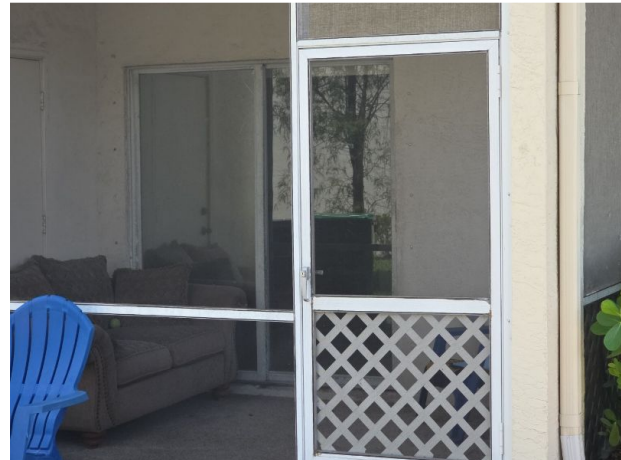
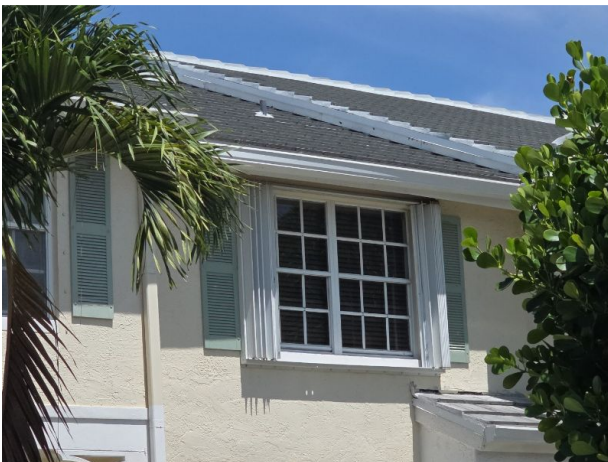
#### GLAZED OPENINGS

Glazed openings are protected with a combination of approved storm panels and approved accordion shutters.

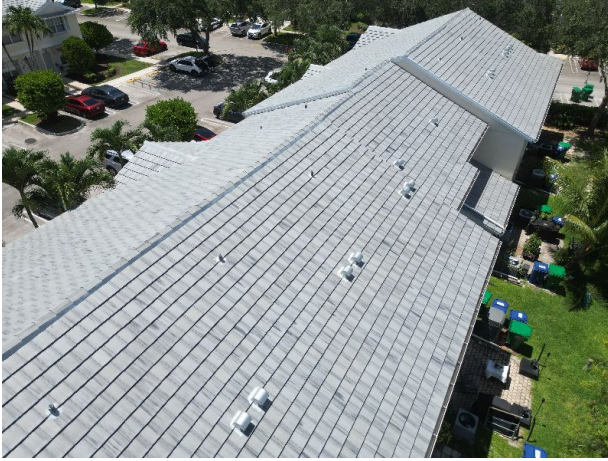
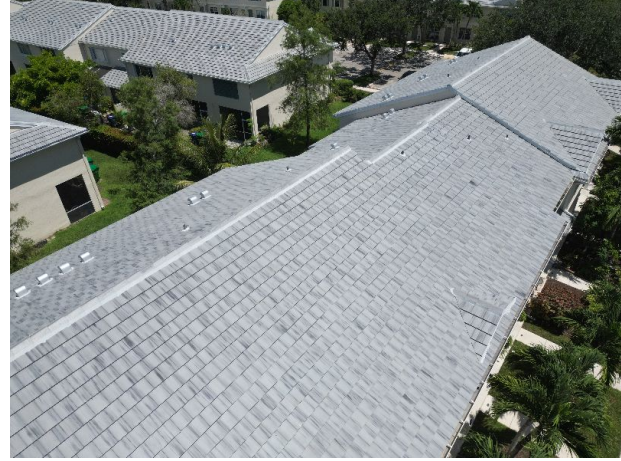
### ROOF COVERING

| 4.1 Roof Covering Type: | Permit<br>Application Date | FBC / MDC Product<br>Approval # | Year of Original Installation<br>or Replacement | No Information<br>Provided for Compliance |
|---|---|---|---|---|
| <input checked="" type="checkbox"/> Concrete/Clay Tile | <b>10/29/2025</b> | <b>25-001249</b> | . | |

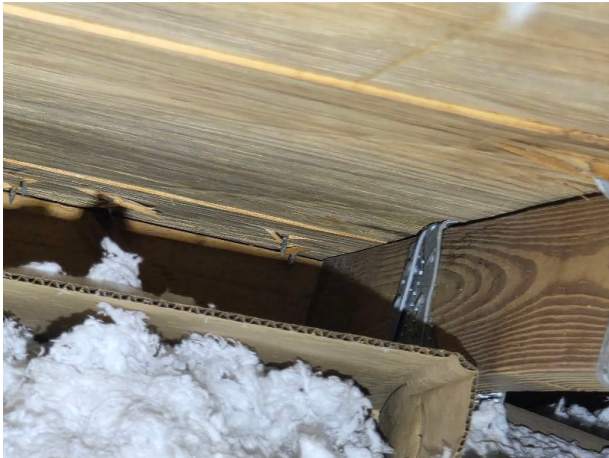
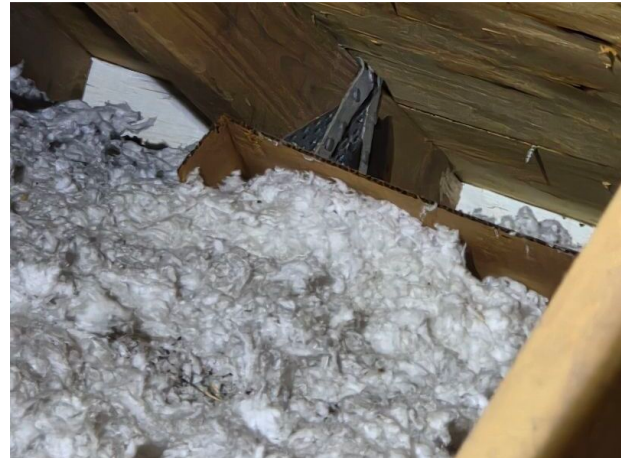
### ROOF TO WALL ATTACHMENT

- ☒ Metal Connectors consisting of two (2) separate straps, one on either side of the truss/rafter where each strap wraps over the truss/rafter and is secured with a minimum of two (2) nails on one side, and a minimum of one (1) nail on the opposing side, OR
- ☐ Metal connectors consisting of a single strap that wraps over the truss/rafter, are secured to the side of the wall and/or bottom of the top plate with a minimum of three (3) nails on each side, OR
- ☐ Purpose-made metal connector(s) or structural fastener(s) with a substantiated wind allowable uplift capacity of 891 lbs. or greater installed per the manufacturer's installation specifications (requires site-specific documentation).
