## Uniform Mitigation Verification Inspection Form

### Windstorm Mitigation Inspection

**5603-5673 NW 99TH WAY CORAL SPRINGS, FL. 33076**

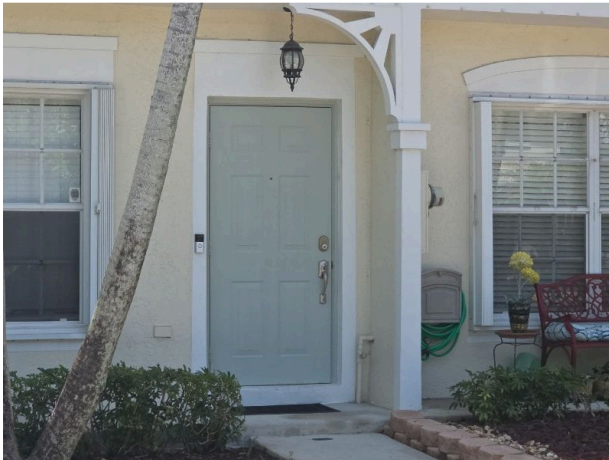
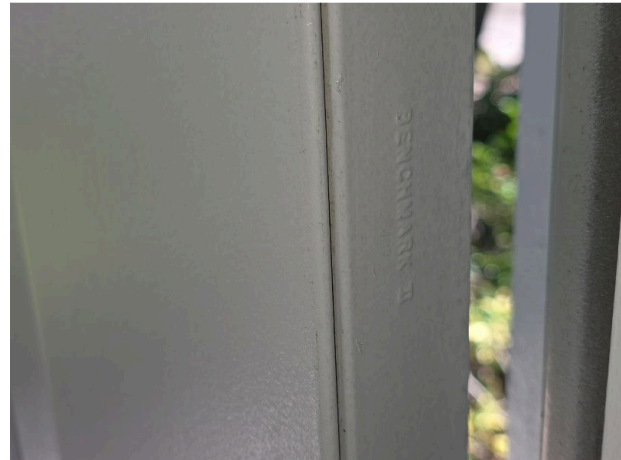
### UNGLAZED OPENINGS

Entry doors are impact rated and approved(NOA #02-0408.04)

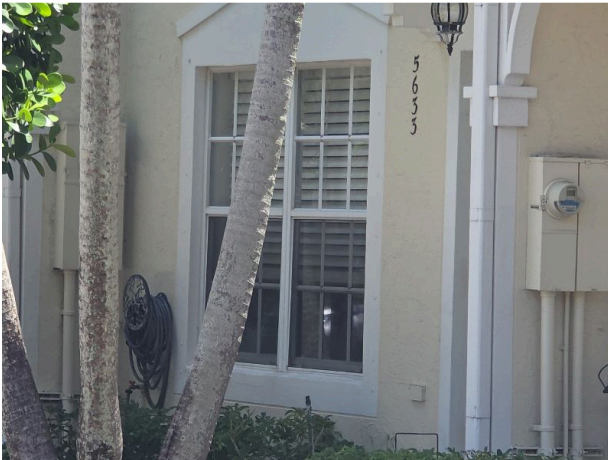
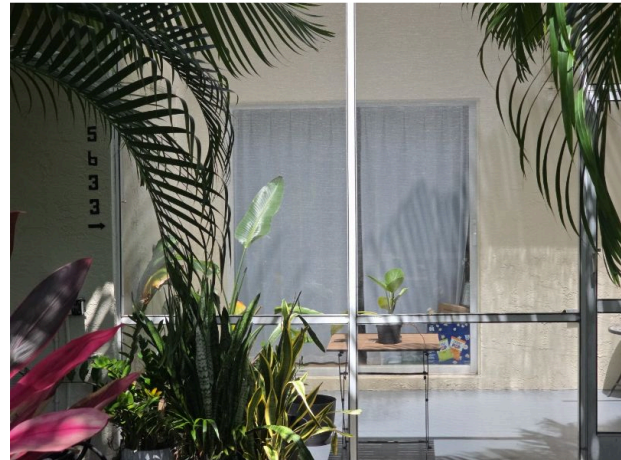
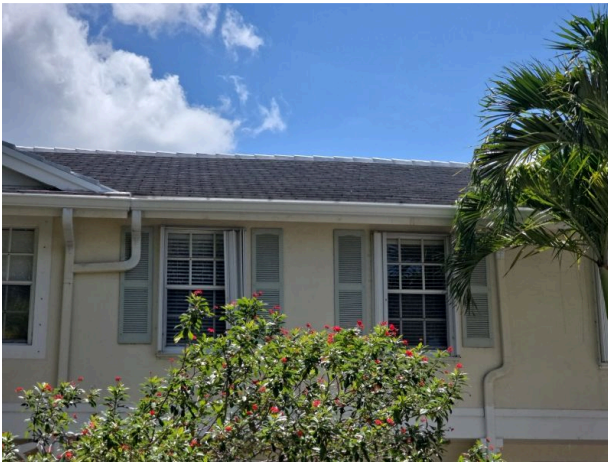
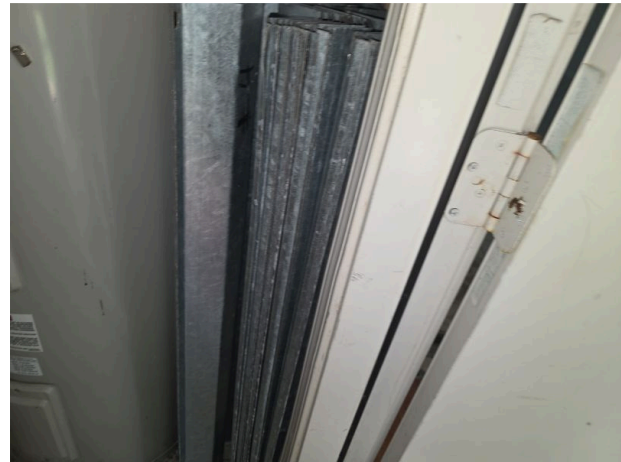
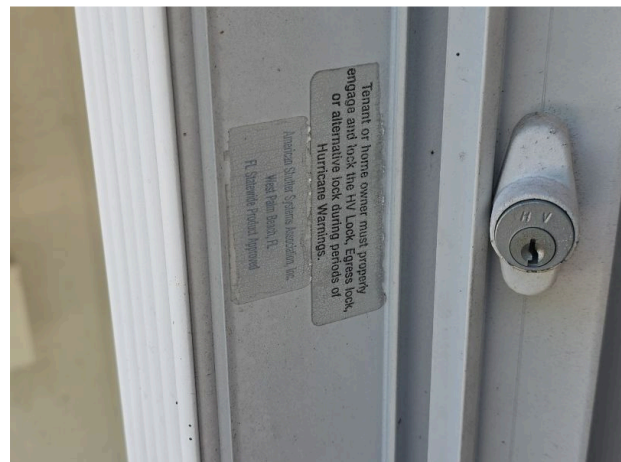
### Glazed Openings

Glazed openings are protected with a combination of approved storm panels and approved accordion shutters.

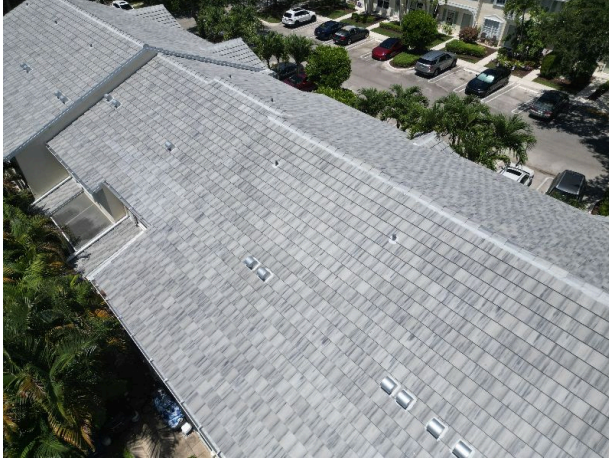
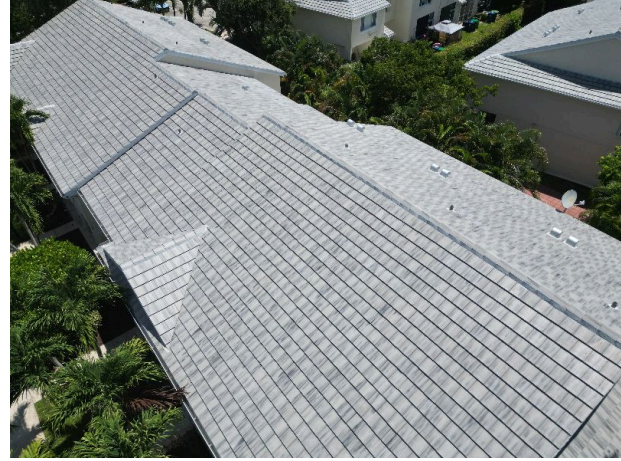
### ROOF COVERING

| 4.1 Roof Covering Type: | Permit Application Date | FBC / MDC Product Approval # | Year of Original Installation or Replacement | No Information Provided for Compliance |
|---|---|---|---|---|
| <input checked="" type="checkbox"/> Concrete/Clay Tile | <b>10/8/2025</b> | <b>25-001180</b> | <b>.</b> | <input type="checkbox"/> |

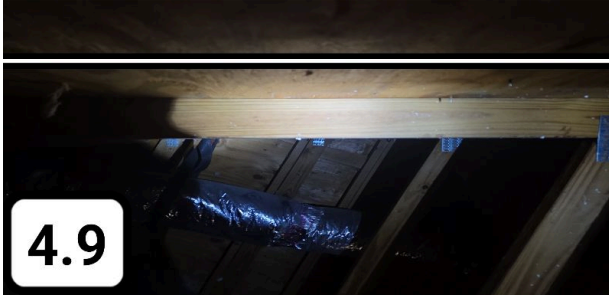
### ROOF SLOPE

☐ Greater than or equal to (≥ 6:12) ☒ Less than (< 6:12).

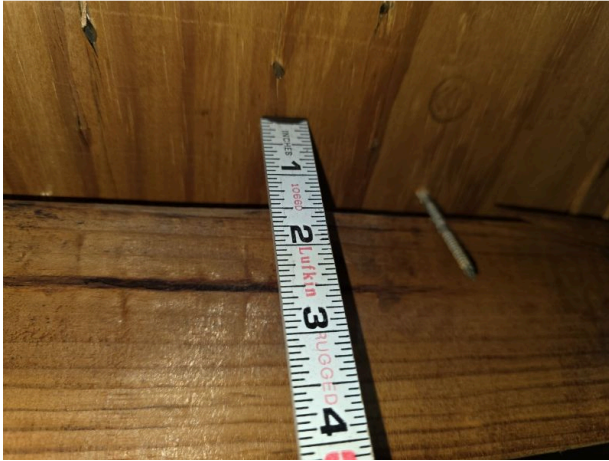
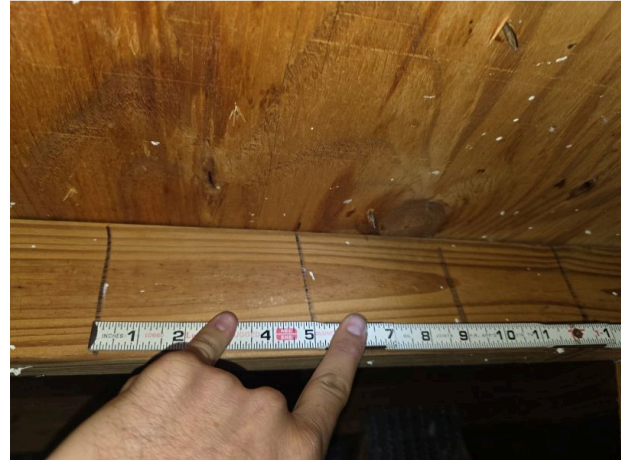
### ROOF TO DECK ATTACHMENT

- ☒ C. Plywood/OSB roof sheathing with a minimum thickness of 7/16" attached to the roof truss/rafter (spaced a maximum of 24" o.c.) by 8d common nails spaced a maximum of 6" in the field. OR Dimensional lumber/Tongue & Groove decking with a minimum of 2 nails per board (or 1 nail per board if each board is equal to or less than 6" in width). OR Any system of screws, nails, adhesives, other deck fastening system or truss/rafter spacing that is shown to have an equivalent or greater resistance than 8d common nails spaced a maximum of 6" in the field (max 24" truss/rafter spacing) or has a mean ultimate uplift resistance of at least 182 psf.

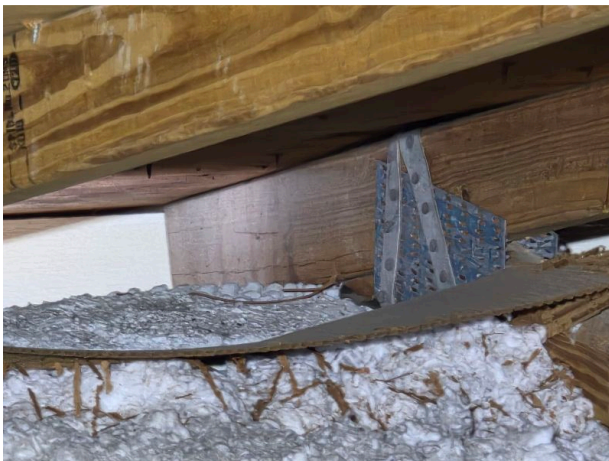
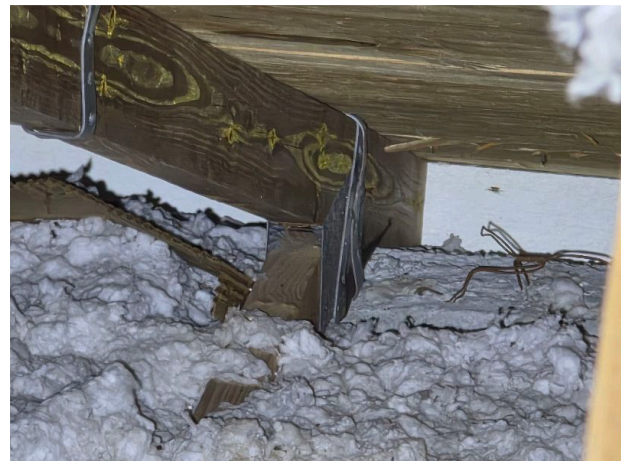
### ROOF TO WALL ATTACHMENT

- ☒ Metal Connectors consisting of two (2) separate straps, one on either side of the truss/rafter where each strap wraps over the truss/rafter and is secured with a minimum of two (2) nails on one side, and a minimum of one (1) nail on the opposing side, OR
- ☐ Metal connectors consisting of a single strap that wraps over the truss/rafter, are secured to the side of the wall and/or bottom of the top plate with a minimum of three (3) nails on each side, OR
- ☐ Purpose-made metal connector(s) or structural fastener(s) with a substantiated wind allowable uplift capacity of 891 lbs. or greater installed per the manufacturer's installation specifications (requires site-specific documentation).
