## Uniform Mitigation Verification Inspection Form

### Windstorm Mitigation Inspection

**5604-5638 NW 99TH LN CORAL SPRINGS, FL. 33076**

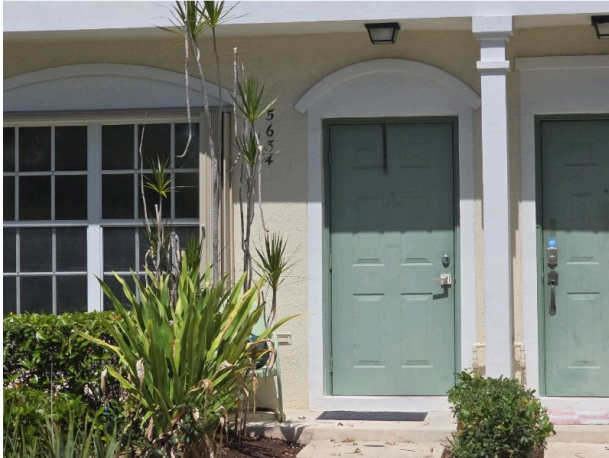
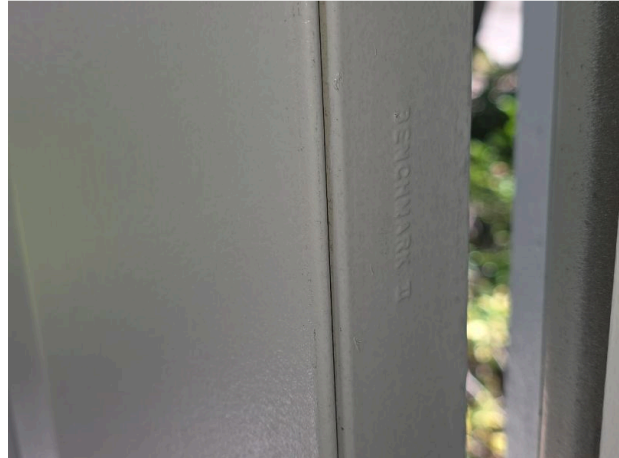
#### UNGLAZED OPENINGS

Entry doors are impact rated and approved(NOA #02-0408.04)

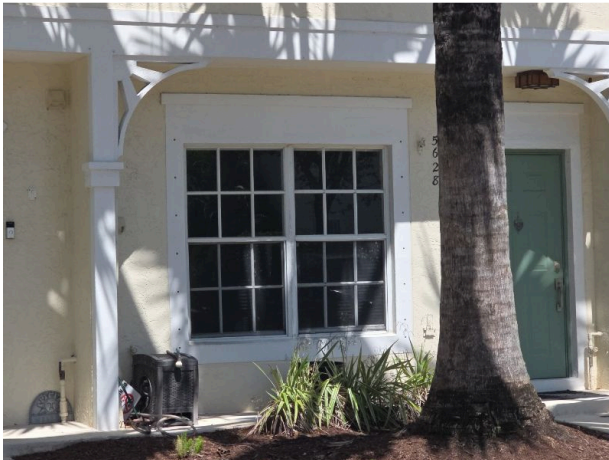
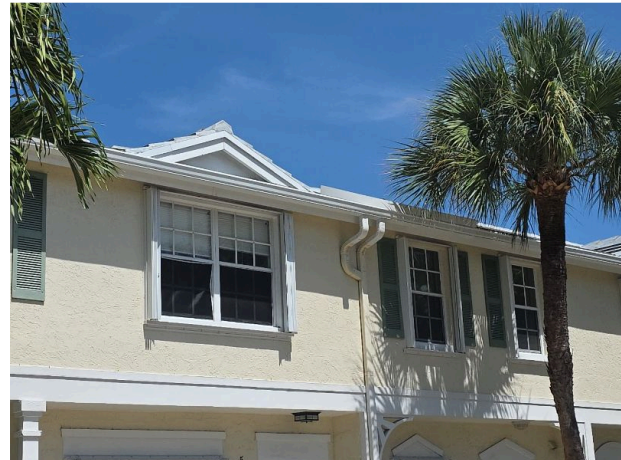
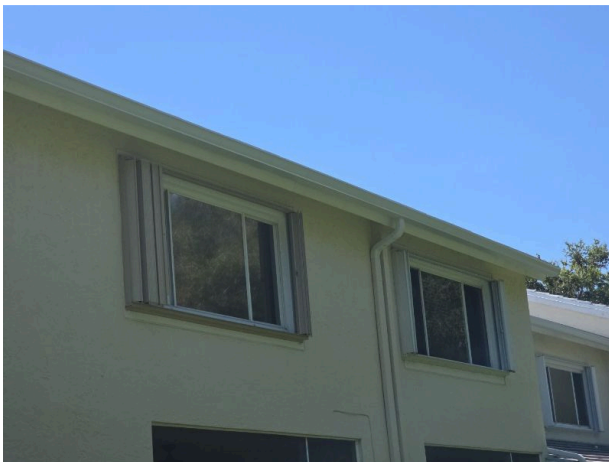
#### GLAZED OPENINGS

Glazed openings are protected with a combination of approved storm panels and approved accordion shutters.

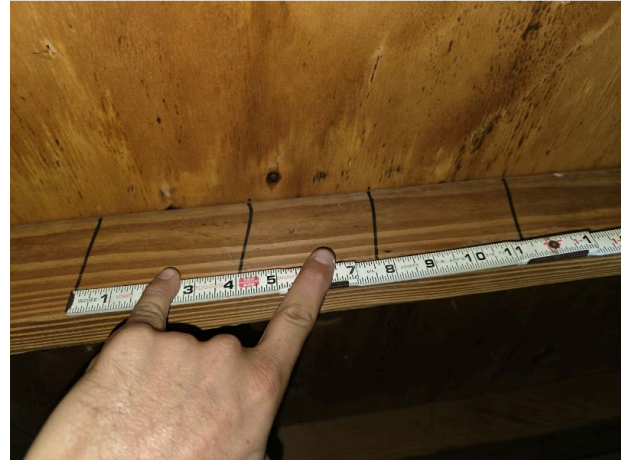
### ROOF TO DECK ATTACHMENT

- ☒ C. Plywood/OSB roof sheathing with a minimum thickness of 7/16" attached to the roof truss/rafter (spaced a maximum of 24" o.c.) by 8d common nails spaced a maximum of 6" in the field. OR Dimensional lumber/Tongue & Groove decking with a minimum of 2 nails per board (or 1 nail per board if each board is equal to or less than 6" in width). OR Any system of screws, nails, adhesives, other deck fastening system or truss/rafter spacing that is shown to have an equivalent or greater resistance than 8d common nails spaced a maximum of 6" in the field (max 24" truss/rafter spacing) or has a mean ultimate uplift resistance of at least 182 psf.

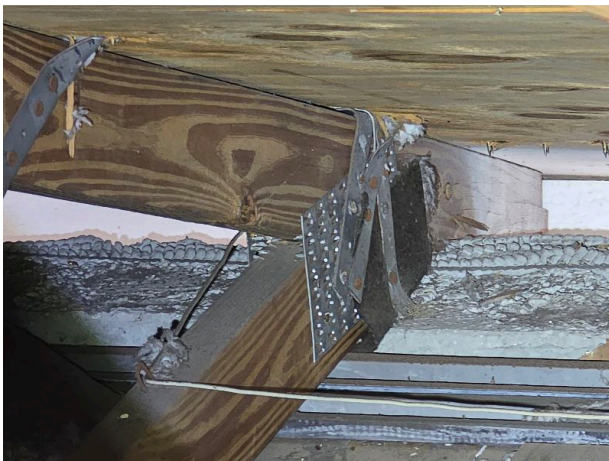
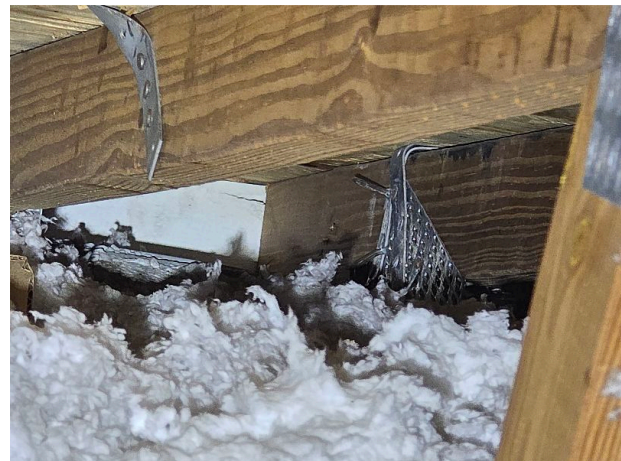
### ROOF TO WALL ATTACHMENT

- ☒ Metal Connectors consisting of two (2) separate straps, one on either side of the truss/rafter where each strap wraps over the truss/rafter and is secured with a minimum of two (2) nails on one side, and a minimum of one (1) nail on the opposing side, OR
- ☐ Metal connectors consisting of a single strap that wraps over the truss/rafter, are secured to the side of the wall and/or bottom of the top plate with a minimum of three (3) nails on each side, OR
- ☐ Purpose-made metal connector(s) or structural fastener(s) with a substantiated wind allowable uplift capacity of 891 lbs. or greater installed per the manufacturer's installation specifications (requires site-specific documentation).
