## Uniform Mitigation Verification Inspection Form

### Windstorm Mitigation Inspection

**5644-5678 NW 99TH LN CORAL SPRINGS, FL. 33076**

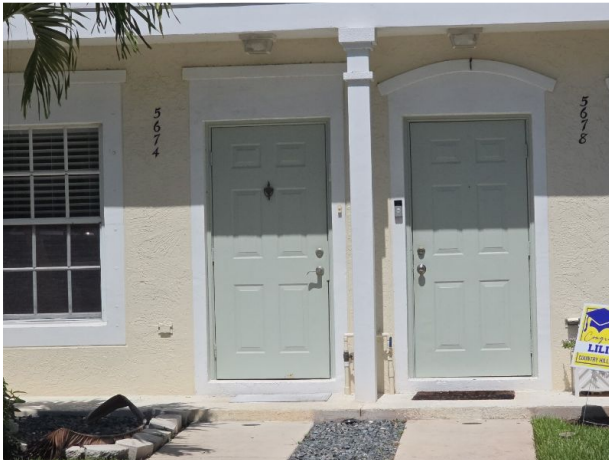
#### UNGLAZED OPENINGS

Entry doors are impact rated and approved(NOA #02-0408.04)

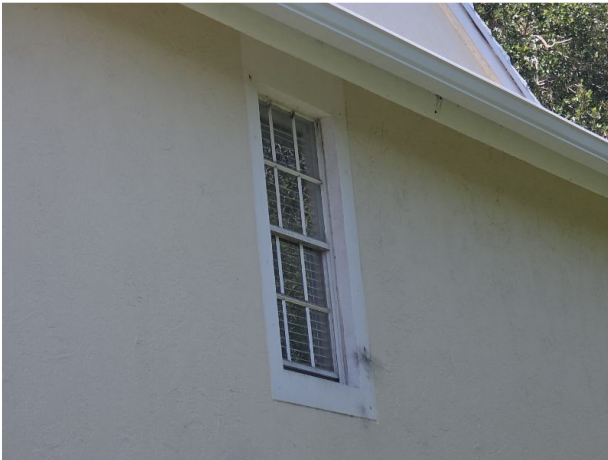
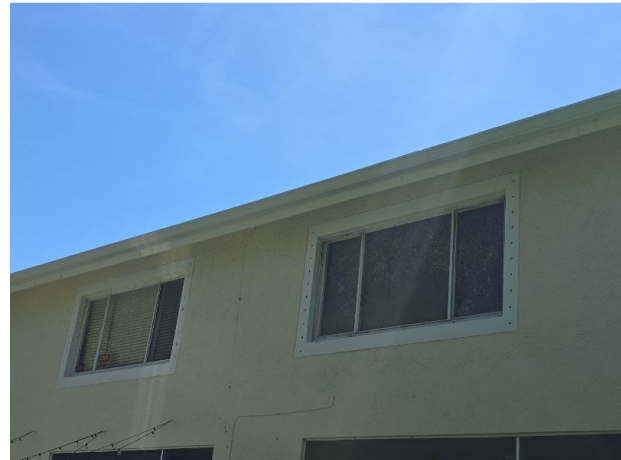
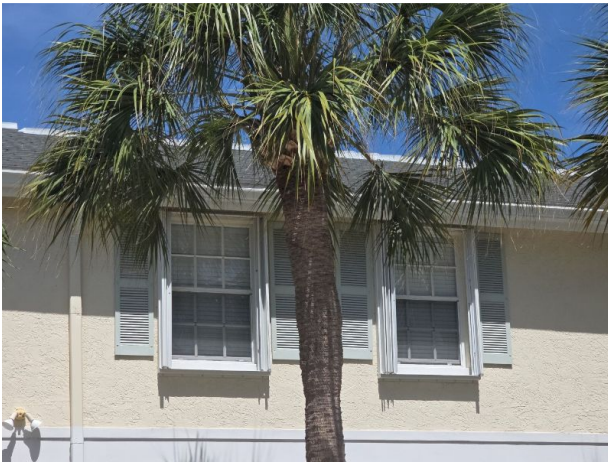
#### GLAZED OPENINGS

Glazed openings are protected with a combination of approved storm panels and approved accordion shutters.

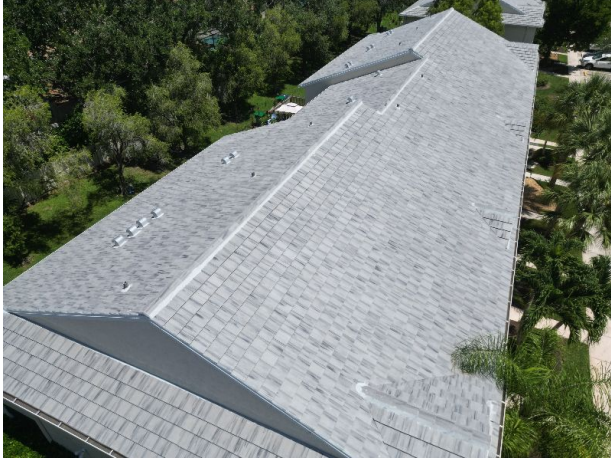
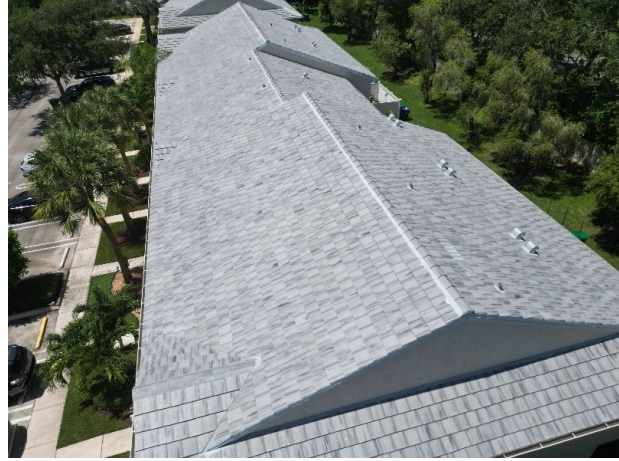
### ROOF COVERING

| 4.1 Roof Covering Type: | Permit Application Date | FBC / MDC Product Approval # | Year of Original Installation or Replacement | No Information Provided for Compliance |
|---|---|---|---|---|
| <input checked="" type="checkbox"/> Concrete/Clay Tile | <b>10/22/2025</b> | <b>25-001215</b> | <b>.</b> | <input type="checkbox"/> |

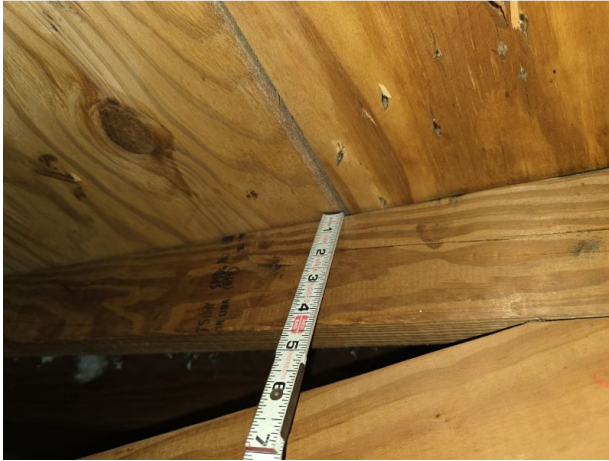
### ROOF TO DECK ATTACHMENT

- ☒ C. Plywood/OSB roof sheathing with a minimum thickness of 7/16" attached to the roof truss/rafter (spaced a maximum of 24" o.c.) by 8d common nails spaced a maximum of 6" in the field. OR Dimensional lumber/Tongue & Groove decking with a minimum of 2 nails per board (or 1 nail per board if each board is equal to or less than 6" in width). OR Any system of screws, nails, adhesives, other deck fastening system or truss/rafter spacing that is shown to have an equivalent or greater resistance than 8d common nails spaced a maximum of 6" in the field (max 24" truss/rafter spacing) or has a mean ultimate uplift resistance of at least 182 psf.

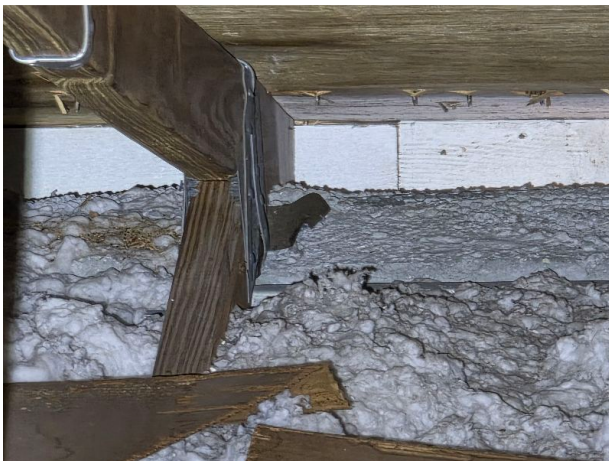
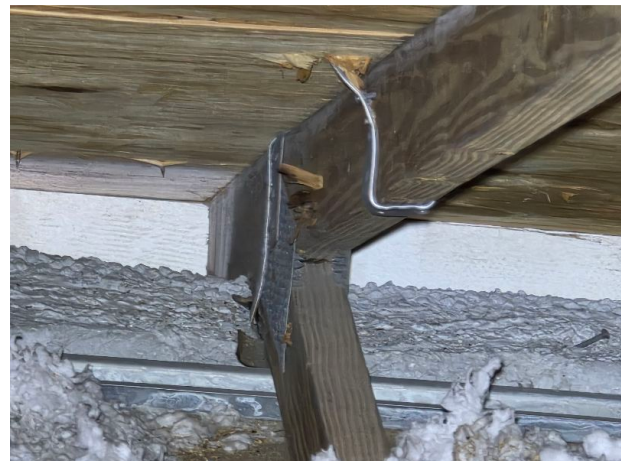
### ROOF TO WALL ATTACHMENT

- ☒ Metal Connectors consisting of two (2) separate straps, one on either side of the truss/rafter where each strap wraps over the truss/rafter and is secured with a minimum of two (2) nails on one side, and a minimum of one (1) nail on the opposing side, OR
- ☐ Metal connectors consisting of a single strap that wraps over the truss/rafter, are secured to the side of the wall and/or bottom of the top plate with a minimum of three (3) nails on each side, OR
- ☐ Purpose-made metal connector(s) or structural fastener(s) with a substantiated wind allowable uplift capacity of 891 lbs. or greater installed per the manufacturer's installation specifications (requires site-specific documentation).
