## Uniform Mitigation Verification Inspection Form

### Windstorm Mitigation Inspection

**5645-5679 NW 99TH LN CORAL SPRINGS, FL. 33076**

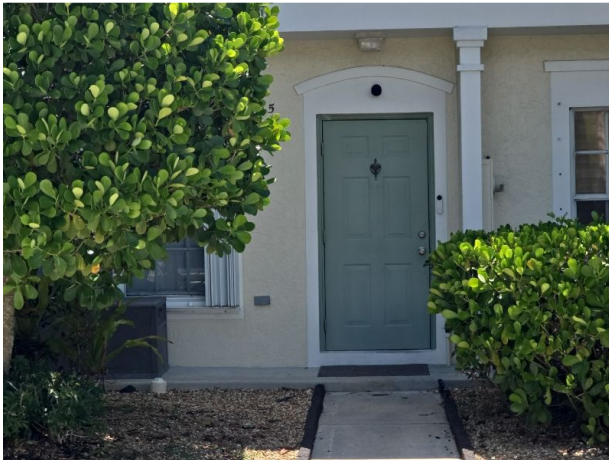
### UNGLAZED OPENINGS

Entry doors are impact rated and approved(NOA #02-0408.04)

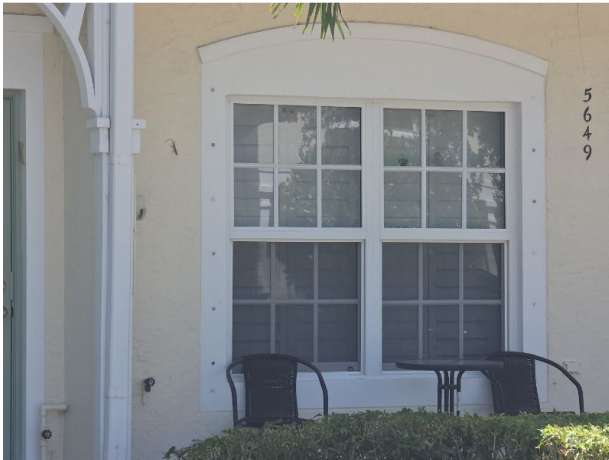
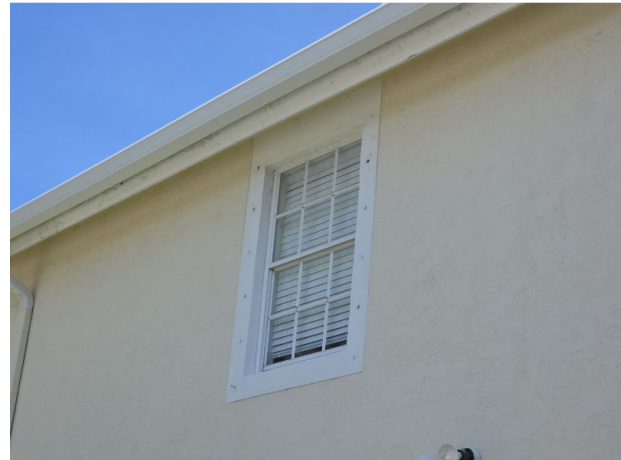
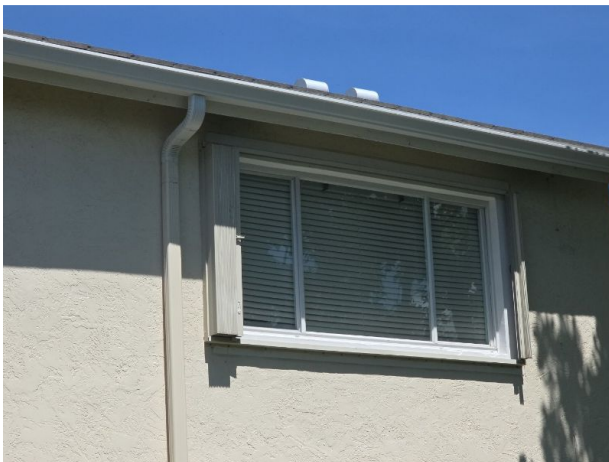
### Glazed Openings

Glazed openings are protected with a combination of approved storm panels and approved accordion shutters.

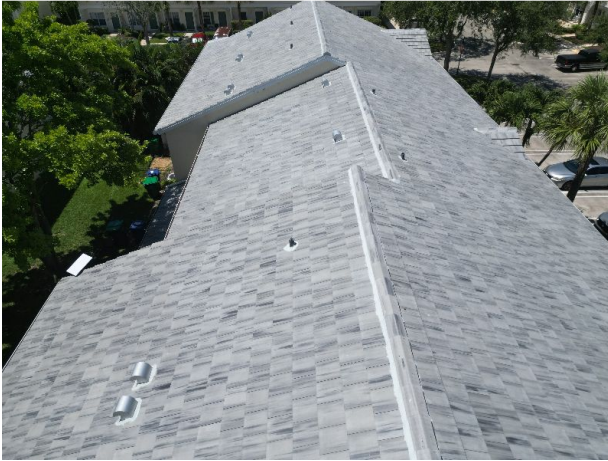
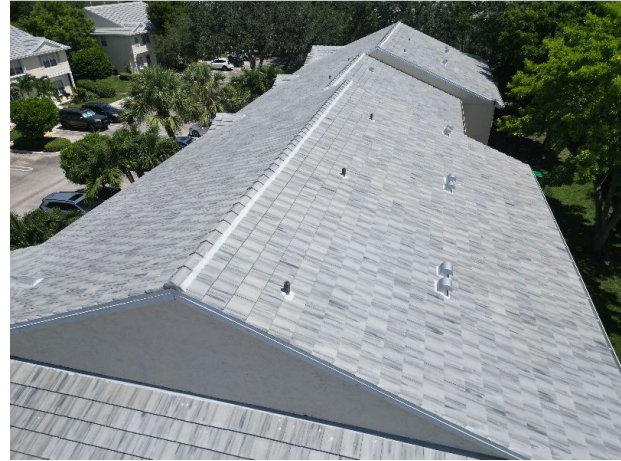
### ROOF COVERING

| 4.1 Roof Covering Type: | Permit<br>Application Date | FBC / MDC Product<br>Approval # | Year of Original Installation<br>or Replacement | No Information<br>Provided for Compliance |
|---|---|---|---|---|
| <input checked="" type="checkbox"/> Concrete/Clay Tile | <b>10/21/2025</b> | <b>25-001211</b> | . | |

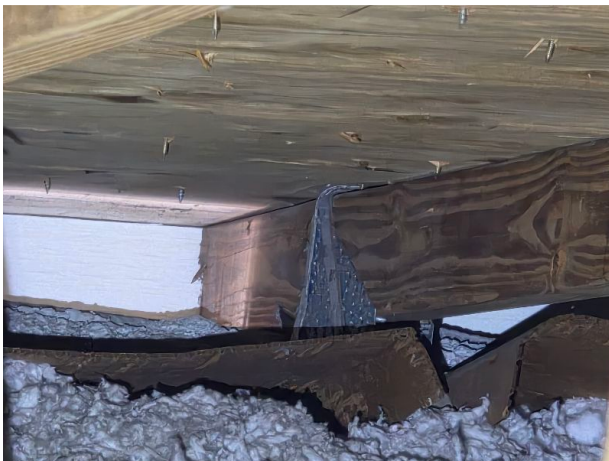
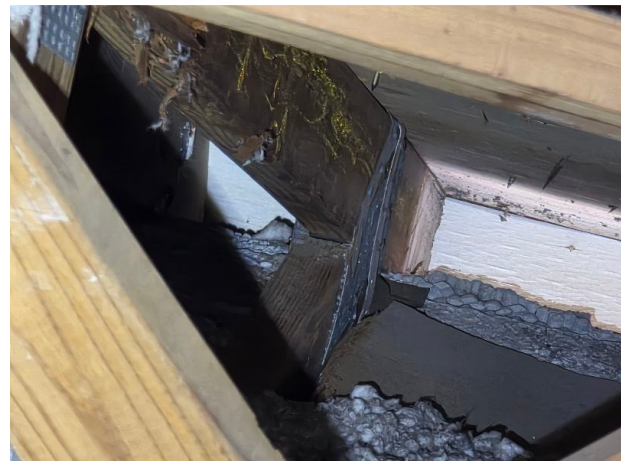
### ROOF TO WALL ATTACHMENT

- ☒ Metal Connectors consisting of two (2) separate straps, one on either side of the truss/rafter where each strap wraps over the truss/rafter and is secured with a minimum of two (2) nails on one side, and a minimum of one (1) nail on the opposing side, OR
- ☐ Metal connectors consisting of a single strap that wraps over the truss/rafter, are secured to the side of the wall and/or bottom of the top plate with a minimum of three (3) nails on each side, OR
- ☐ Purpose-made metal connector(s) or structural fastener(s) with a substantiated wind allowable uplift capacity of 891 lbs. or greater installed per the manufacturer's installation specifications (requires site-specific documentation).
