## Uniform Mitigation Verification Inspection Form

### Windstorm Mitigation Inspection

**5701-5771 NW 98TH WAY CORAL SPRINGS, FL. 33076**

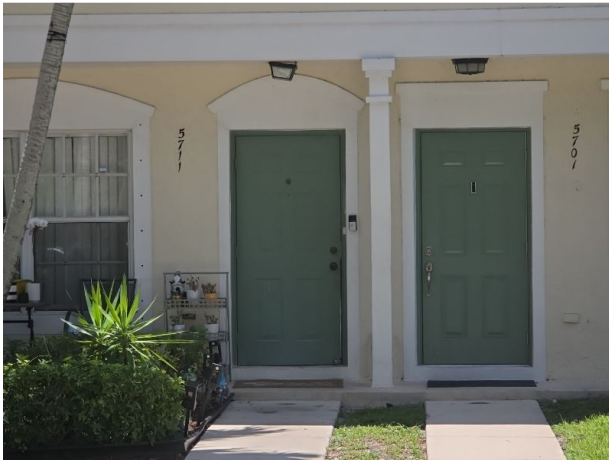
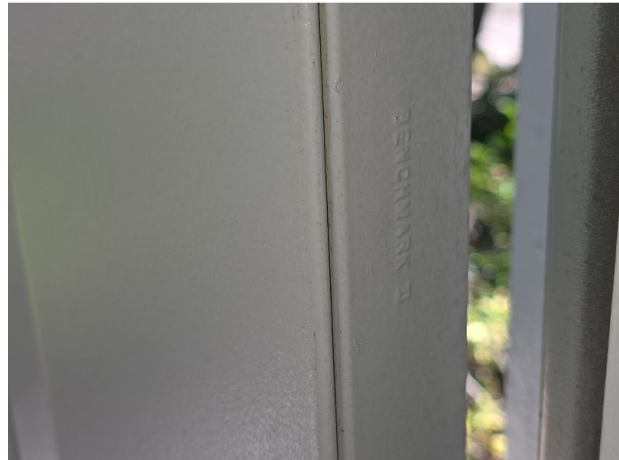
#### UNGLAZED OPENINGS

Entry doors are impact rated and approved(NOA #02-0408.04)

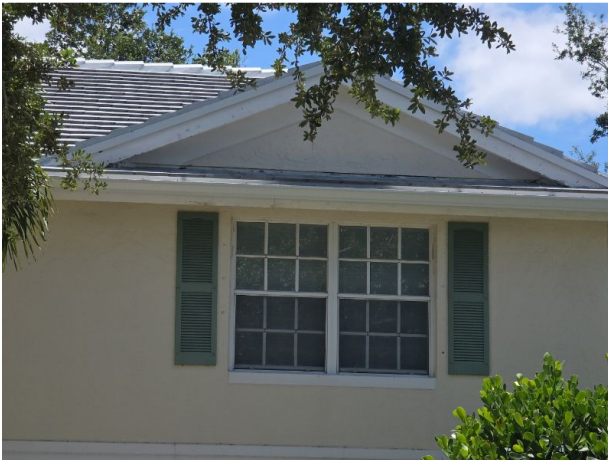
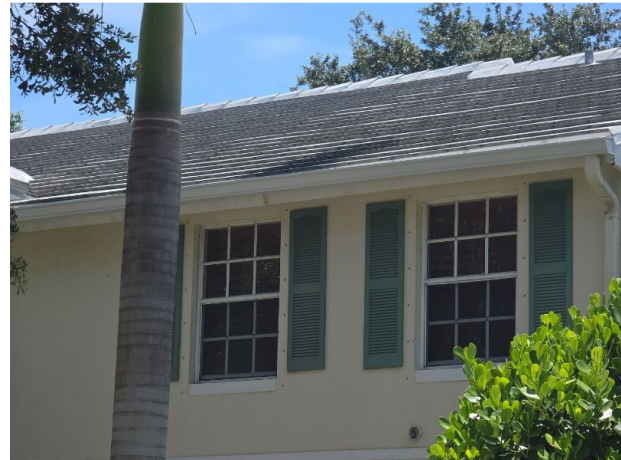
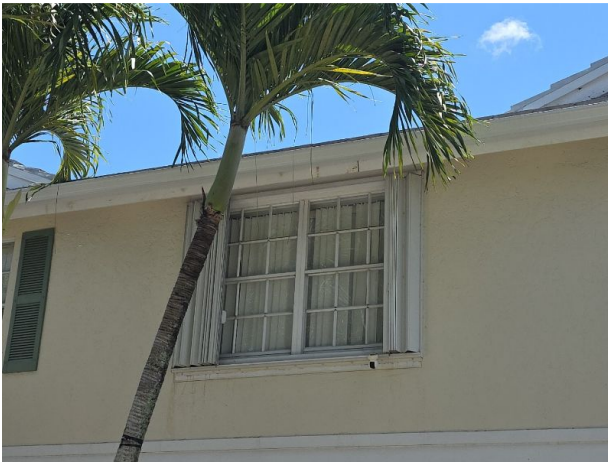
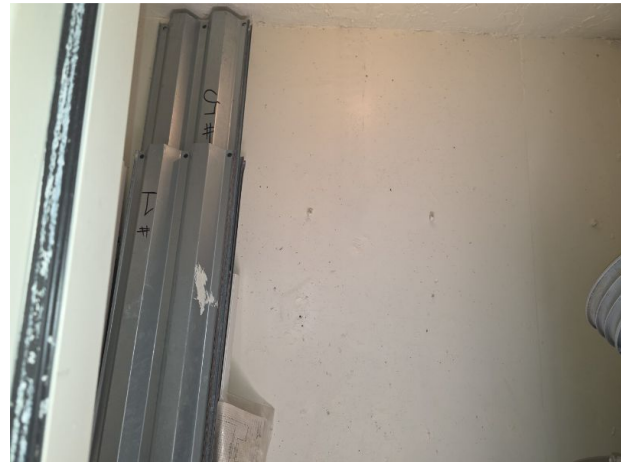
#### GLAZED OPENINGS

Glazed openings are protected with a combination of approved storm panels and approved accordion shutters.
