## Uniform Mitigation Verification Inspection Form

### Windstorm Mitigation Inspection

**5706-5776 NW 99TH LN CORAL SPRINGS, FL. 33076**

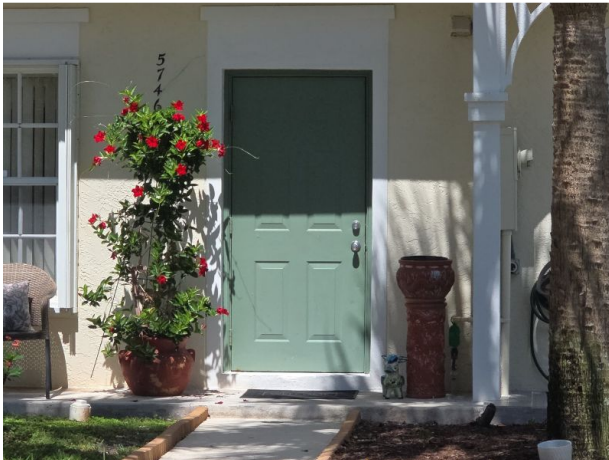
#### UNGLAZED OPENINGS

Entry doors are impact rated and approved(NOA #02-0408.04)

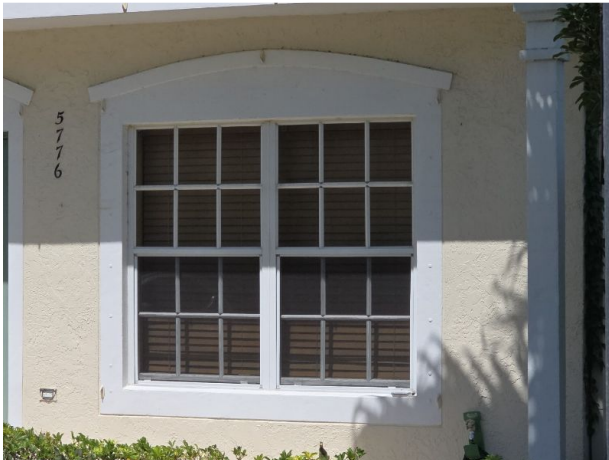
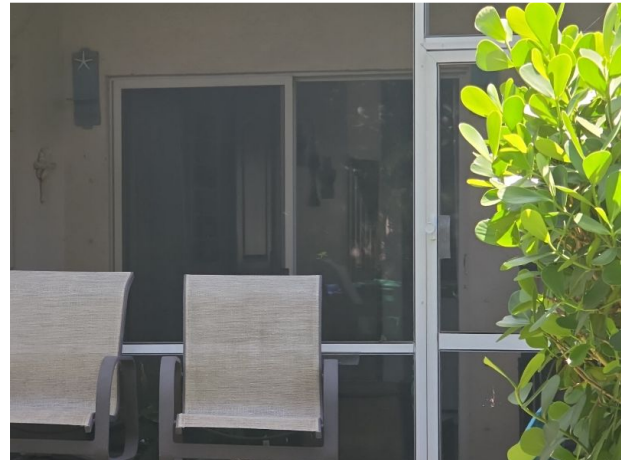
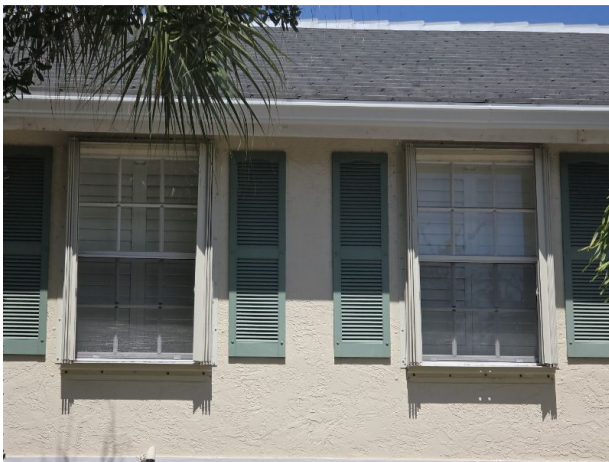
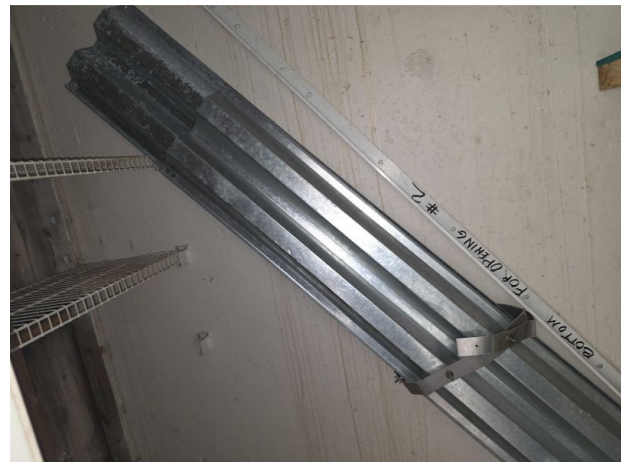
#### GLAZED OPENINGS

Glazed openings are protected with a combination of approved storm panels and approved accordion shutters.

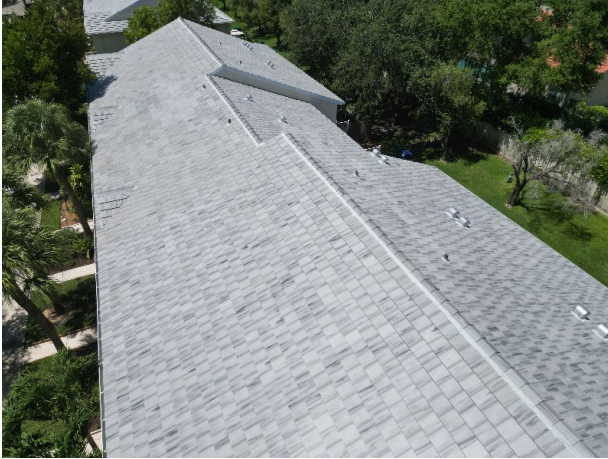
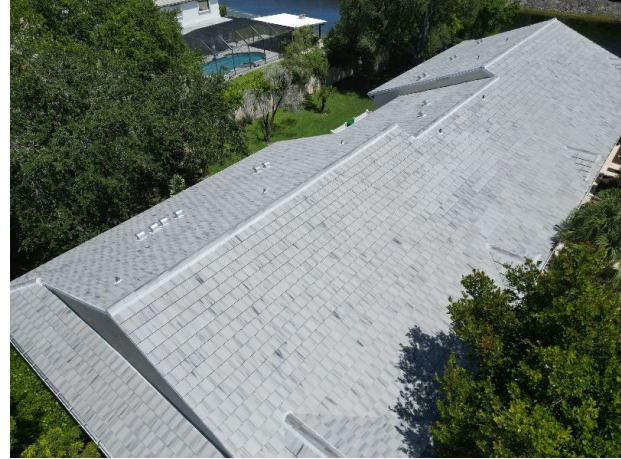
### ROOF COVERING

| 4.1 Roof Covering Type: | Permit Application Date | FBC / MDC Product Approval # | Year of Original Installation or Replacement | No Information Provided for Compliance |
|---|---|---|---|---|
| <input checked="" type="checkbox"/> Concrete/Clay Tile | <b>10/29/2025</b> | <b>25-001250</b> | <b>.</b> | <input type="checkbox"/> |

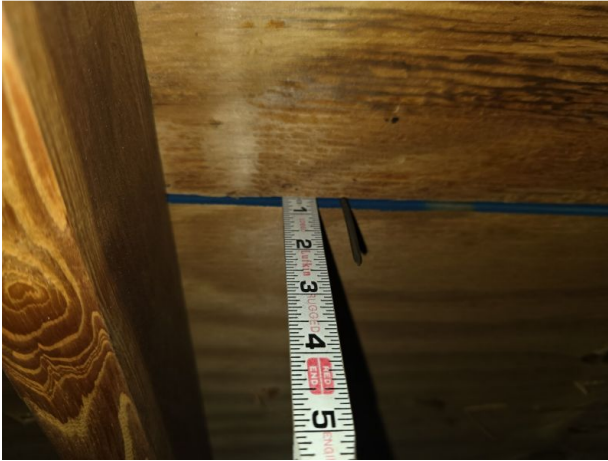
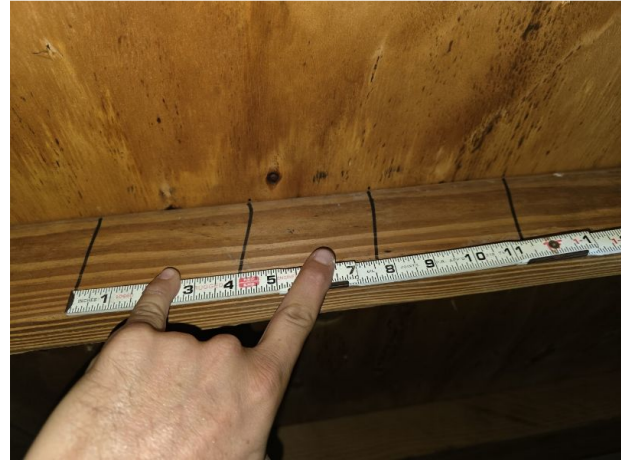
### ROOF TO DECK ATTACHMENT

- ☒ C. Plywood/OSB roof sheathing with a minimum thickness of 7/16" attached to the roof truss/rafter (spaced a maximum of 24" o.c.) by 8d common nails spaced a maximum of 6" in the field. OR Dimensional lumber/Tongue & Groove decking with a minimum of 2 nails per board (or 1 nail per board if each board is equal to or less than 6" in width). OR Any system of screws, nails, adhesives, other deck fastening system or truss/rafter spacing that is shown to have an equivalent or greater resistance than 8d common nails spaced a maximum of 6" in the field (max 24" truss/rafter spacing) or has a mean ultimate uplift resistance of at least 182 psf.

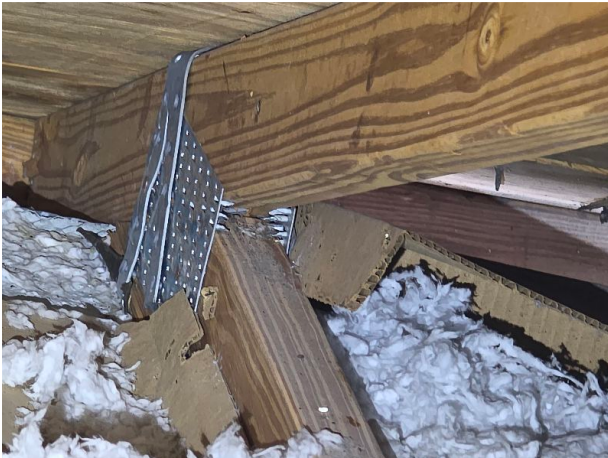
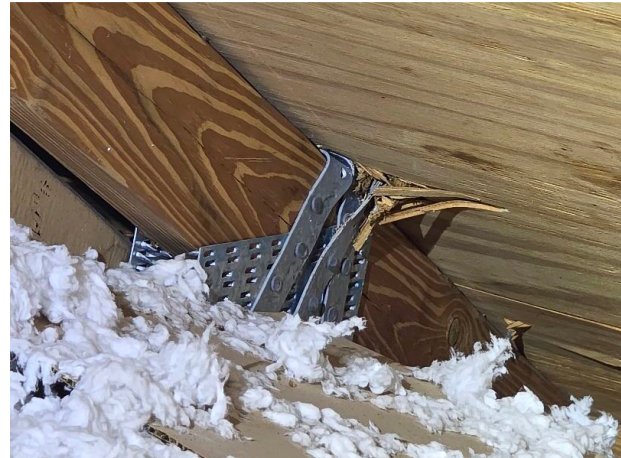
### ROOF TO WALL ATTACHMENT

- ☒ Metal Connectors consisting of two (2) separate straps, one on either side of the truss/rafter where each strap wraps over the truss/rafter and is secured with a minimum of two (2) nails on one side, and a minimum of one (1) nail on the opposing side, OR
- ☐ Metal connectors consisting of a single strap that wraps over the truss/rafter, are secured to the side of the wall and/or bottom of the top plate with a minimum of three (3) nails on each side, OR
- ☐ Purpose-made metal connector(s) or structural fastener(s) with a substantiated wind allowable uplift capacity of 891 lbs. or greater installed per the manufacturer's installation specifications (requires site-specific documentation).
