## Uniform Mitigation Verification Inspection Form

### Windstorm Mitigation Inspection

**9803-9831 NW 57TH MANOR CORAL SPRINGS, FL. 33076**

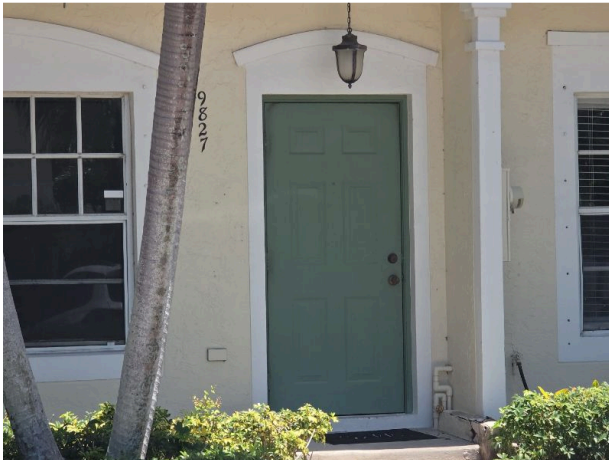
#### UNGLAZED OPENINGS

Entry doors are impact rated and approved(NOA #02-0408.04)

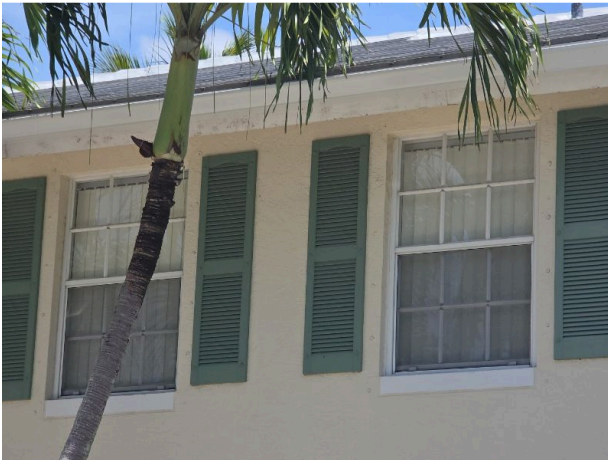
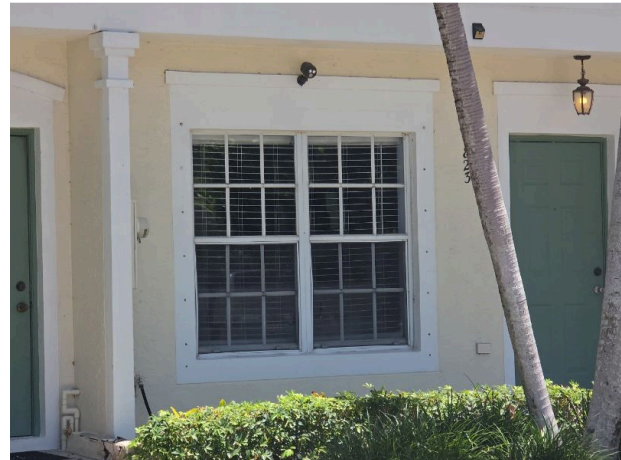
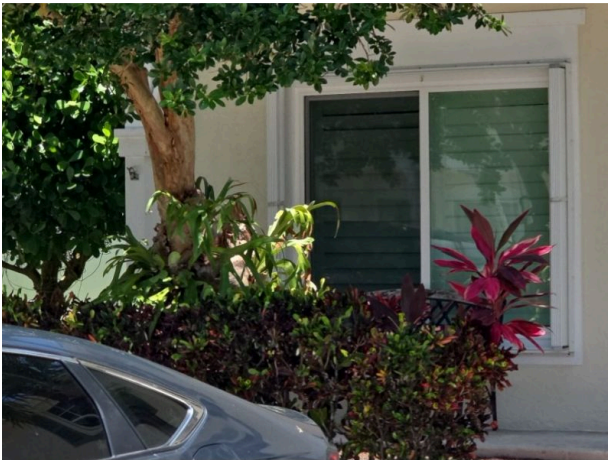
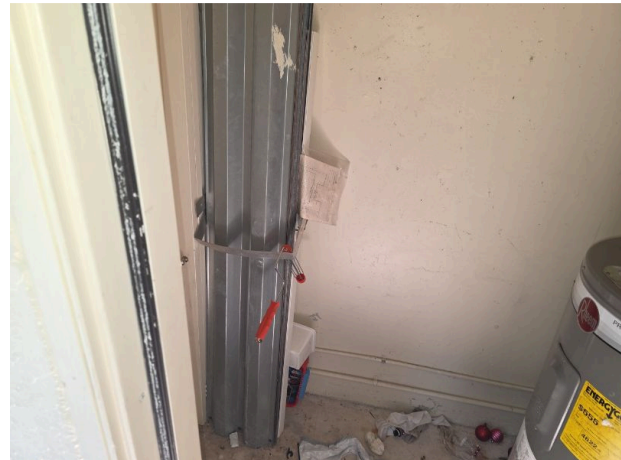
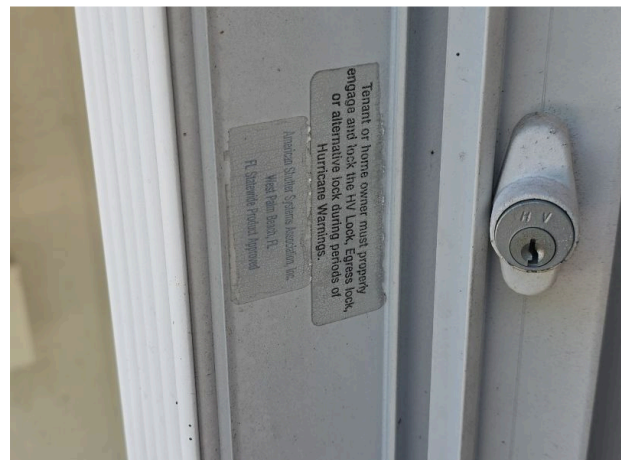
#### GLAZED OPENINGS

Glazed openings are protected with a combination of approved storm panels and approved accordion shutters.

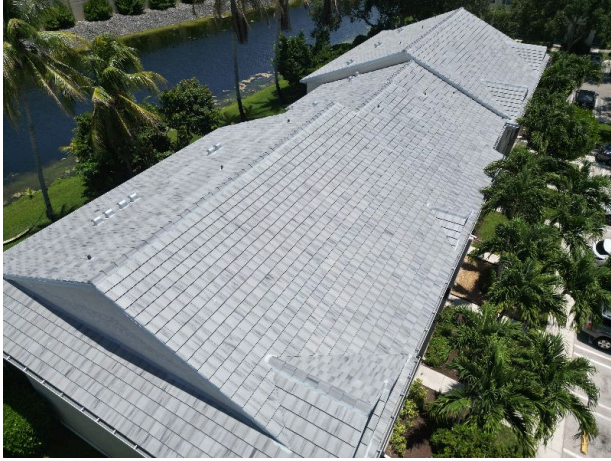
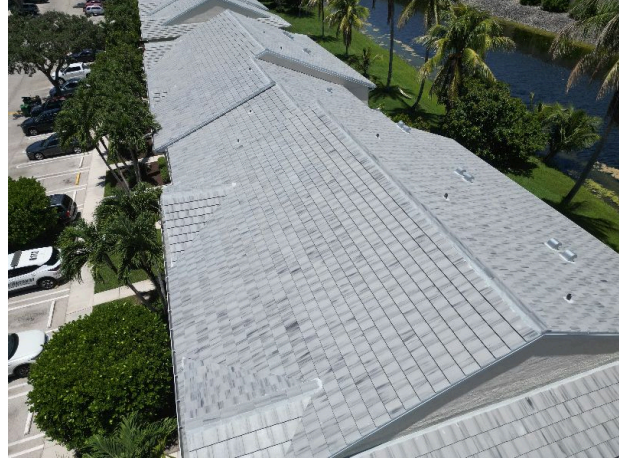
### ROOF COVERING

| 4.1 Roof Covering Type: | Permit<br>Application Date | FBC / MDC Product<br>Approval # | Year of Original Installation<br>or Replacement | No Information<br>Provided for Compliance |
|---|---|---|---|---|
| <input checked="" type="checkbox"/> Concrete/Clay Tile | <b>11/4/2025</b> | <b>25-001273</b> | . | |

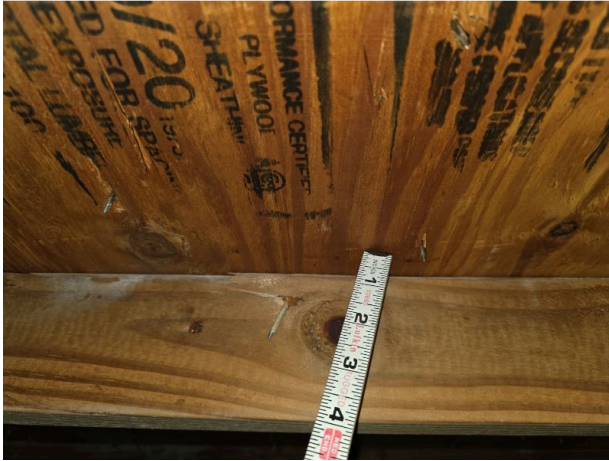
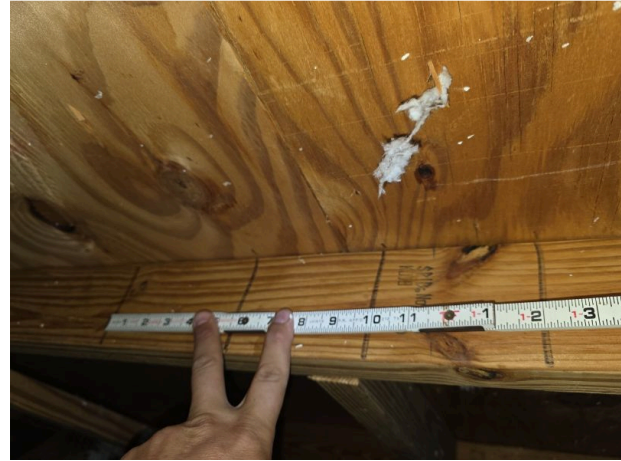
### ROOF TO DECK ATTACHMENT

- ☒ C. Plywood/OSB roof sheathing with a minimum thickness of 7/16" attached to the roof truss/rafter (spaced a maximum of 24" o.c.) by 8d common nails spaced a maximum of 6" in the field. OR Dimensional lumber/Tongue & Groove decking with a minimum of 2 nails per board (or 1 nail per board if each board is equal to or less than 6" in width). OR Any system of screws, nails, adhesives, other deck fastening system or truss/rafter spacing that is shown to have an equivalent or greater resistance than 8d common nails spaced a maximum of 6" in the field (max 24" truss/rafter spacing) or has a mean ultimate uplift resistance of at least 182 psf.

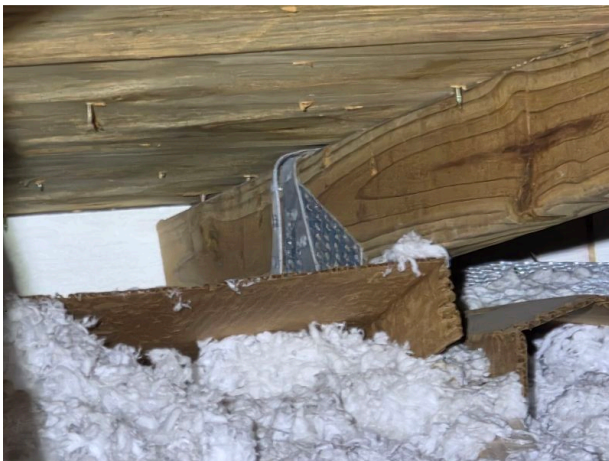
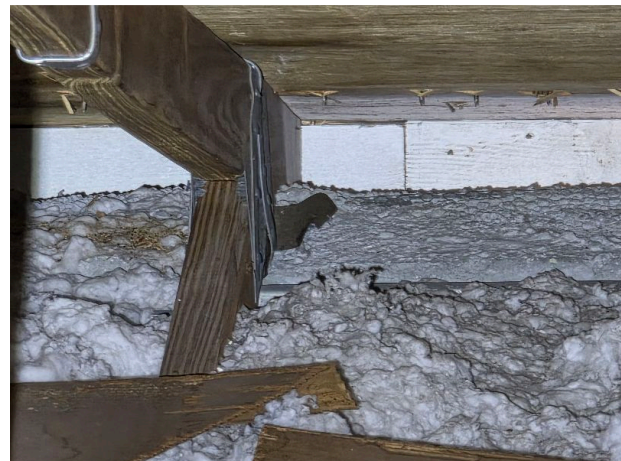
### ROOF TO WALL ATTACHMENT

- ☒ Metal Connectors consisting of two (2) separate straps, one on either side of the truss/rafter where each strap wraps over the truss/rafter and is secured with a minimum of two (2) nails on one side, and a minimum of one (1) nail on the opposing side, OR
- ☐ Metal connectors consisting of a single strap that wraps over the truss/rafter, are secured to the side of the wall and/or bottom of the top plate with a minimum of three (3) nails on each side, OR
- ☐ Purpose-made metal connector(s) or structural fastener(s) with a substantiated wind allowable uplift capacity of 891 lbs. or greater installed per the manufacturer's installation specifications (requires site-specific documentation).
