## Uniform Mitigation Verification Inspection Form

### Windstorm Mitigation Inspection

**9804-9832 NW 56TH PL CORAL SPRINGS, FL. 33076**

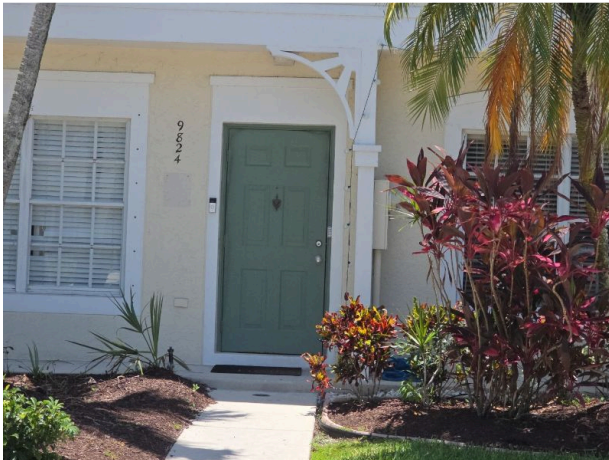
#### UNGLAZED OPENINGS

Entry doors are impact rated and approved(NOA #02-0408.04)

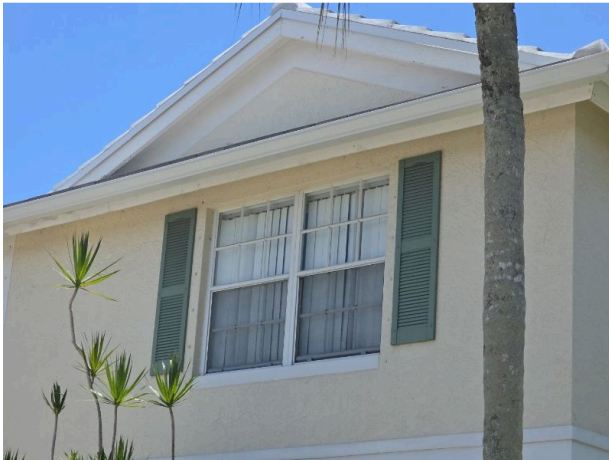
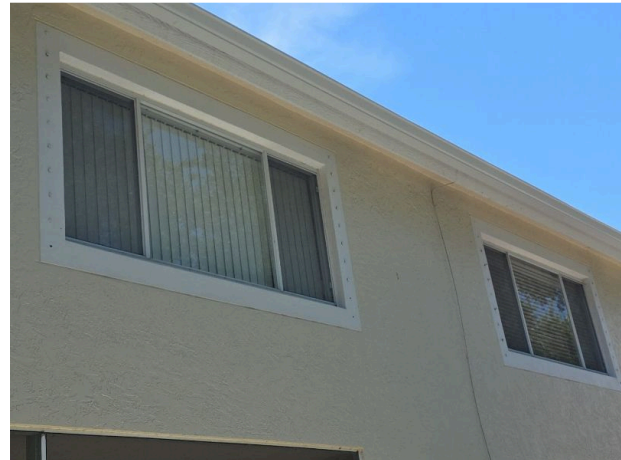
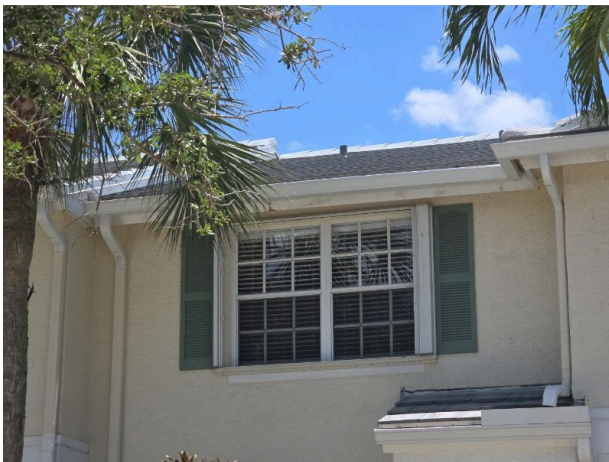
#### GLAZED OPENINGS

Glazed openings are protected with a combination of approved storm panels and approved accordion shutters.

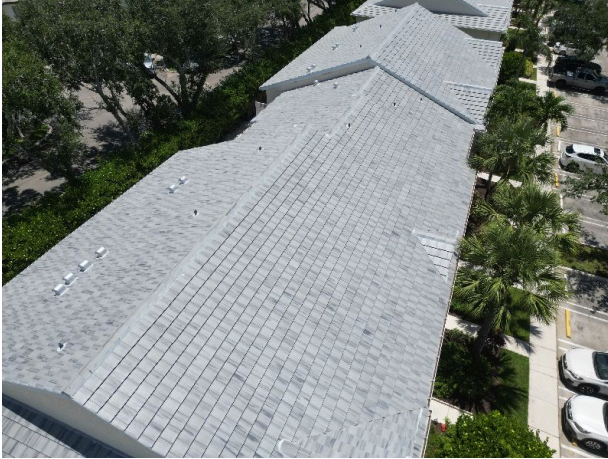
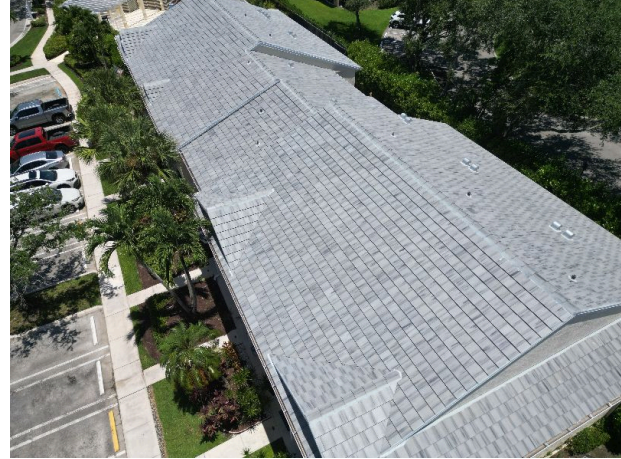
### ROOF COVERING

| 4.1 Roof Covering Type: | Permit Application Date | FBC / MDC Product Approval # | Year of Original Installation or Replacement | No Information Provided for Compliance |
|---|---|---|---|---|
| <input checked="" type="checkbox"/> Concrete/Clay Tile | <b>10/29/2025</b> | <b>25-001234</b> | . | |

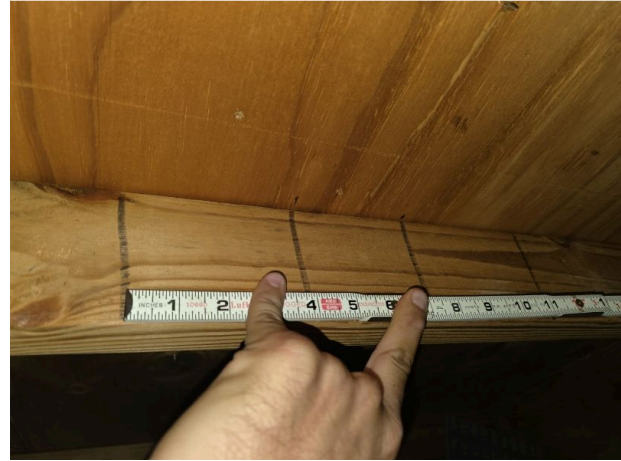
### ROOF TO DECK ATTACHMENT

- ☒ C. Plywood/OSB roof sheathing with a minimum thickness of 7/16" attached to the roof truss/rafter (spaced a maximum of 24" o.c.) by 8d common nails spaced a maximum of 6" in the field. OR Dimensional lumber/Tongue & Groove decking with a minimum of 2 nails per board (or 1 nail per board if each board is equal to or less than 6" in width). OR Any system of screws, nails, adhesives, other deck fastening system or truss/rafter spacing that is shown to have an equivalent or greater resistance than 8d common nails spaced a maximum of 6" in the field (max 24" truss/rafter spacing) or has a mean ultimate uplift resistance of at least 182 psf.

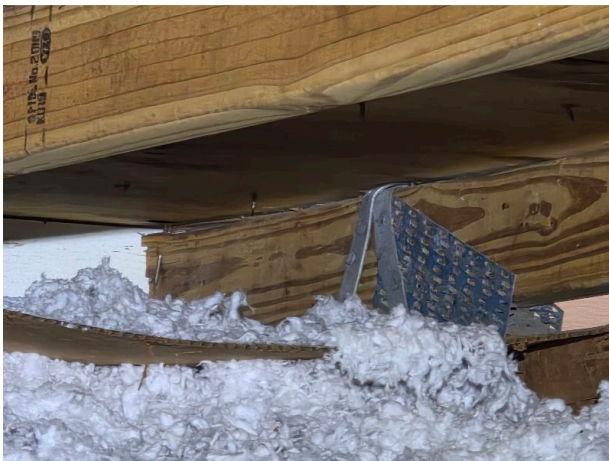
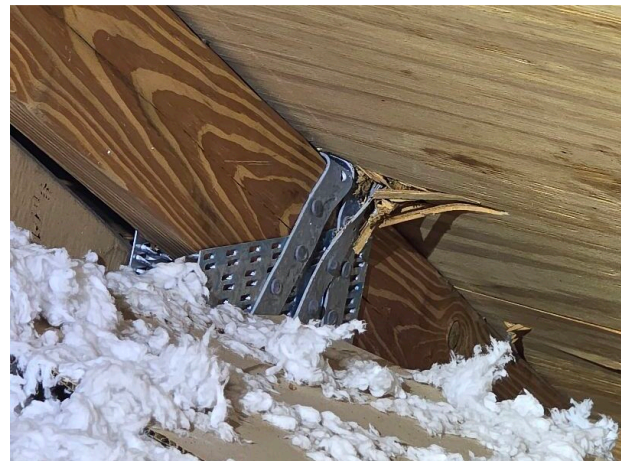
### ROOF TO WALL ATTACHMENT

- ☒ Metal Connectors consisting of two (2) separate straps, one on either side of the truss/rafter where each strap wraps over the truss/rafter and is secured with a minimum of two (2) nails on one side, and a minimum of one (1) nail on the opposing side, OR
- ☐ Metal connectors consisting of a single strap that wraps over the truss/rafter, are secured to the side of the wall and/or bottom of the top plate with a minimum of three (3) nails on each side, OR
- ☐ Purpose-made metal connector(s) or structural fastener(s) with a substantiated wind allowable uplift capacity of 891 lbs. or greater installed per the manufacturer's installation specifications (requires site-specific documentation).
