## Uniform Mitigation Verification Inspection Form

### Windstorm Mitigation Inspection

**9841-9869 NW 56TH PL CORAL SPRINGS, FL. 33076**

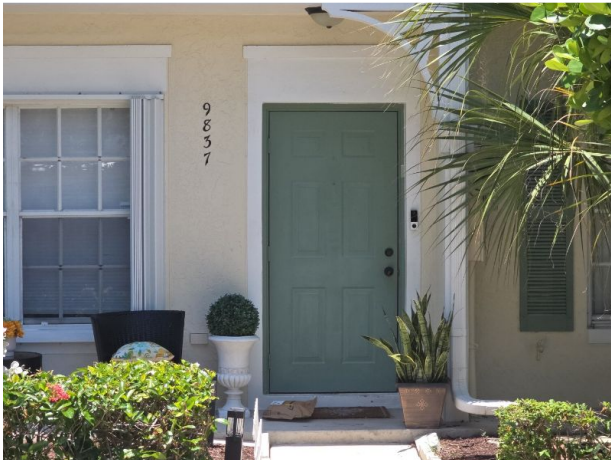
#### UNGLAZED OPENINGS

Entry doors are impact rated and approved(NOA #02-0408.04)

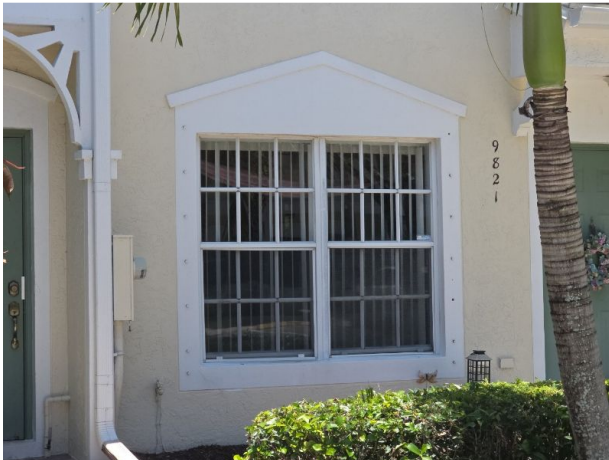
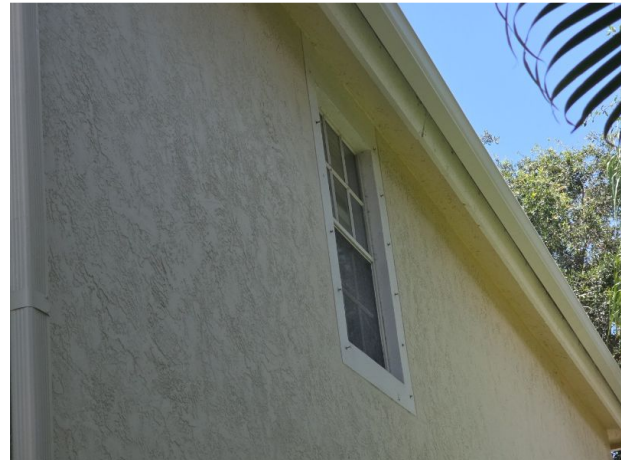
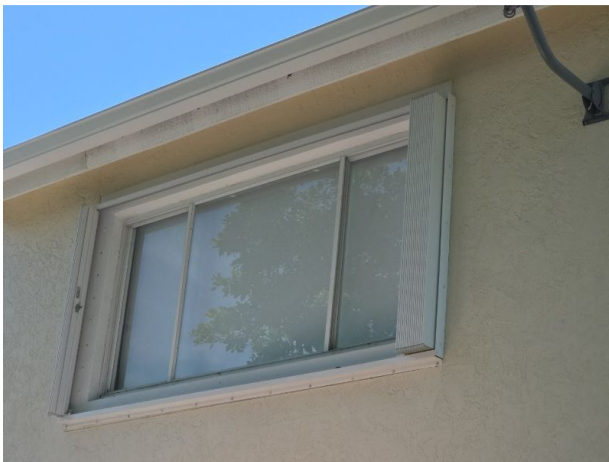
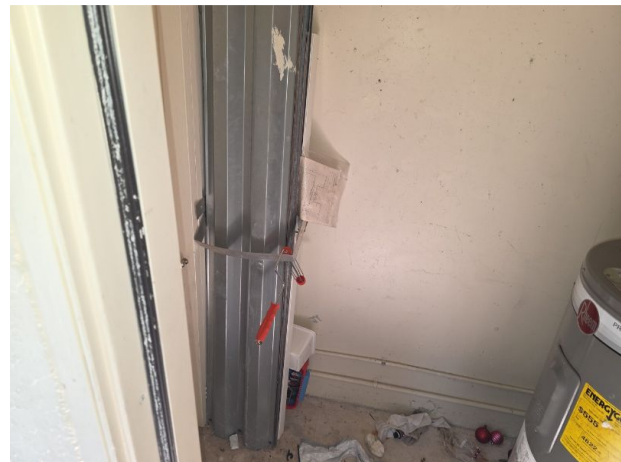
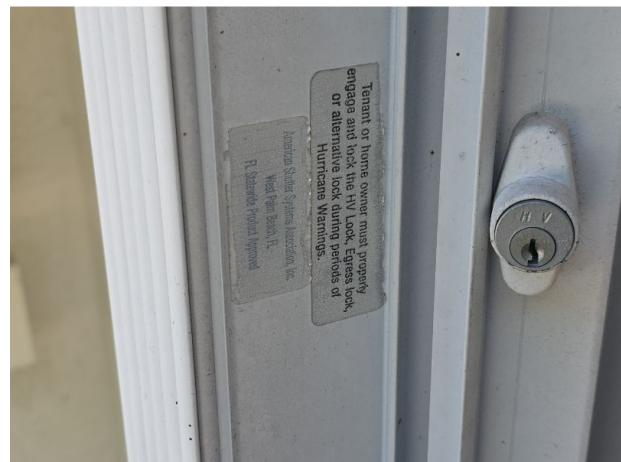
#### GLAZED OPENINGS

Glazed openings are protected with a combination of approved storm panels and approved accordion shutters.

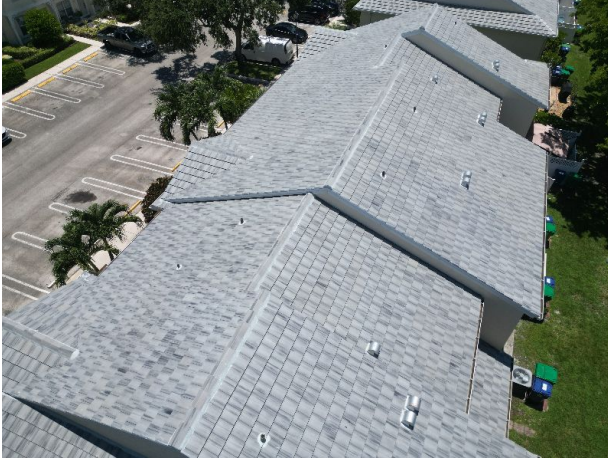
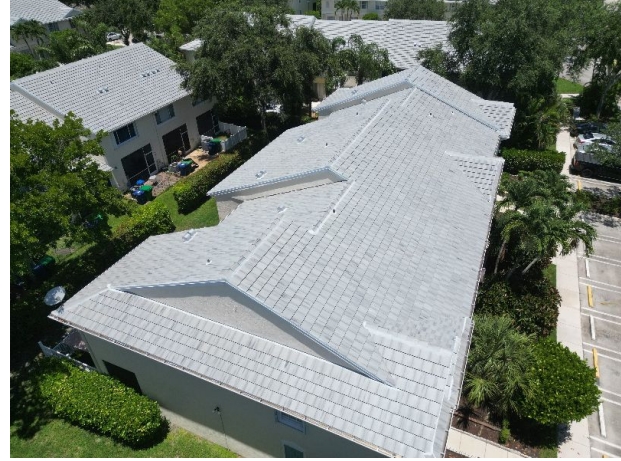
### ROOF COVERING

| 4.1 Roof Covering Type: | Permit Application Date | FBC / MDC Product Approval # | Year of Original Installation or Replacement | No Information Provided for Compliance |
|---|---|---|---|---|
| <input checked="" type="checkbox"/> Concrete/Clay Tile | <b>10/29/2025</b> | <b>25-001233</b> | <b>.</b> | _____ |

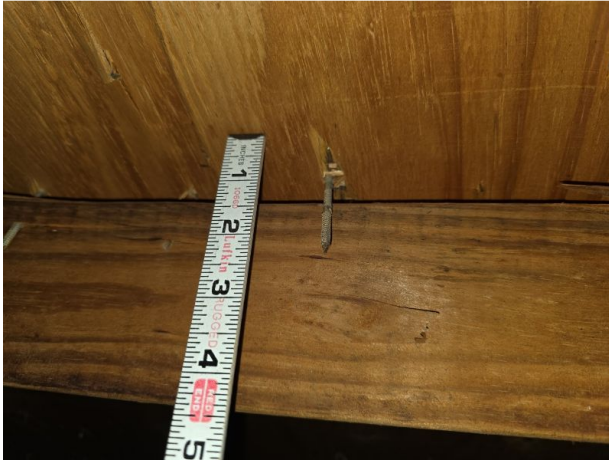
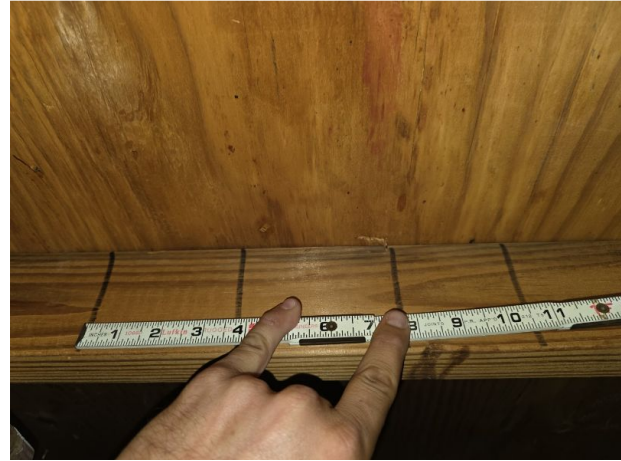
### ROOF TO DECK ATTACHMENT

- ☒ C. Plywood/OSB roof sheathing with a minimum thickness of 7/16" attached to the roof truss/rafter (spaced a maximum of 24" o.c.) by 8d common nails spaced a maximum of 6" in the field. OR Dimensional lumber/Tongue & Groove decking with a minimum of 2 nails per board (or 1 nail per board if each board is equal to or less than 6" in width). OR Any system of screws, nails, adhesives, other deck fastening system or truss/rafter spacing that is shown to have an equivalent or greater resistance than 8d common nails spaced a maximum of 6" in the field (max 24" truss/rafter spacing) or has a mean ultimate uplift resistance of at least 182 psf.

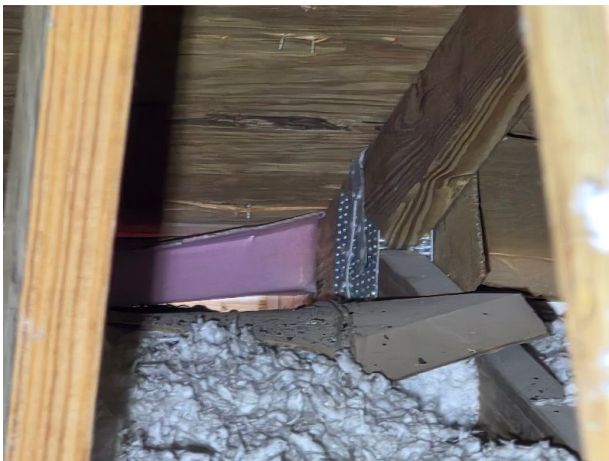
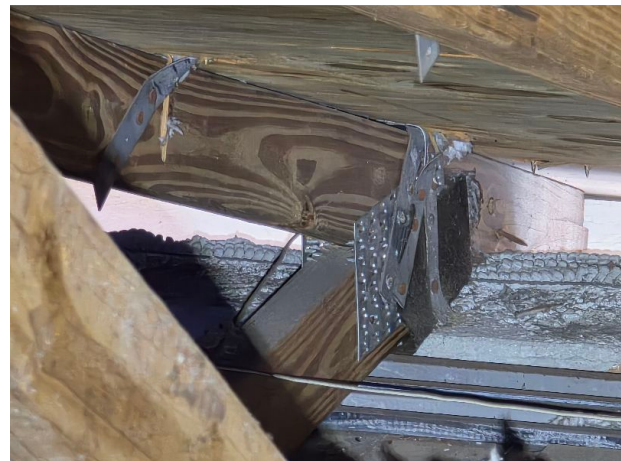
### ROOF TO WALL ATTACHMENT

- ☒ Metal Connectors consisting of two (2) separate straps, one on either side of the truss/rafter where each strap wraps over the truss/rafter and is secured with a minimum of two (2) nails on one side, and a minimum of one (1) nail on the opposing side, OR
- ☐ Metal connectors consisting of a single strap that wraps over the truss/rafter, are secured to the side of the wall and/or bottom of the top plate with a minimum of three (3) nails on each side, OR
- ☐ Purpose-made metal connector(s) or structural fastener(s) with a substantiated wind allowable uplift capacity of 891 lbs. or greater installed per the manufacturer's installation specifications (requires site-specific documentation).
