## Uniform Mitigation Verification Inspection Form

### Windstorm Mitigation Inspection

**9826-9850 NW 57TH MANOR CORAL SPRINGS, FL. 33076**

| OWNER NAME: <b>CORAL REEF CLUB HOMEOWNERS ASSOCIATION</b> | | TEL: |

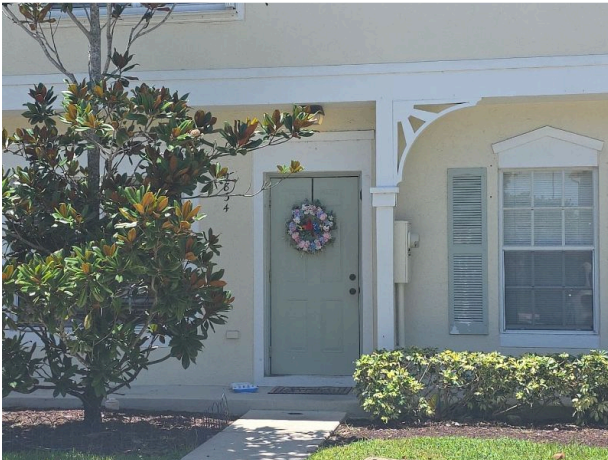
#### UNGLAZED OPENINGS

Entry doors are impact rated and approved(NOA #02-0408.04)

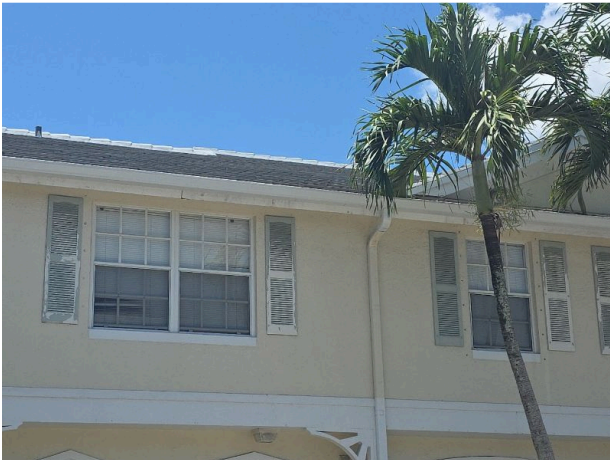
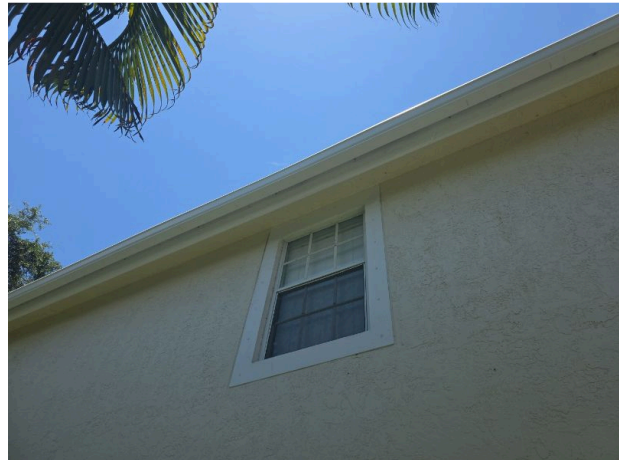
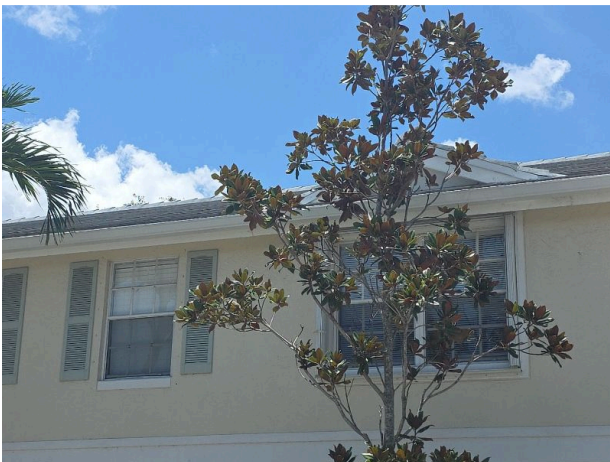
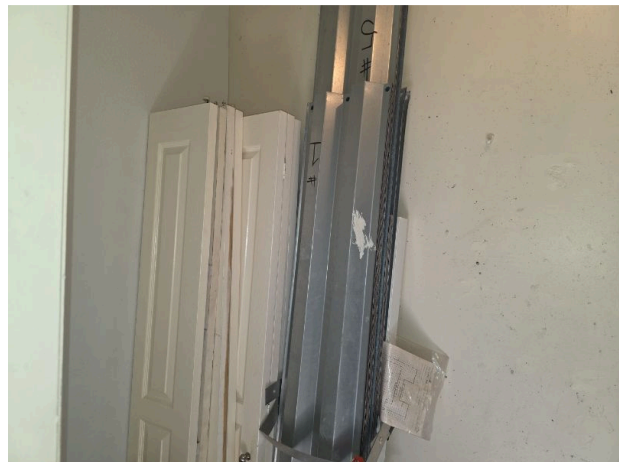
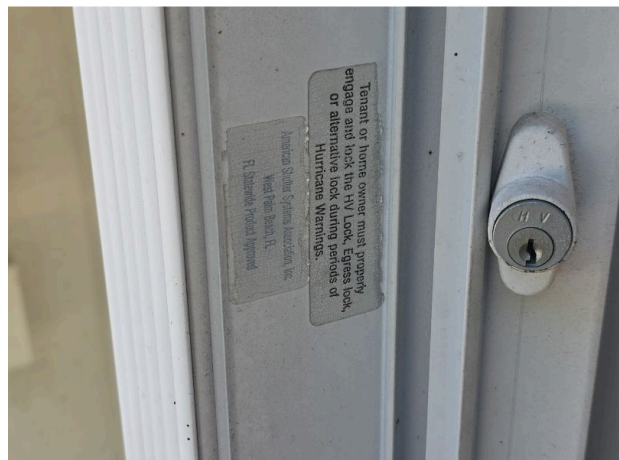
#### GLAZED OPENINGS

Glazed openings are protected with a combination of approved storm panels and approved accordion shutters.

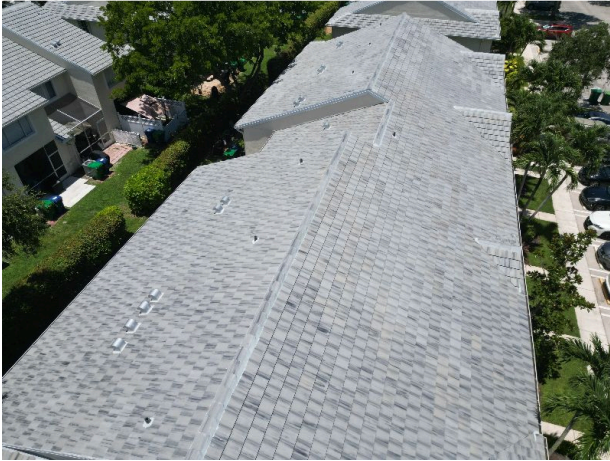
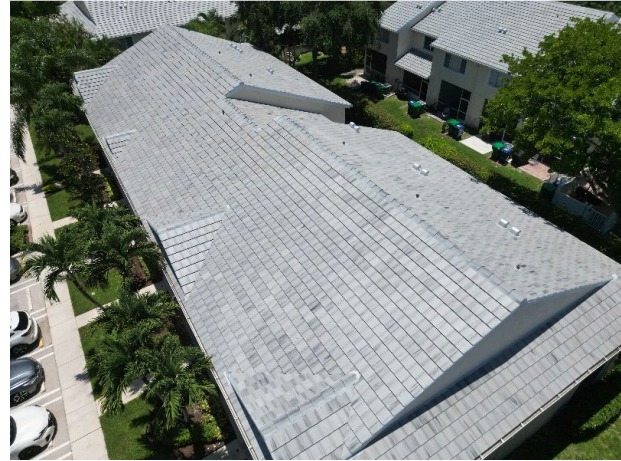
### ROOF COVERING

| 4.1 Roof Covering Type: | Permit<br>Application Date | FBC / MDC Product<br>Approval # | Year of Original Installation<br>or Replacement | No Information<br>Provided for Compliance |
|---|---|---|---|---|
| <input checked="" type="checkbox"/> Concrete/Clay Tile | <b>10/29/2025</b> | <b>25-001236</b> | <b>.</b> | <input type="checkbox"/> |

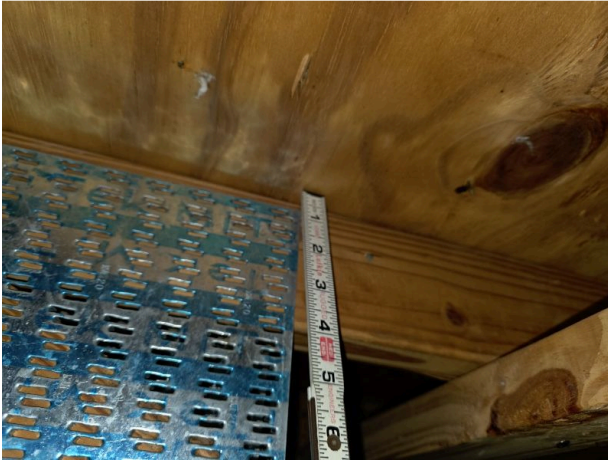
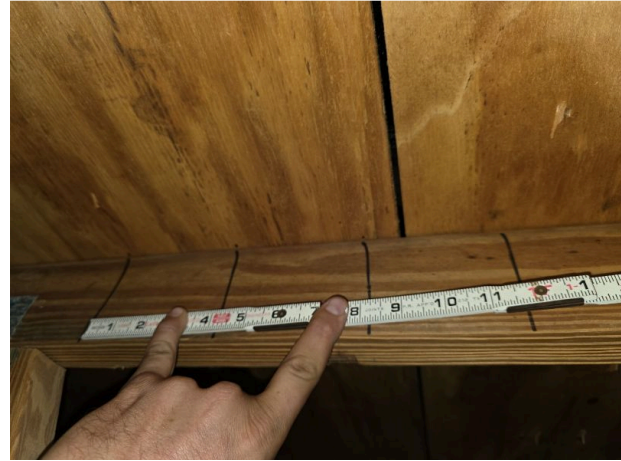
### ROOF TO DECK ATTACHMENT

- ☒ C. Plywood/OSB roof sheathing with a minimum thickness of 7/16" attached to the roof truss/rafter (spaced a maximum of 24" o.c.) by 8d common nails spaced a maximum of 6" in the field. OR Dimensional lumber/Tongue & Groove decking with a minimum of 2 nails per board (or 1 nail per board if each board is equal to or less than 6" in width). OR Any system of screws, nails, adhesives, other deck fastening system or truss/rafter spacing that is shown to have an equivalent or greater resistance than 8d common nails spaced a maximum of 6" in the field (max 24" truss/rafter spacing) or has a mean ultimate uplift resistance of at least 182 psf.

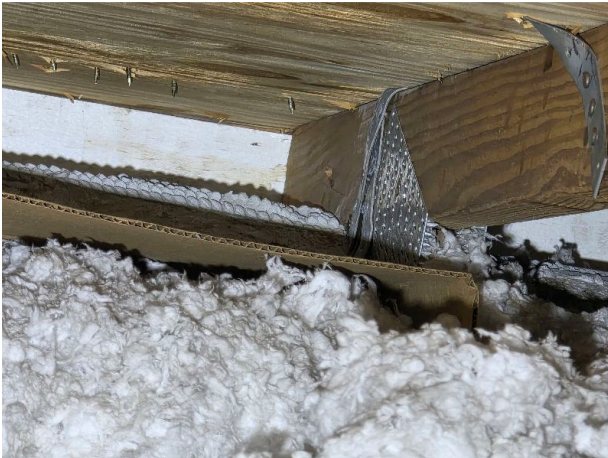
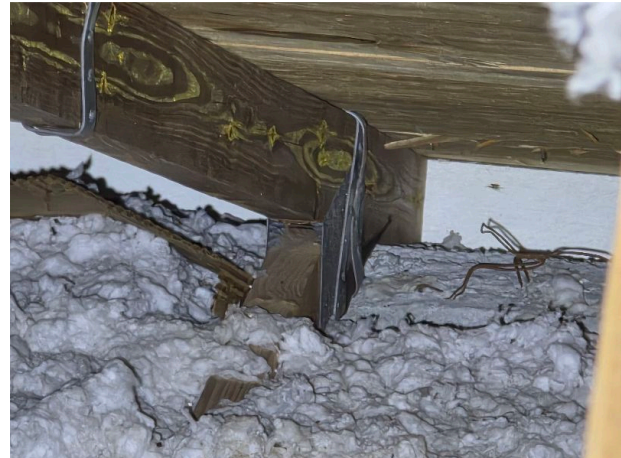
### ROOF TO WALL ATTACHMENT

- ☒ Metal Connectors consisting of two (2) separate straps, one on either side of the truss/rafter where each strap wraps over the truss/rafter and is secured with a minimum of two (2) nails on one side, and a minimum of one (1) nail on the opposing side, OR
- ☐ Metal connectors consisting of a single strap that wraps over the truss/rafter, are secured to the side of the wall and/or bottom of the top plate with a minimum of three (3) nails on each side, OR
- ☐ Purpose-made metal connector(s) or structural fastener(s) with a substantiated wind allowable uplift capacity of 891 lbs. or greater installed per the manufacturer's installation specifications (requires site-specific documentation).
