## Uniform Mitigation Verification Inspection Form

### Windstorm Mitigation Inspection

**9835-9855 NW 57TH MANOR CORAL SPRINGS, FL. 33076**

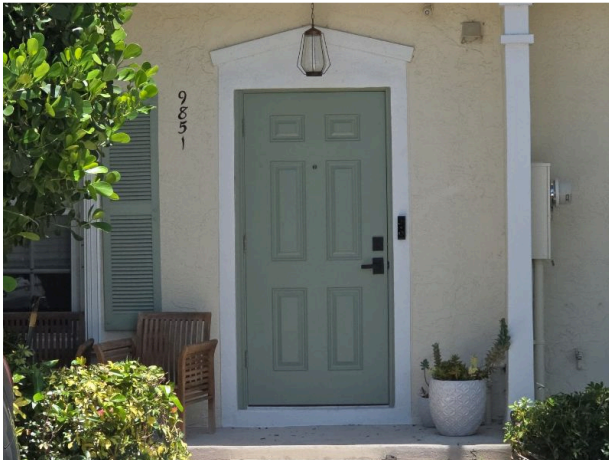
#### UNGLAZED OPENINGS

Entry doors are impact rated and approved(NOA #02-0408.04)

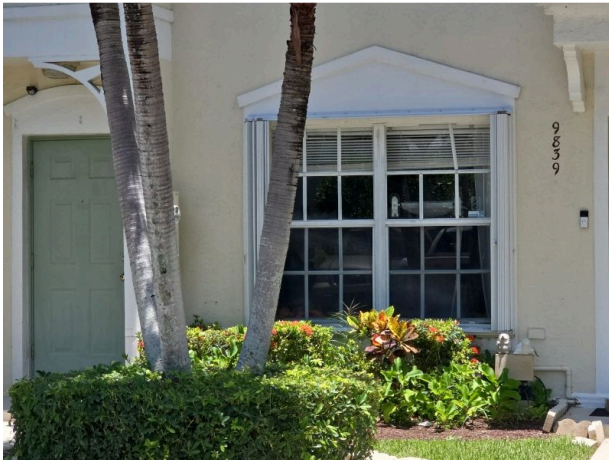
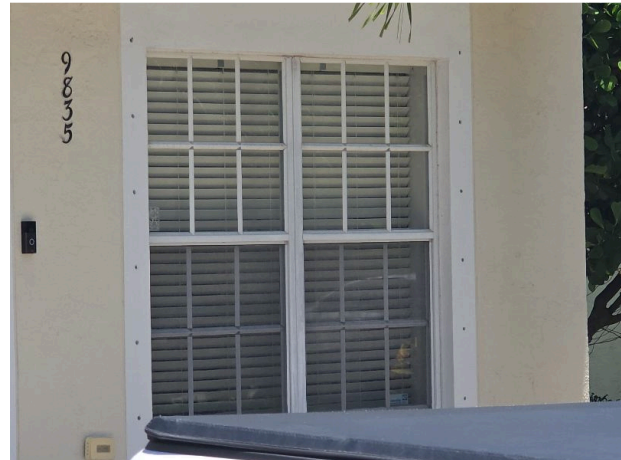
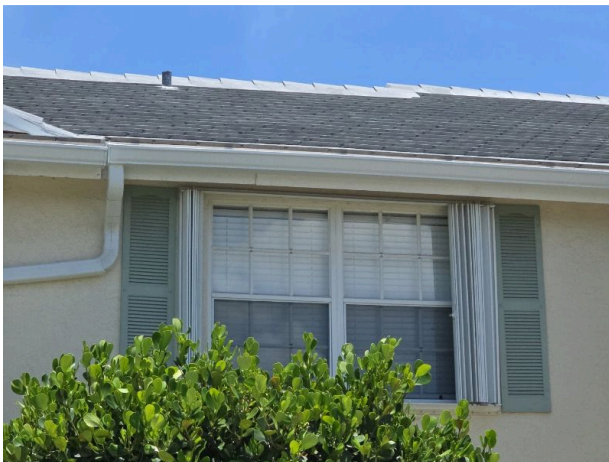
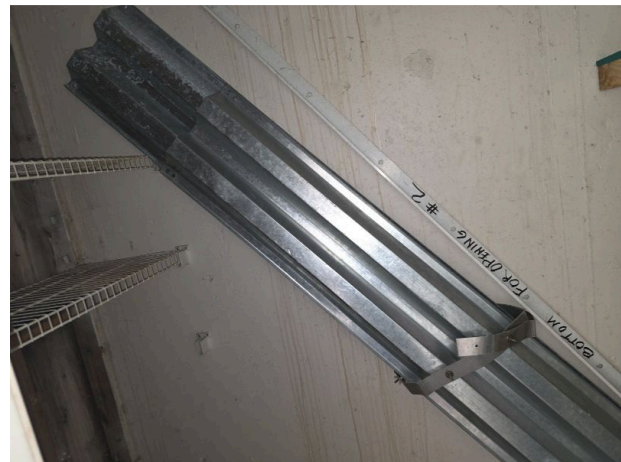
#### GLAZED OPENINGS

Glazed openings are protected with a combination of approved storm panels and approved accordion shutters.

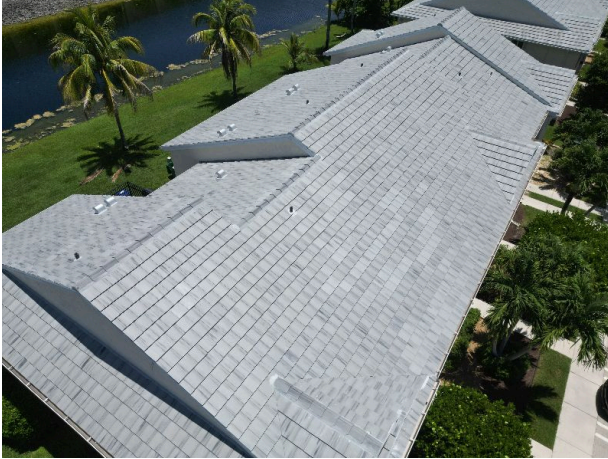
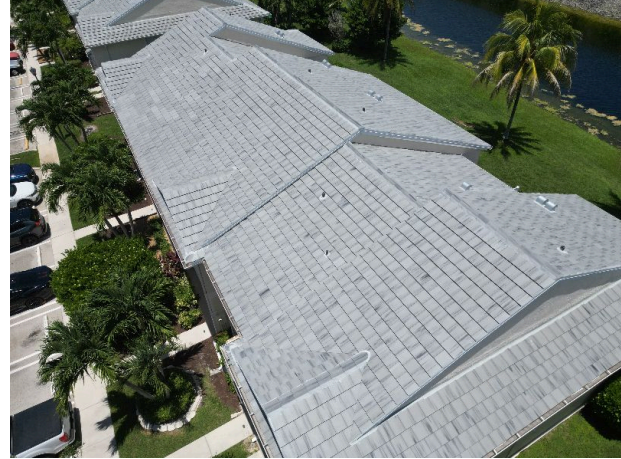
### ROOF COVERING

| 4.1 Roof Covering Type: | Permit<br>Application Date | FBC / MDC Product<br>Approval # | Year of Original Installation<br>or Replacement | No Information<br>Provided for Compliance |
|---|---|---|---|---|
| <input checked="" type="checkbox"/> Concrete/Clay Tile | <b>11/4/2025</b> | <b>25-001271</b> | . | |

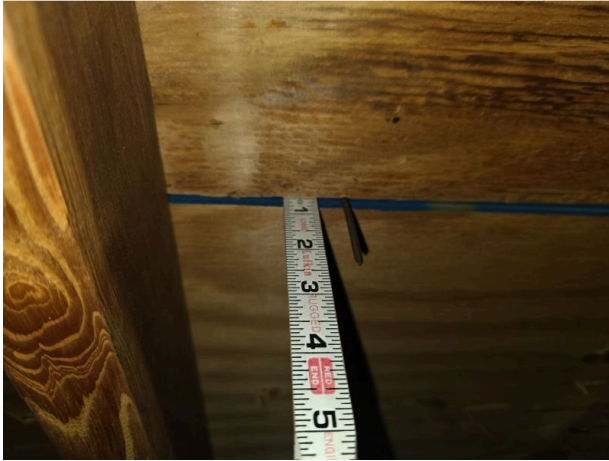
### ROOF TO DECK ATTACHMENT

- ☒ C. Plywood/OSB roof sheathing with a minimum thickness of 7/16" attached to the roof truss/rafter (spaced a maximum of 24" o.c.) by 8d common nails spaced a maximum of 6" in the field. OR Dimensional lumber/Tongue & Groove decking with a minimum of 2 nails per board (or 1 nail per board if each board is equal to or less than 6" in width). OR Any system of screws, nails, adhesives, other deck fastening system or truss/rafter spacing that is shown to have an equivalent or greater resistance than 8d common nails spaced a maximum of 6" in the field (max 24" truss/rafter spacing) or has a mean ultimate uplift resistance of at least 182 psf.

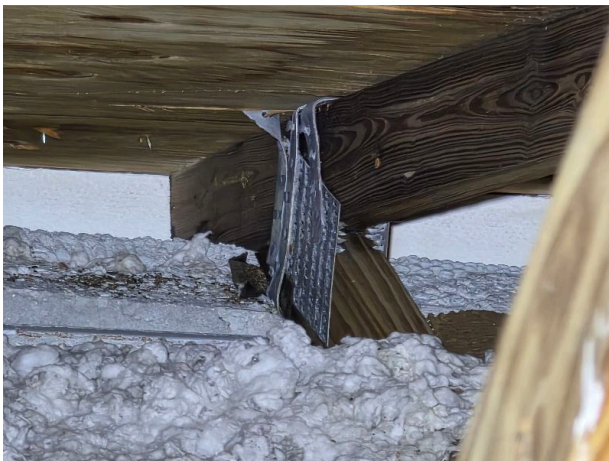
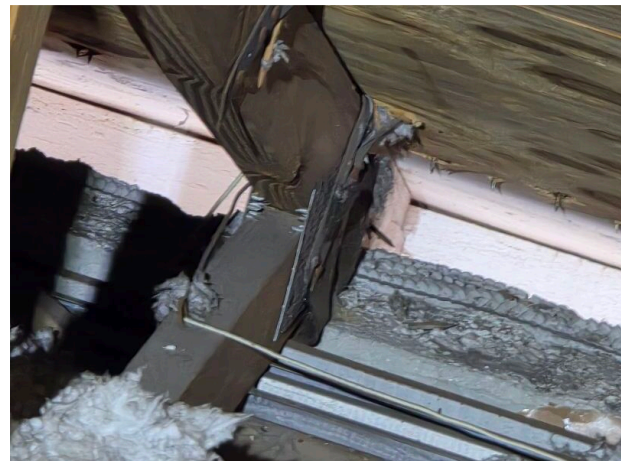
### ROOF TO WALL ATTACHMENT

☒ **D. Double Wraps**

- ☒ Metal Connectors consisting of two (2) separate straps, one on either side of the truss/rafter where each strap wraps over the truss/rafter and is secured with a minimum of two (2) nails on one side, and a minimum of one (1) nail on the opposing side, OR
- ☐ Metal connectors consisting of a single strap that wraps over the truss/rafter, are secured to the side of the wall and/or bottom of the top plate with a minimum of three (3) nails on each side, OR
- ☐ Purpose-made metal connector(s) or structural fastener(s) with a substantiated wind allowable uplift capacity of 891 lbs. or greater installed per the manufacturer's installation specifications (requires site-specific documentation).
