## Uniform Mitigation Verification Inspection Form

### Windstorm Mitigation Inspection

**9836-9864 NW 56TH PL CORAL SPRINGS, FL. 33076**

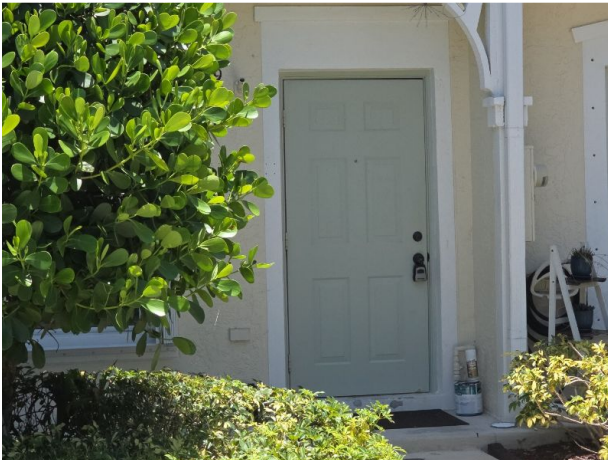
#### UNGLAZED OPENINGS

Entry doors are impact rated and approved(NOA #02-0408.04)

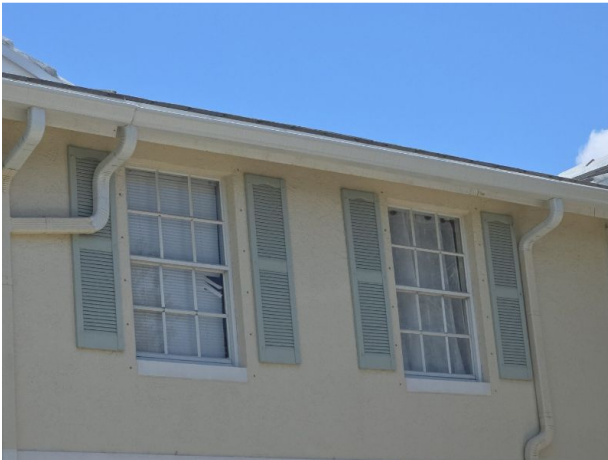
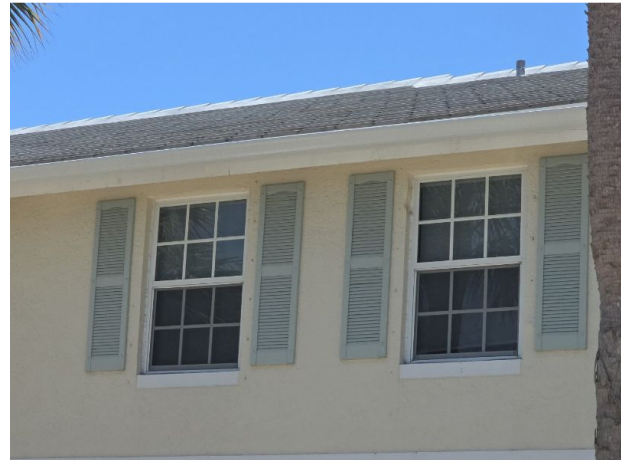
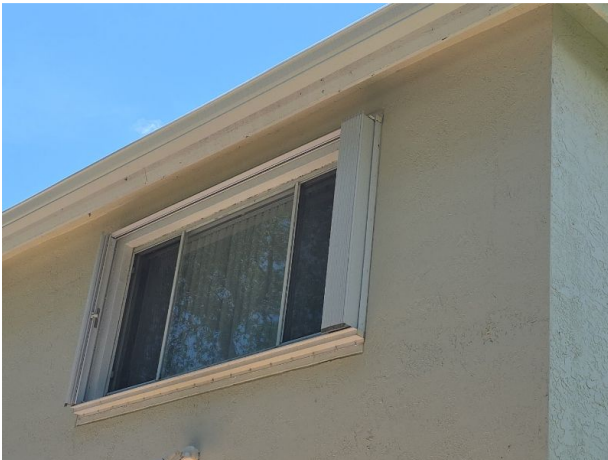
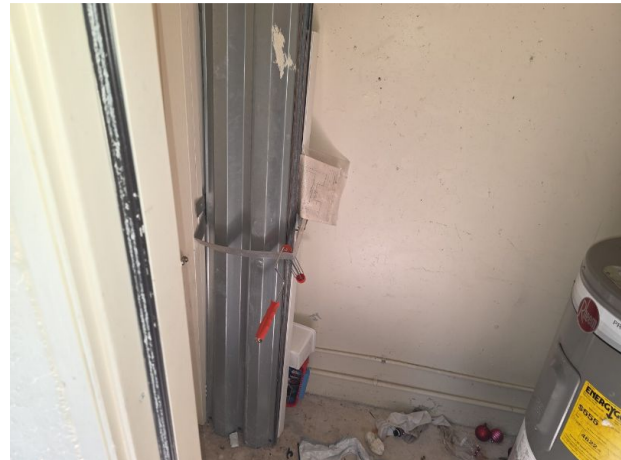
#### GLAZED OPENINGS

Glazed openings are protected with a combination of approved storm panels and approved accordion shutters.

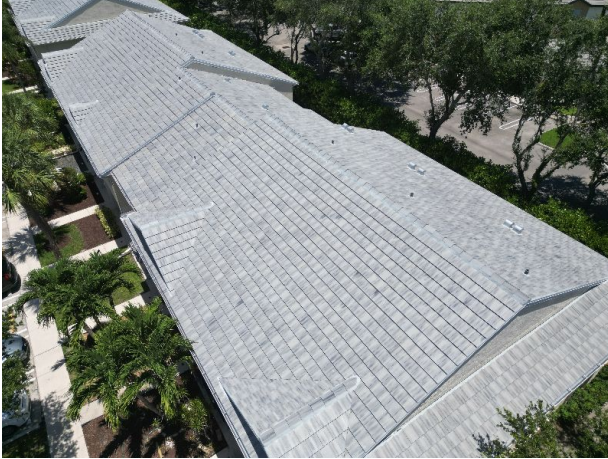
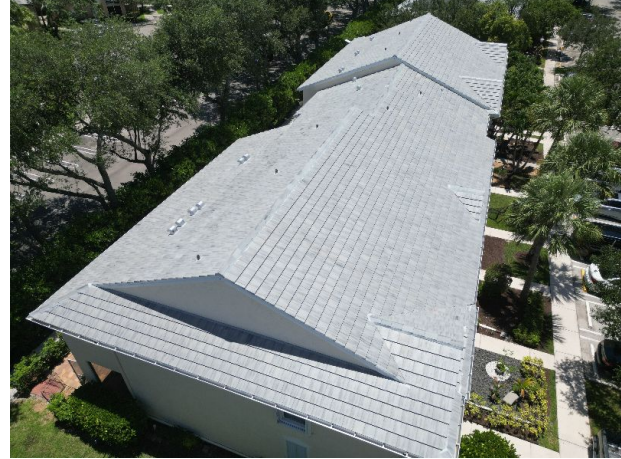
### ROOF COVERING

| 4.1 Roof Covering Type: | Permit Application Date | FBC / MDC Product Approval # | Year of Original Installation or Replacement | No Information Provided for Compliance |
|---|---|---|---|---|
| <input checked="" type="checkbox"/> Concrete/Clay Tile | <b>10/8/2025</b> | <b>25-001182</b> | <b>.</b> | _____ |

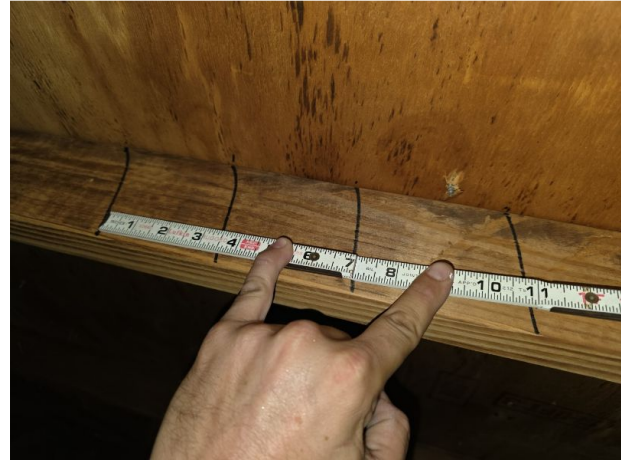
### ROOF TO DECK ATTACHMENT

- ☒ C. Plywood/OSB roof sheathing with a minimum thickness of 7/16" attached to the roof truss/rafter (spaced a maximum of 24" o.c.) by 8d common nails spaced a maximum of 6" in the field. OR Dimensional lumber/Tongue & Groove decking with a minimum of 2 nails per board (or 1 nail per board if each board is equal to or less than 6" in width). OR Any system of screws, nails, adhesives, other deck fastening system or truss/rafter spacing that is shown to have an equivalent or greater resistance than 8d common nails spaced a maximum of 6" in the field (max 24" truss/rafter spacing) or has a mean ultimate uplift resistance of at least 182 psf.

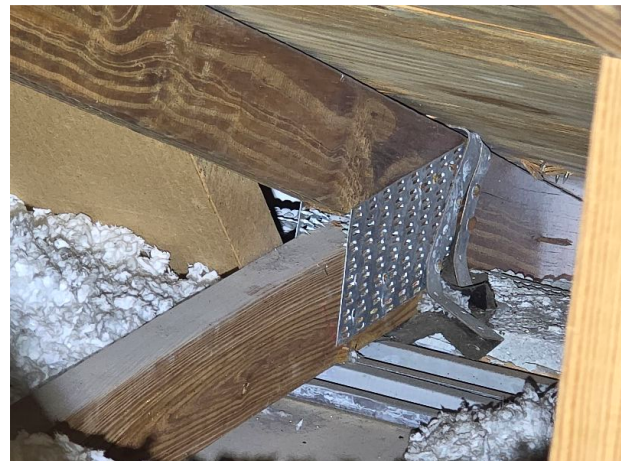
### ROOF TO WALL ATTACHMENT

- ☒ Metal Connectors consisting of two (2) separate straps, one on either side of the truss/rafter where each strap wraps over the truss/rafter and is secured with a minimum of two (2) nails on one side, and a minimum of one (1) nail on the opposing side, OR
- ☐ Metal connectors consisting of a single strap that wraps over the truss/rafter, are secured to the side of the wall and/or bottom of the top plate with a minimum of three (3) nails on each side, OR
- ☐ Purpose-made metal connector(s) or structural fastener(s) with a substantiated wind allowable uplift capacity of 891 lbs. or greater installed per the manufacturer's installation specifications (requires site-specific documentation).
