## Uniform Mitigation Verification Inspection Form

### Windstorm Mitigation Inspection

**9841-9869 NW 56TH PL CORAL SPRINGS, FL. 33076**

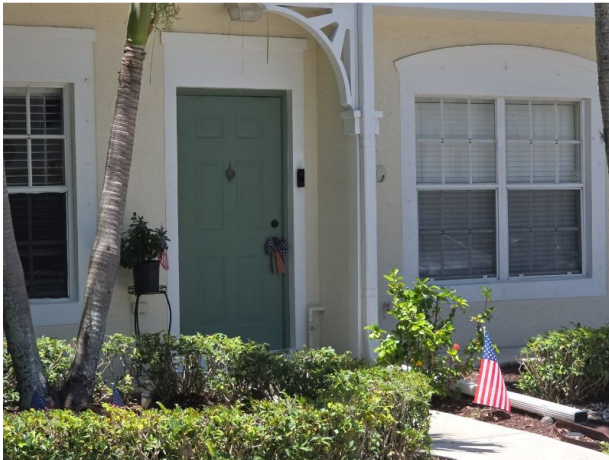
#### UNGLAZED OPENINGS

Entry doors are impact rated and approved(NOA #02-0408.04)

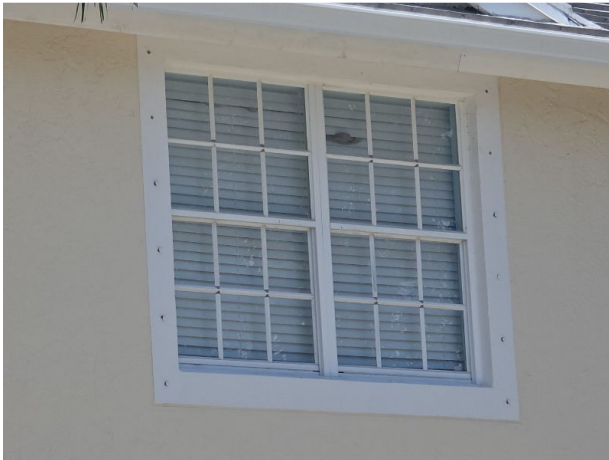
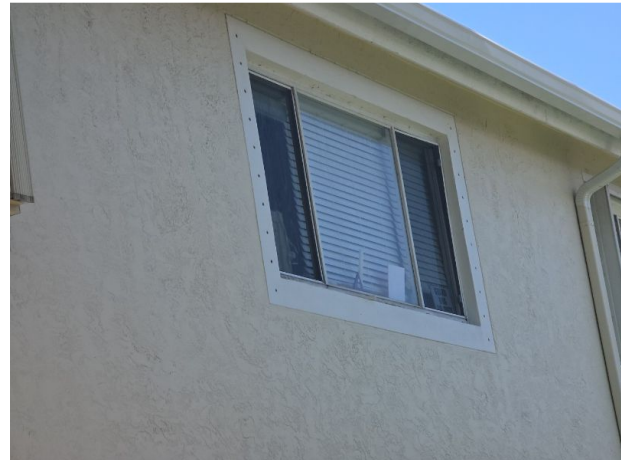
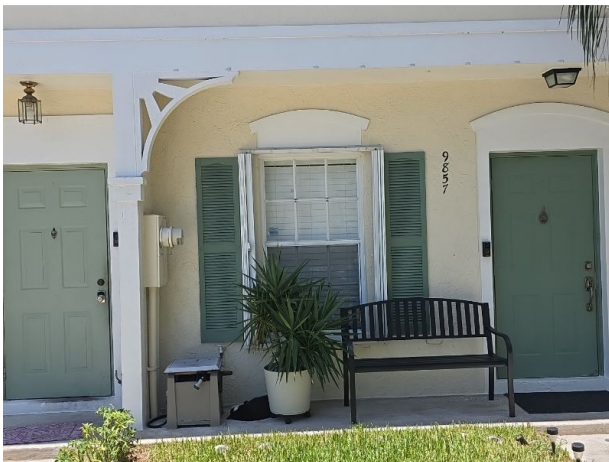
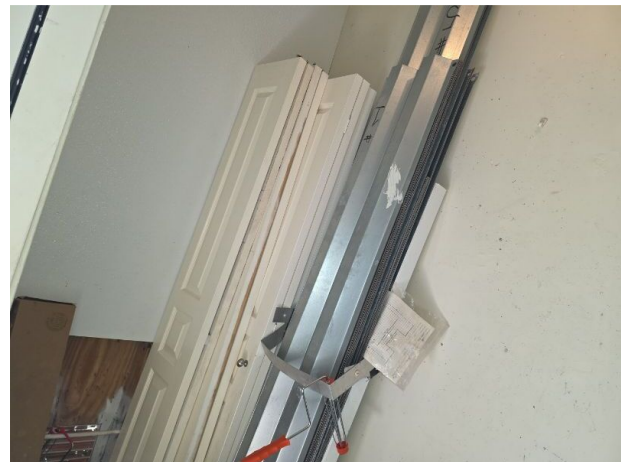
#### GLAZED OPENINGS

Glazed openings are protected with a combination of approved storm panels and approved accordion shutters.

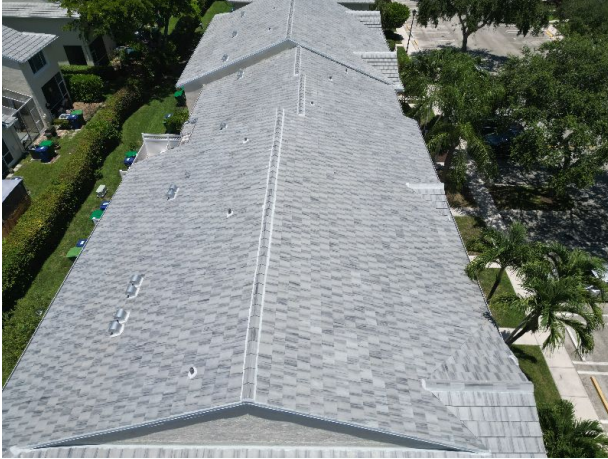
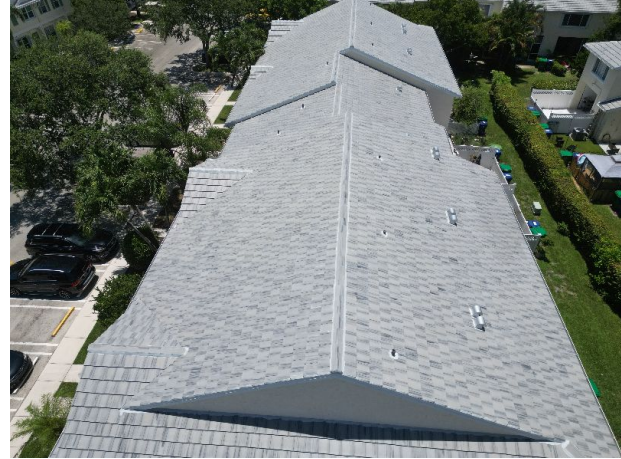
### ROOF COVERING

| 4.1 Roof Covering Type: | Permit Application Date | FBC / MDC Product Approval # | Year of Original Installation or Replacement | No Information Provided for Compliance |
|---|---|---|---|---|
| <input checked="" type="checkbox"/> Concrete/Clay Tile | <b>10/15/2025</b> | <b>25-001203</b> | <b>.</b> | <input type="checkbox"/> |

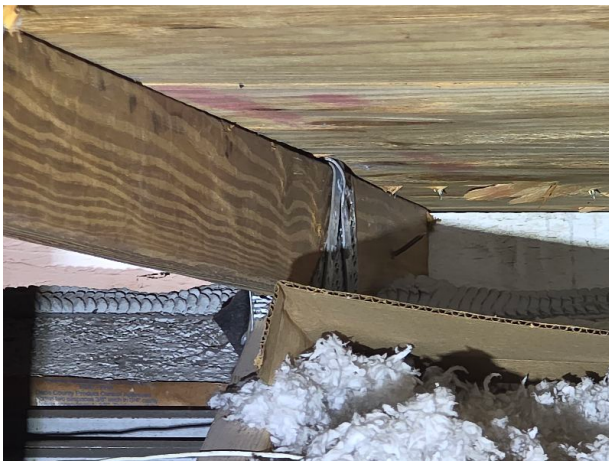
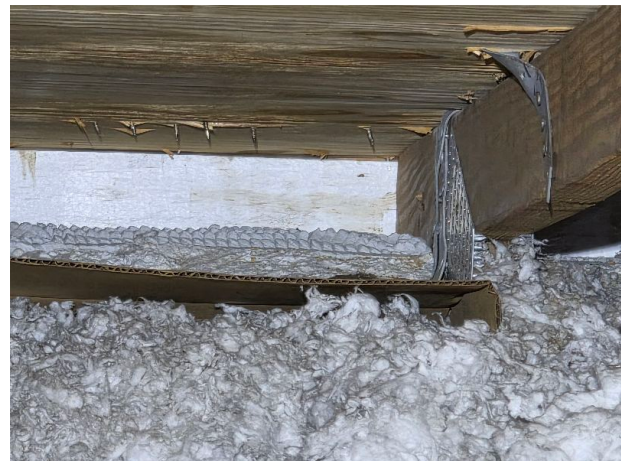
### ROOF TO WALL ATTACHMENT

- ☒ Metal Connectors consisting of two (2) separate straps, one on either side of the truss/rafter where each strap wraps over the truss/rafter and is secured with a minimum of two (2) nails on one side, and a minimum of one (1) nail on the opposing side, OR
- ☐ Metal connectors consisting of a single strap that wraps over the truss/rafter, are secured to the side of the wall and/or bottom of the top plate with a minimum of three (3) nails on each side, OR
- ☐ Purpose-made metal connector(s) or structural fastener(s) with a substantiated wind allowable uplift capacity of 891 lbs. or greater installed per the manufacturer's installation specifications (requires site-specific documentation).
