## Uniform Mitigation Verification Inspection Form

### Windstorm Mitigation Inspection

**9854-9874 NW 57TH MANOR CORAL SPRINGS, FL. 33076**

| OWNER NAME: <b>CORAL REEF CLUB HOMEOWNERS ASSOCIATION</b> | | TEL: |

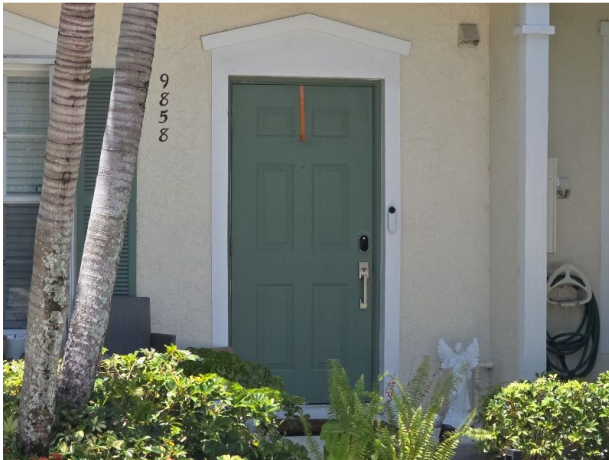
#### UNGLAZED OPENINGS

Entry doors are impact rated and approved(NOA #02-0408.04)

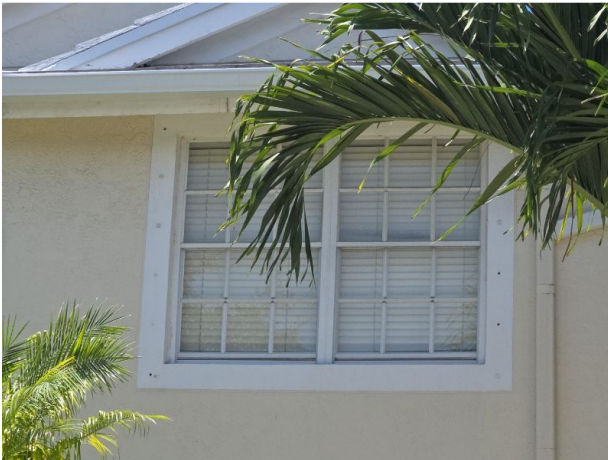
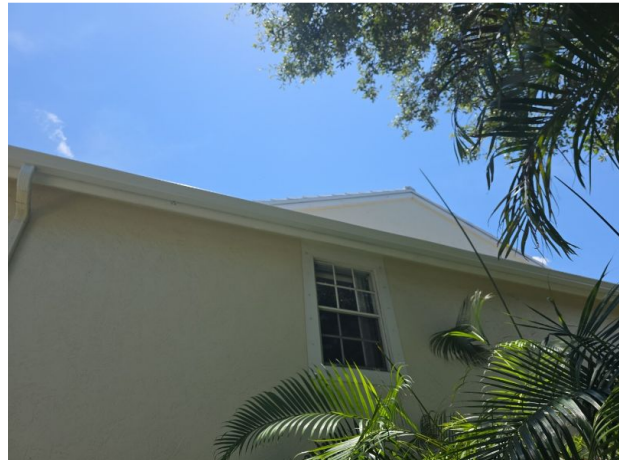
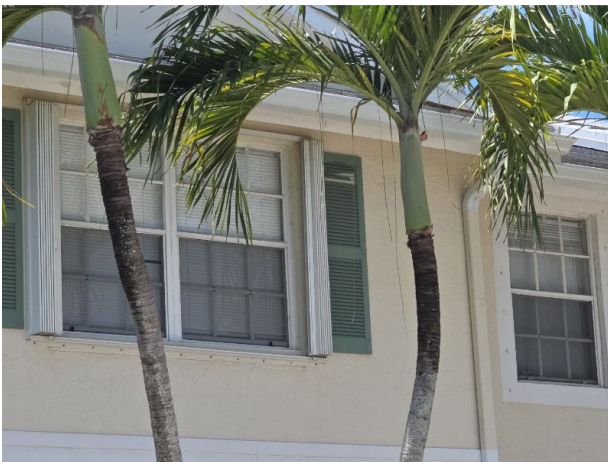
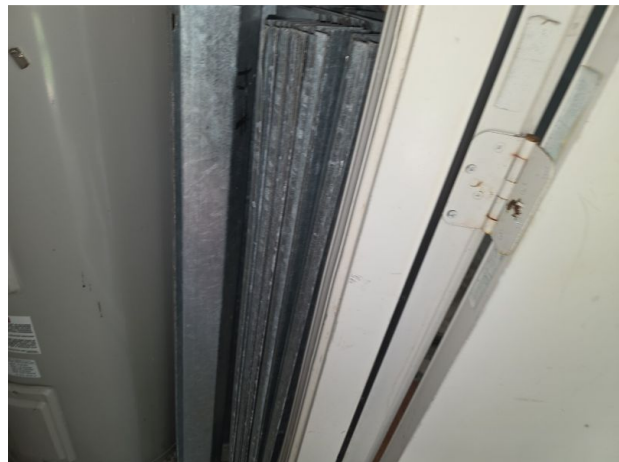
#### GLAZED OPENINGS

Glazed openings are protected with a combination of approved storm panels and approved accordion shutters.

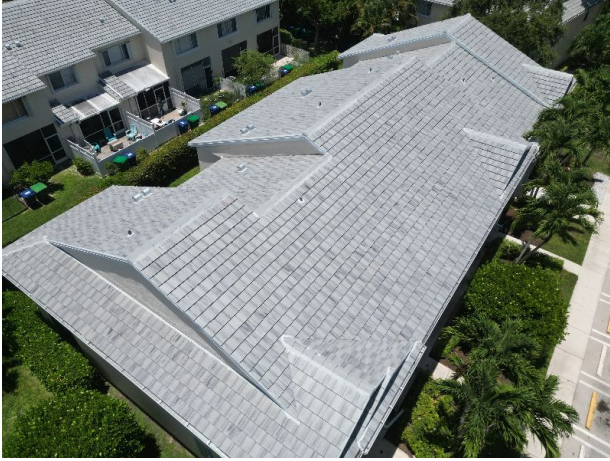
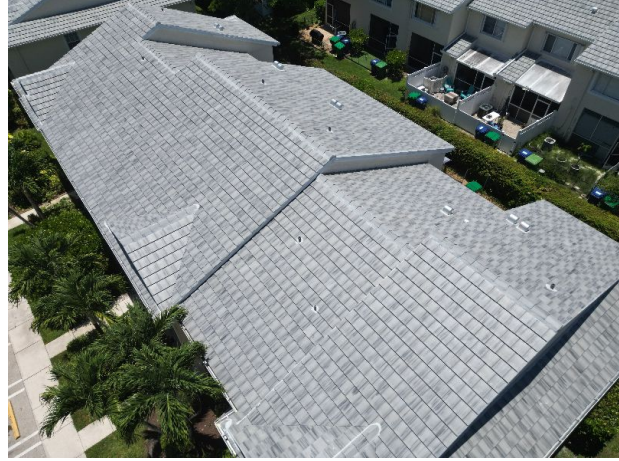
### ROOF COVERING

| 4.1 Roof Covering Type: | Permit<br>Application Date | FBC / MDC Product<br>Approval # | Year of Original Installation<br>or Replacement | No Information<br>Provided for Compliance |
|---|---|---|---|---|
| <input checked="" type="checkbox"/> Concrete/Clay Tile | <b>10/15/2025</b> | <b>25-001206</b> | <b>.</b> | <input type="checkbox"/> |

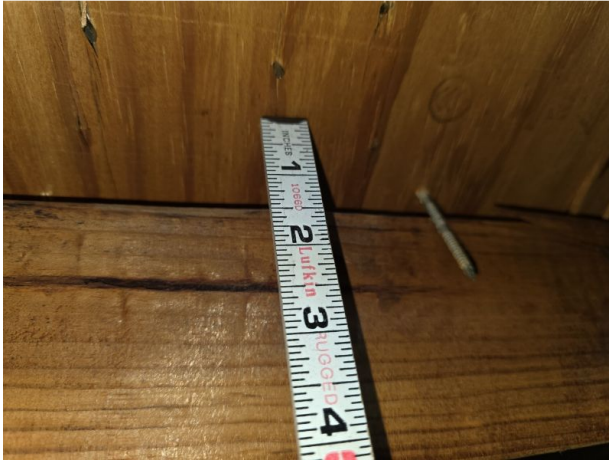
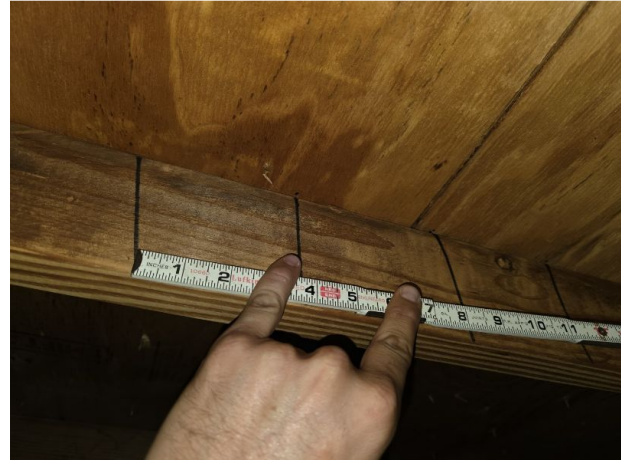
### ROOF TO DECK ATTACHMENT

- ☒ C. Plywood/OSB roof sheathing with a minimum thickness of 7/16" attached to the roof truss/rafter (spaced a maximum of 24" o.c.) by 8d common nails spaced a maximum of 6" in the field. OR Dimensional lumber/Tongue & Groove decking with a minimum of 2 nails per board (or 1 nail per board if each board is equal to or less than 6" in width). OR Any system of screws, nails, adhesives, other deck fastening system or truss/rafter spacing that is shown to have an equivalent or greater resistance than 8d common nails spaced a maximum of 6" in the field (max 24" truss/rafter spacing) or has a mean ultimate uplift resistance of at least 182 psf.

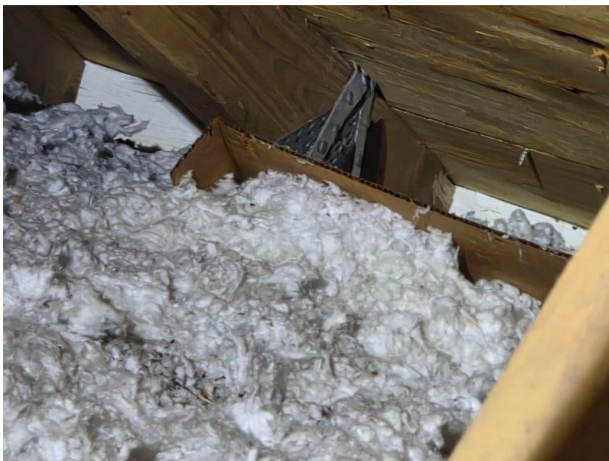
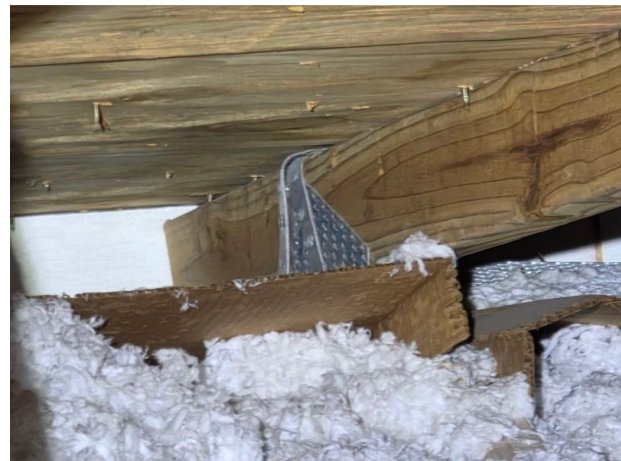
### ROOF TO WALL ATTACHMENT

- ☒ Metal Connectors consisting of two (2) separate straps, one on either side of the truss/rafter where each strap wraps over the truss/rafter and is secured with a minimum of two (2) nails on one side, and a minimum of one (1) nail on the opposing side, OR
- ☐ Metal connectors consisting of a single strap that wraps over the truss/rafter, are secured to the side of the wall and/or bottom of the top plate with a minimum of three (3) nails on each side, OR
- ☐ Purpose-made metal connector(s) or structural fastener(s) with a substantiated wind allowable uplift capacity of 891 lbs. or greater installed per the manufacturer's installation specifications (requires site-specific documentation).
