## Uniform Mitigation Verification Inspection Form

### Windstorm Mitigation Inspection

**9859-9879 NW 57TH MANOR CORAL SPRINGS, FL. 33076**

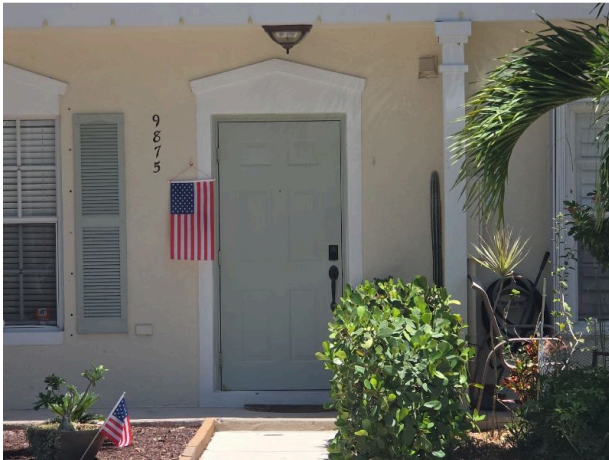
#### UNGLAZED OPENINGS

Entry doors are impact rated and approved(NOA #02-0408.04)

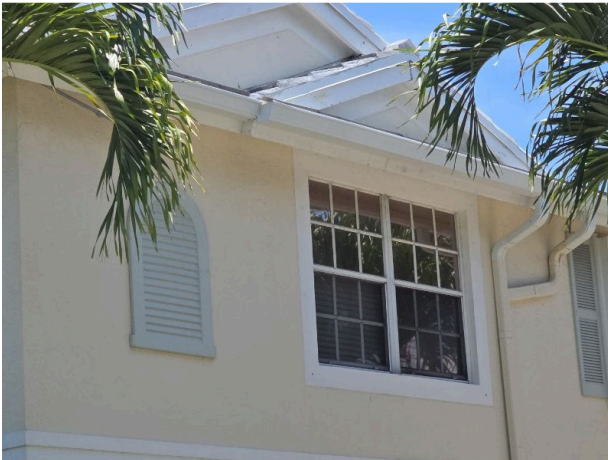
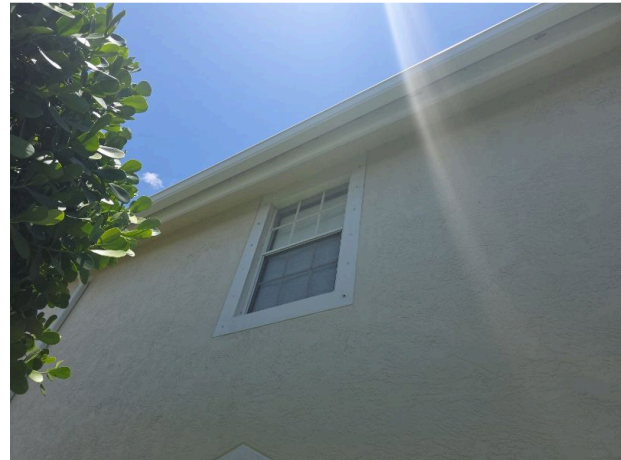
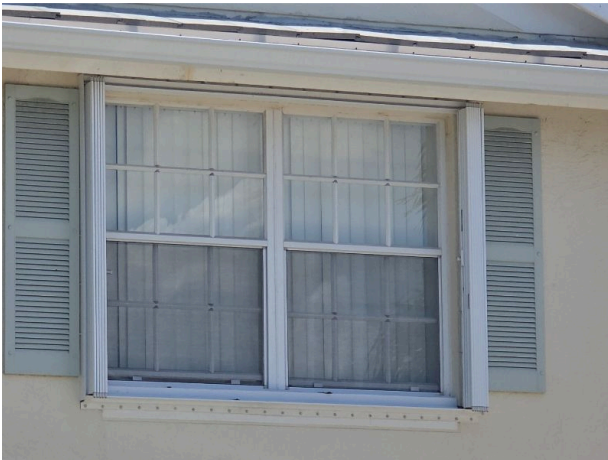
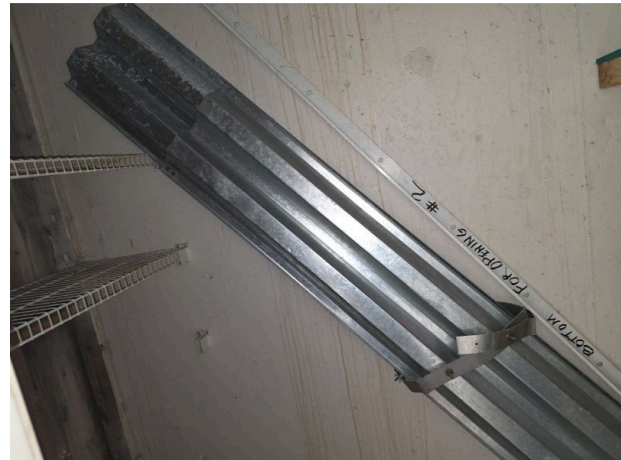
#### GLAZED OPENINGS

Glazed openings are protected with a combination of approved storm panels and approved accordion shutters.

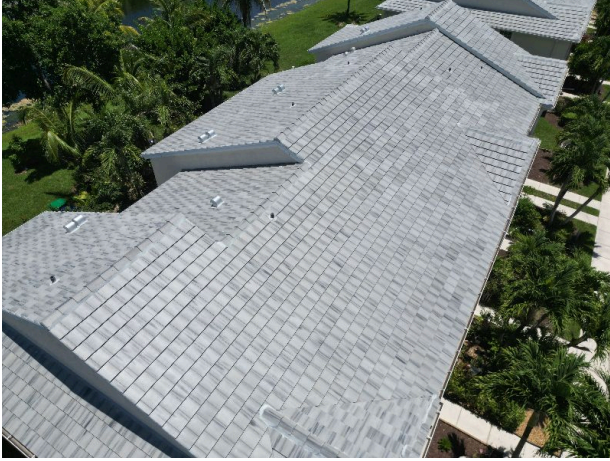
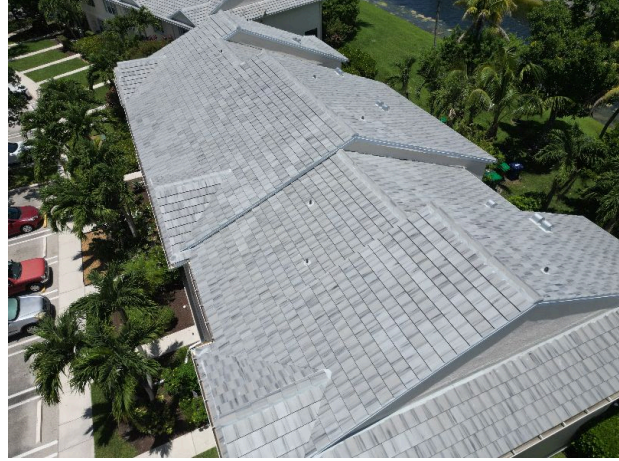
### ROOF COVERING

| 4.1 Roof Covering Type: | Permit Application Date | FBC / MDC Product Approval # | Year of Original Installation or Replacement | No Information Provided for Compliance |
|---|---|---|---|---|
| <input checked="" type="checkbox"/> Concrete/Clay Tile | <b>11/4/2025</b> | <b>25-001274</b> | . | |

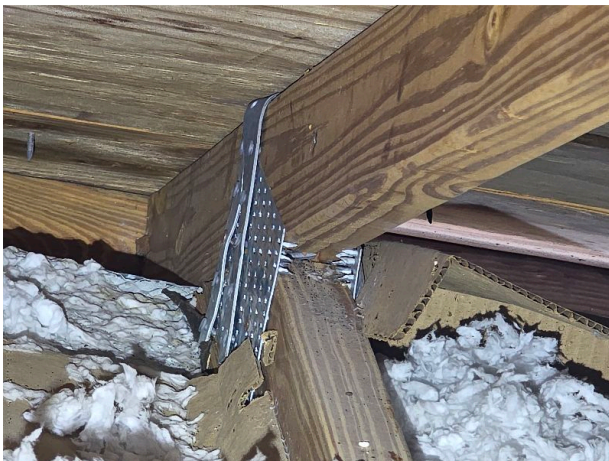
### ROOF TO WALL ATTACHMENT

- ☒ Metal Connectors consisting of two (2) separate straps, one on either side of the truss/rafter where each strap wraps over the truss/rafter and is secured with a minimum of two (2) nails on one side, and a minimum of one (1) nail on the opposing side, OR
- ☐ Metal connectors consisting of a single strap that wraps over the truss/rafter, are secured to the side of the wall and/or bottom of the top plate with a minimum of three (3) nails on each side, OR
- ☐ Purpose-made metal connector(s) or structural fastener(s) with a substantiated wind allowable uplift capacity of 891 lbs. or greater installed per the manufacturer's installation specifications (requires site-specific documentation).
