## Uniform Mitigation Verification Inspection Form

### Windstorm Mitigation Inspection

**9868-9896 NW 56TH PL CORAL SPRINGS, FL. 33076**

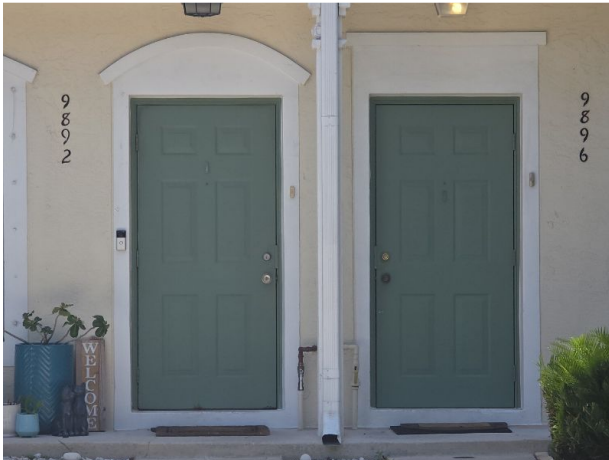
#### UNGLAZED OPENINGS

Entry doors are impact rated and approved(NOA #02-0408.04)

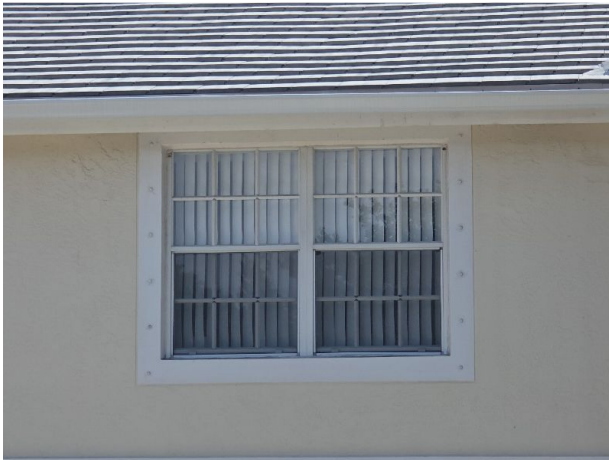
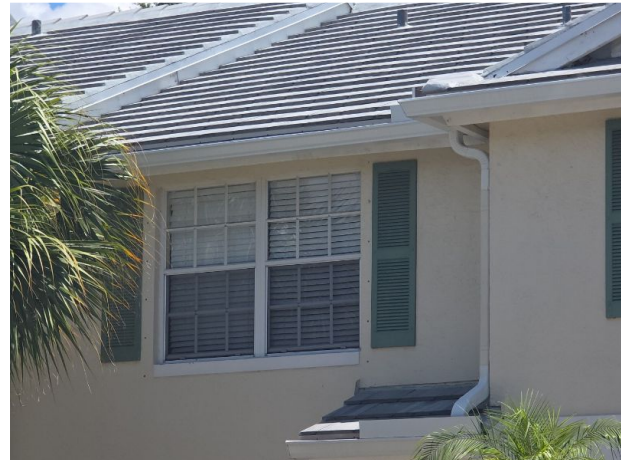
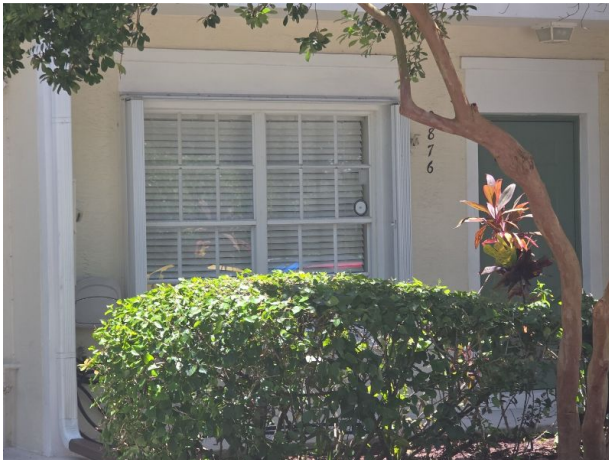
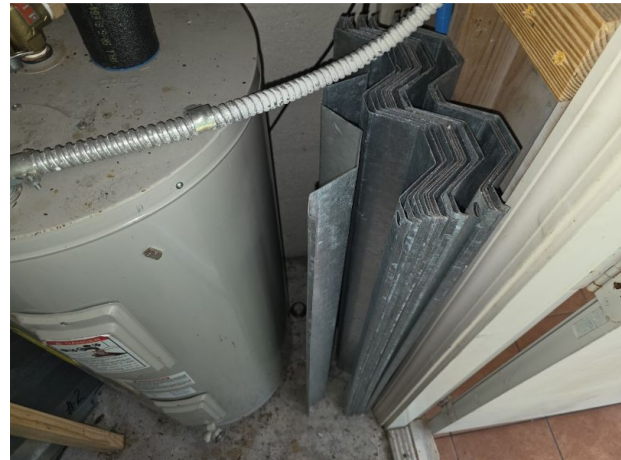
#### GLAZED OPENINGS

Glazed openings are protected with a combination of approved storm panels and approved accordion shutters.

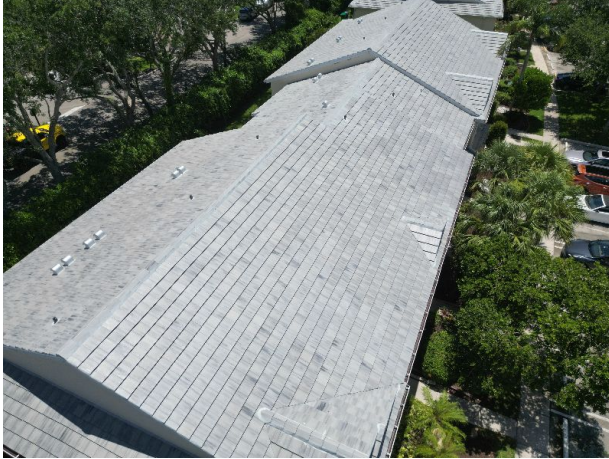
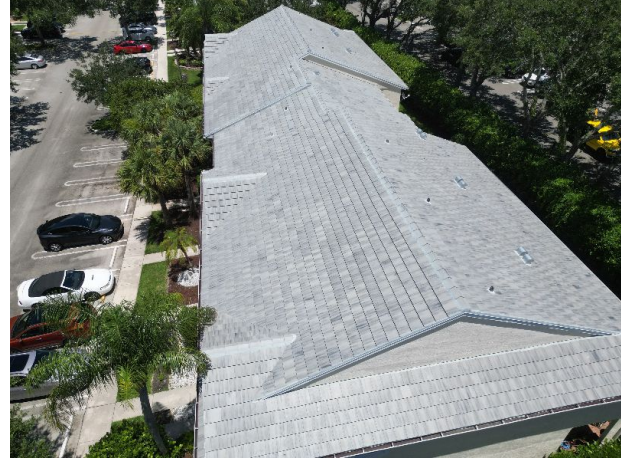
### ROOF COVERING

| 4.1 Roof Covering Type: | Permit Application Date | FBC / MDC Product Approval # | Year of Original Installation or Replacement | No Information Provided for Compliance |
|---|---|---|---|---|
| <input checked="" type="checkbox"/> Concrete/Clay Tile | <b>10/8/2025</b> | <b>25-001168</b> | <b>.</b> | _____ |

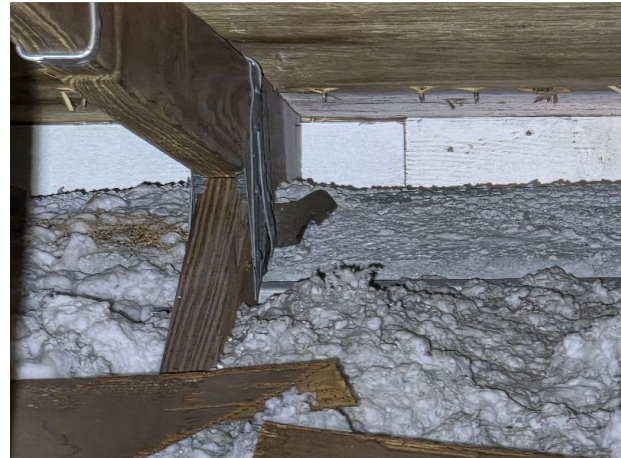
### ROOF TO WALL ATTACHMENT

- ☒ Metal Connectors consisting of two (2) separate straps, one on either side of the truss/rafter where each strap wraps over the truss/rafter and is secured with a minimum of two (2) nails on one side, and a minimum of one (1) nail on the opposing side, OR
- ☐ Metal connectors consisting of a single strap that wraps over the truss/rafter, are secured to the side of the wall and/or bottom of the top plate with a minimum of three (3) nails on each side, OR
- ☐ Purpose-made metal connector(s) or structural fastener(s) with a substantiated wind allowable uplift capacity of 891 lbs. or greater installed per the manufacturer's installation specifications (requires site-specific documentation).
