## Uniform Mitigation Verification Inspection Form

### Windstorm Mitigation Inspection

**9883-9897 NW 57TH MANOR CORAL SPRINGS, FL. 33076**

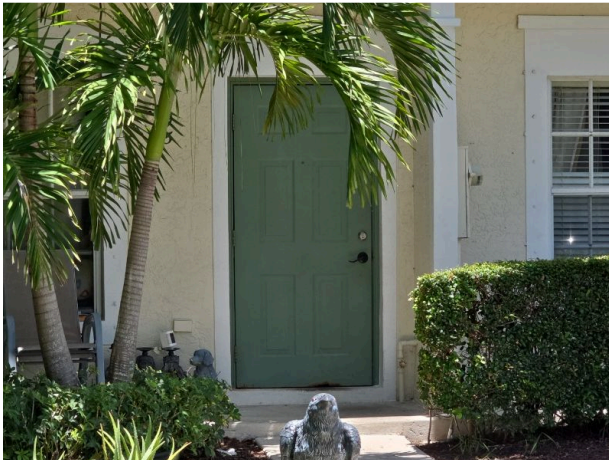
#### UNGLAZED OPENINGS

Entry doors are impact rated and approved(NOA #02-0408.04)

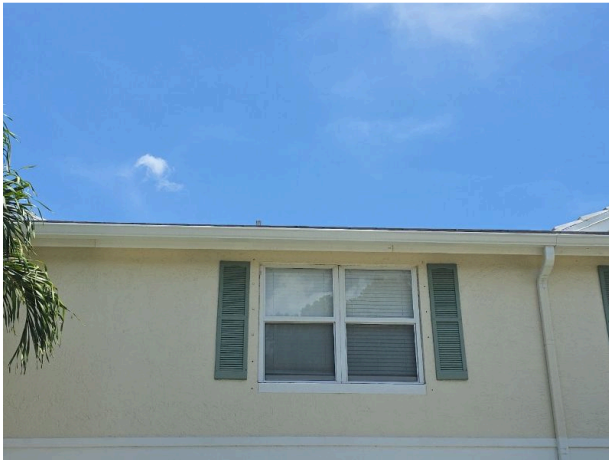
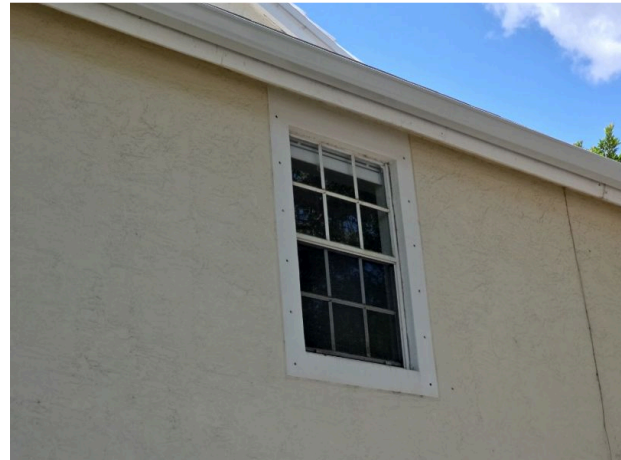
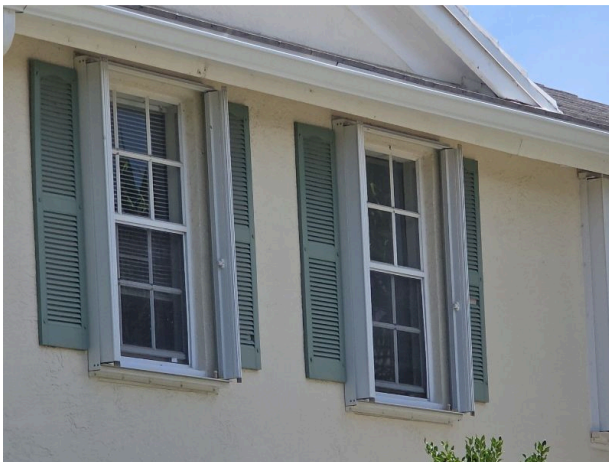
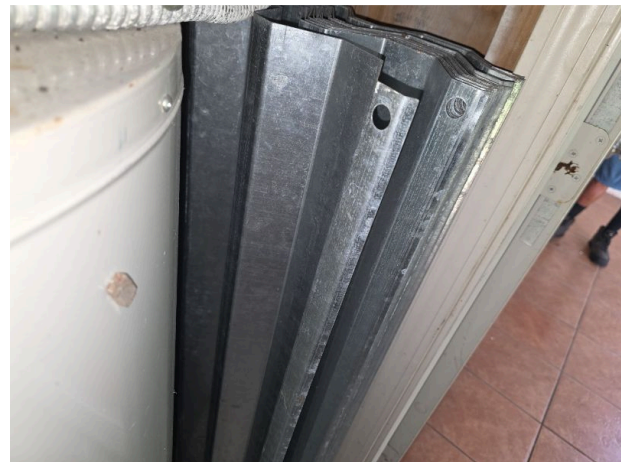
#### GLAZED OPENINGS

Glazed openings are protected with a combination of approved storm panels and approved accordion shutters.

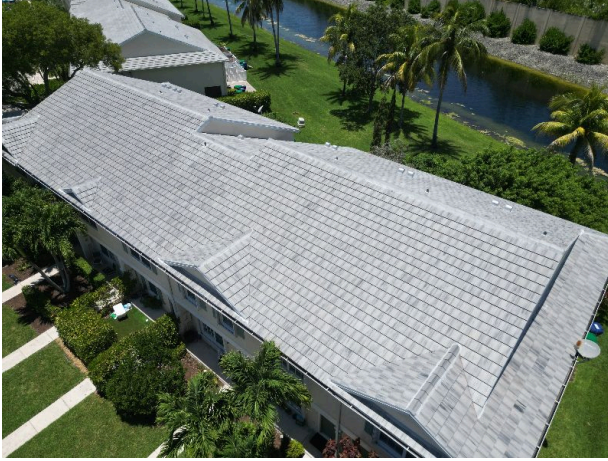
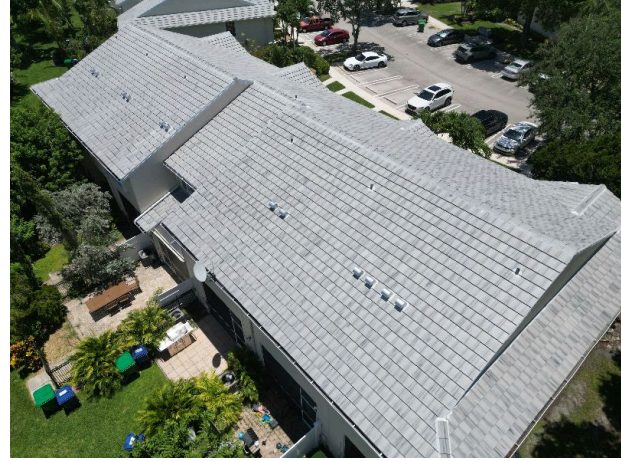
### ROOF COVERING

| 4.1 Roof Covering Type: | Permit Application Date | FBC / MDC Product Approval # | Year of Original Installation or Replacement | No Information Provided for Compliance |
|---|---|---|---|---|
| <input checked="" type="checkbox"/> Concrete/Clay Tile | <b>10/15/2025</b> | <b>25-001205</b> | <b>.</b> | <input type="checkbox"/> |

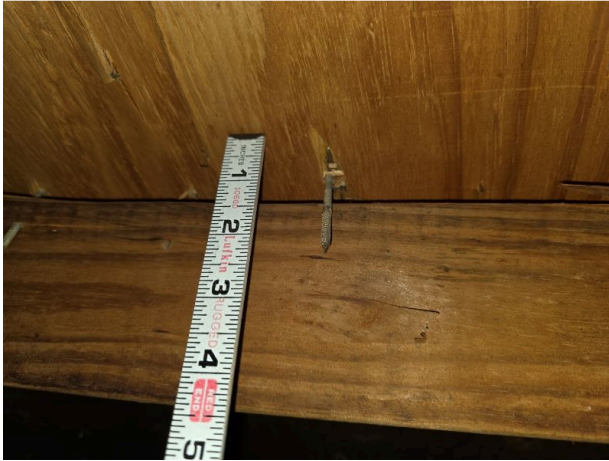
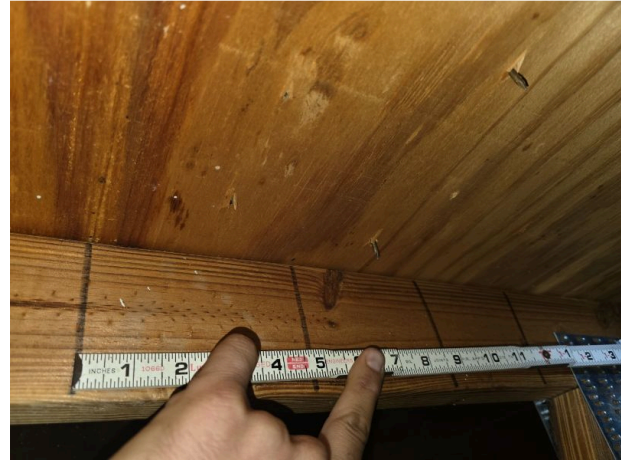
### ROOF TO DECK ATTACHMENT

- ☒ C. Plywood/OSB roof sheathing with a minimum thickness of 7/16" attached to the roof truss/rafter (spaced a maximum of 24" o.c.) by 8d common nails spaced a maximum of 6" in the field. OR Dimensional lumber/Tongue & Groove decking with a minimum of 2 nails per board (or 1 nail per board if each board is equal to or less than 6" in width). OR Any system of screws, nails, adhesives, other deck fastening system or truss/rafter spacing that is shown to have an equivalent or greater resistance than 8d common nails spaced a maximum of 6" in the field (max 24" truss/rafter spacing) or has a mean ultimate uplift resistance of at least 182 psf.

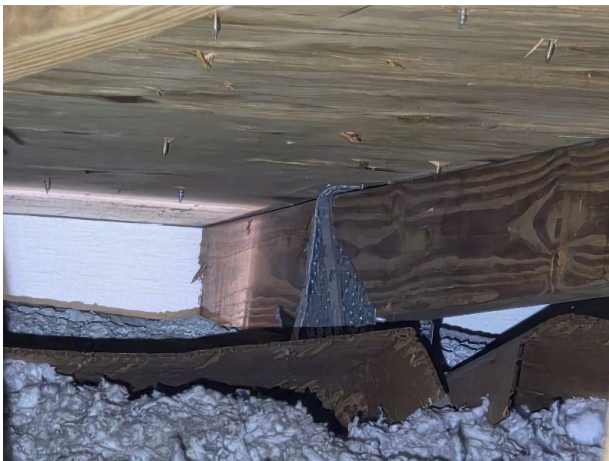
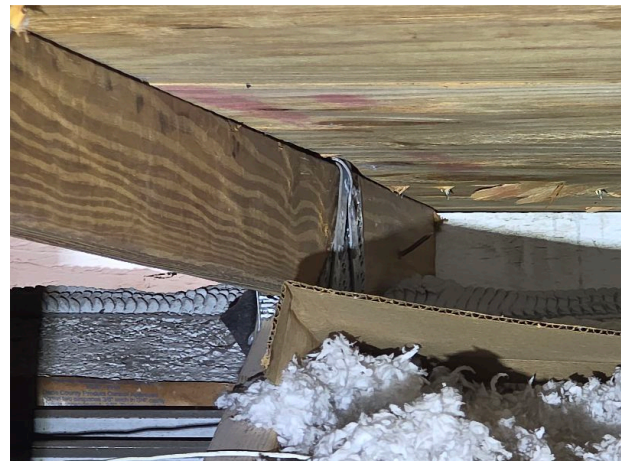
### ROOF TO WALL ATTACHMENT

- ☒ Metal Connectors consisting of two (2) separate straps, one on either side of the truss/rafter where each strap wraps over the truss/rafter and is secured with a minimum of two (2) nails on one side, and a minimum of one (1) nail on the opposing side, OR
- ☐ Metal connectors consisting of a single strap that wraps over the truss/rafter, are secured to the side of the wall and/or bottom of the top plate with a minimum of three (3) nails on each side, OR
- ☐ Purpose-made metal connector(s) or structural fastener(s) with a substantiated wind allowable uplift capacity of 891 lbs. or greater installed per the manufacturer's installation specifications (requires site-specific documentation).
