## Uniform Mitigation Verification Inspection Form

### Windstorm Mitigation Inspection

**9901-9929 NW 57TH MANOR CORAL SPRINGS, FL. 33076**

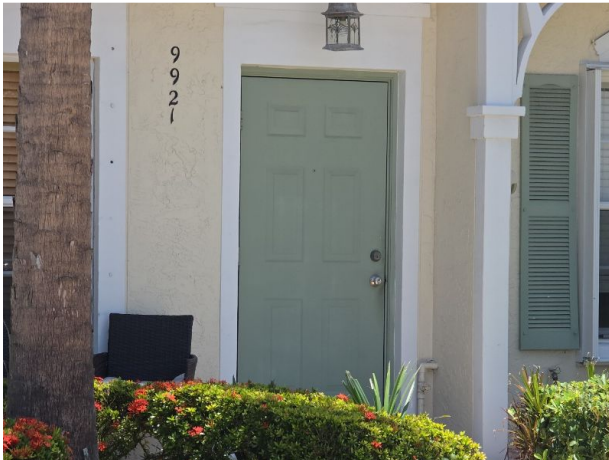
#### UNGLAZED OPENINGS

Entry doors are impact rated and approved(NOA #02-0408.04)

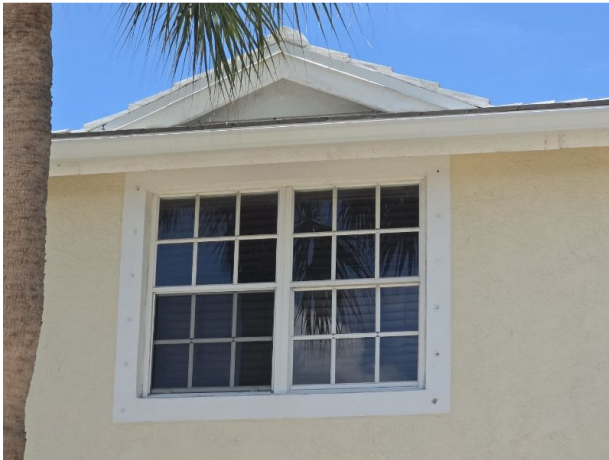
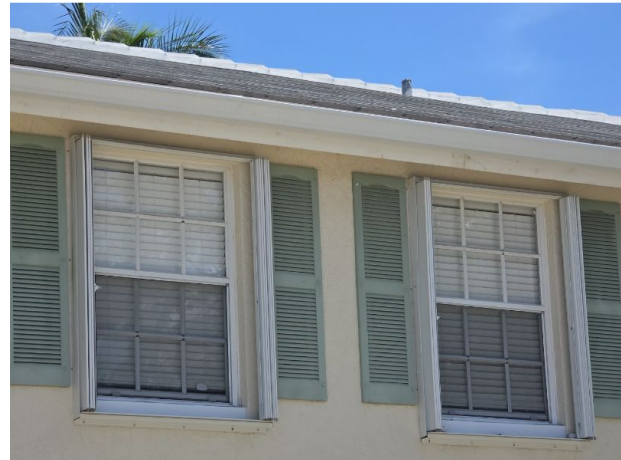
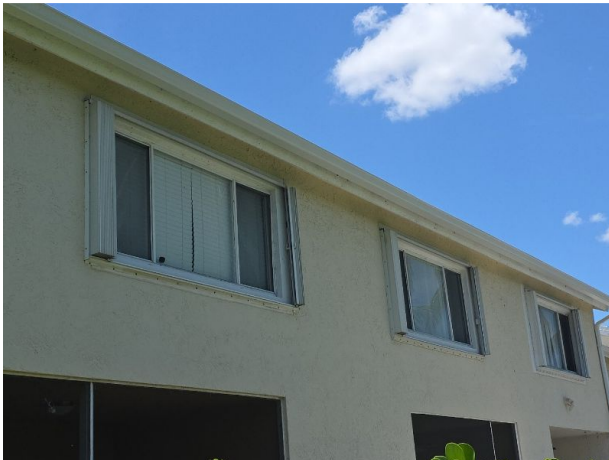
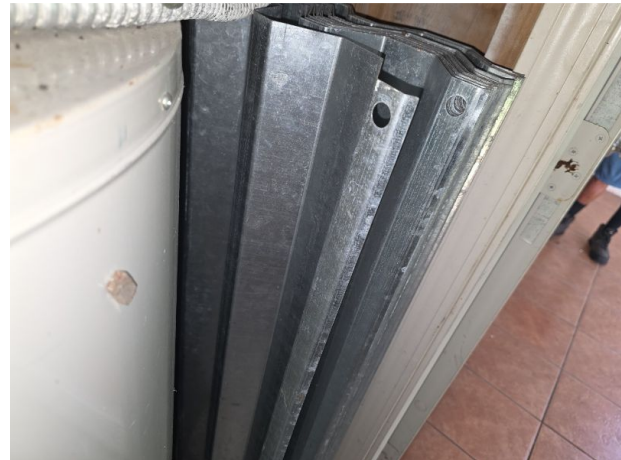
#### GLAZED OPENINGS

Glazed openings are protected with a combination of approved storm panels and approved accordion shutters.

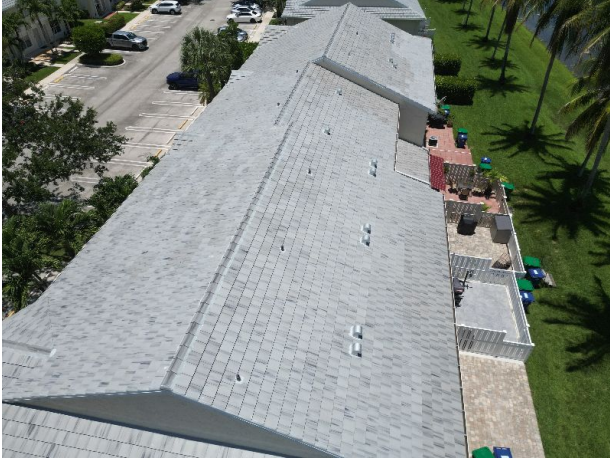
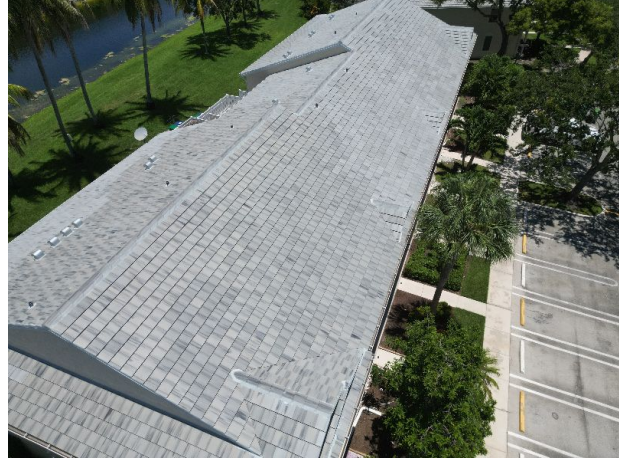
### ROOF COVERING

| 4.1 Roof Covering Type: | Permit Application Date | FBC / MDC Product Approval # | Year of Original Installation or Replacement | No Information Provided for Compliance |
|---|---|---|---|---|
| <input checked="" type="checkbox"/> Concrete/Clay Tile | <b>11/4/2025</b> | <b>25-001275</b> | . | |

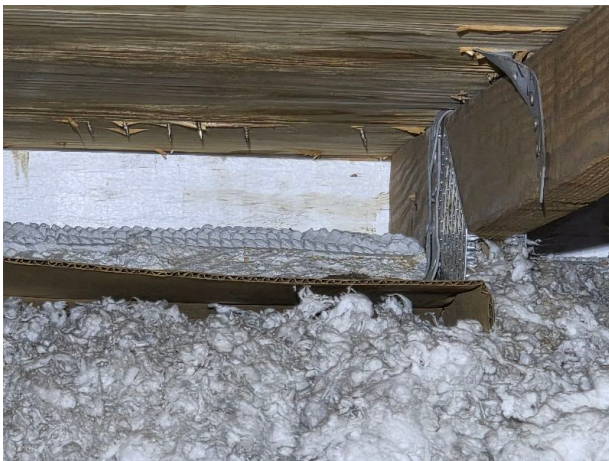
### ROOF TO WALL ATTACHMENT

☒ **D. Double Wraps**

- ☒ Metal Connectors consisting of two (2) separate straps, one on either side of the truss/rafter where each strap wraps over the truss/rafter and is secured with a minimum of two (2) nails on one side, and a minimum of one (1) nail on the opposing side, OR
- ☐ Metal connectors consisting of a single strap that wraps over the truss/rafter, are secured to the side of the wall and/or bottom of the top plate with a minimum of three (3) nails on each side, OR
- ☐ Purpose-made metal connector(s) or structural fastener(s) with a substantiated wind allowable uplift capacity of 891 lbs. or greater installed per the manufacturer's installation specifications (requires site-specific documentation).
