## Uniform Mitigation Verification Inspection Form

### Windstorm Mitigation Inspection

**9902-9930 NW 56TH PL CORAL SPRINGS, FL. 33076**

| INSPECTION DATE: <b>6/30/2026</b> | CONTACT PERSON: | Unit / Bldng |

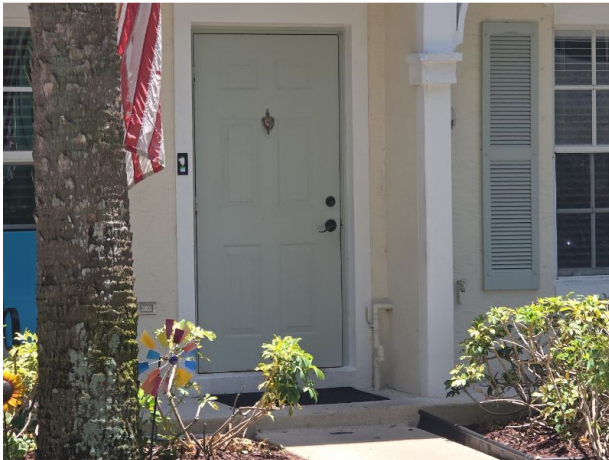
#### UNGLAZED OPENINGS

Entry doors are impact rated and approved(NOA #02-0408.04)

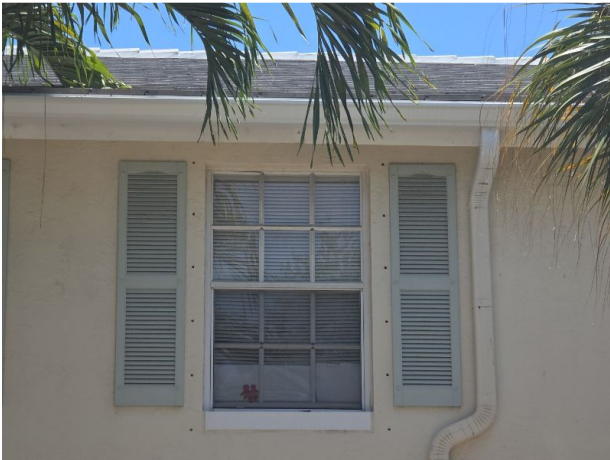
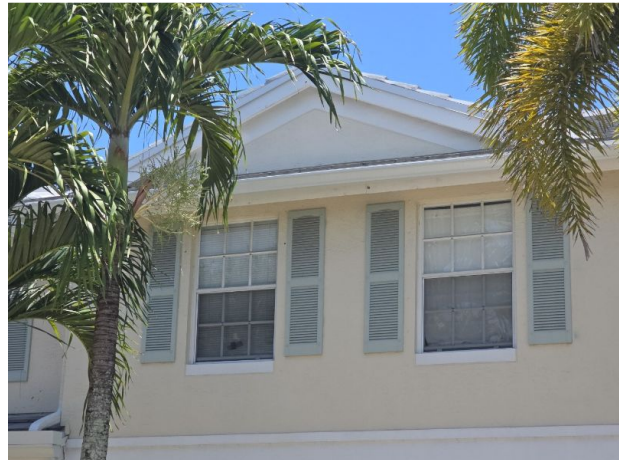
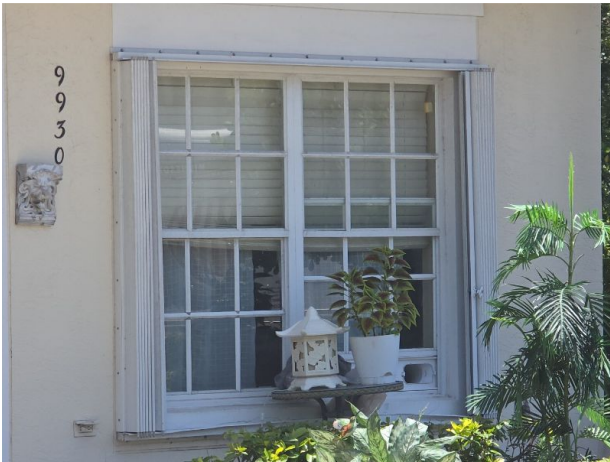
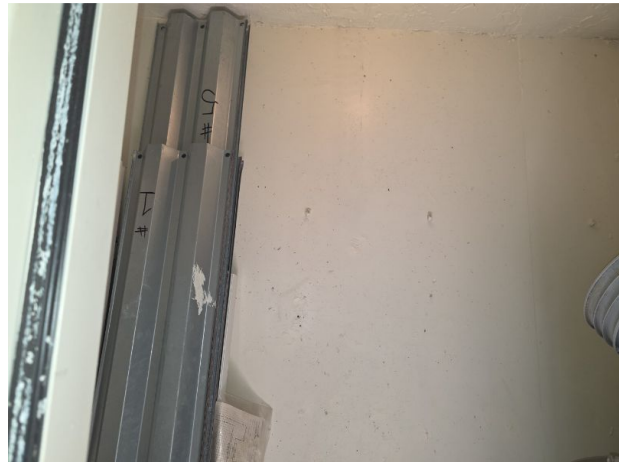
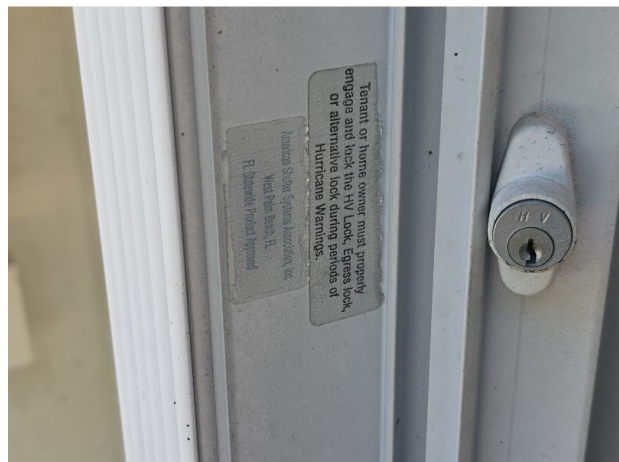
#### GLAZED OPENINGS

Glazed openings are protected with a combination of approved storm panels and approved accordion shutters.

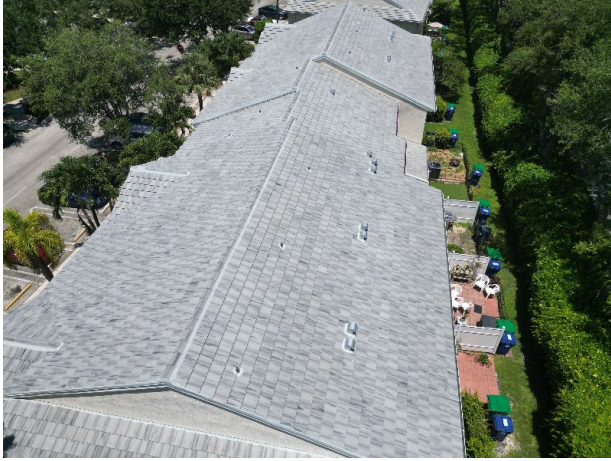
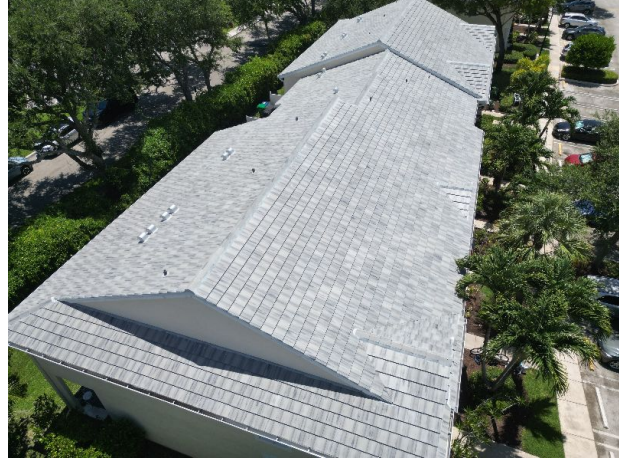
### ROOF COVERING

| 4.1 Roof Covering Type: | Permit<br>Application Date | FBC / MDC Product<br>Approval # | Year of Original Installation<br>or Replacement | No Information<br>Provided for Compliance |
|---|---|---|---|---|
| <input checked="" type="checkbox"/> Concrete/Clay Tile | <b>10/8/2025</b> | <b>25-001181</b> | . | |

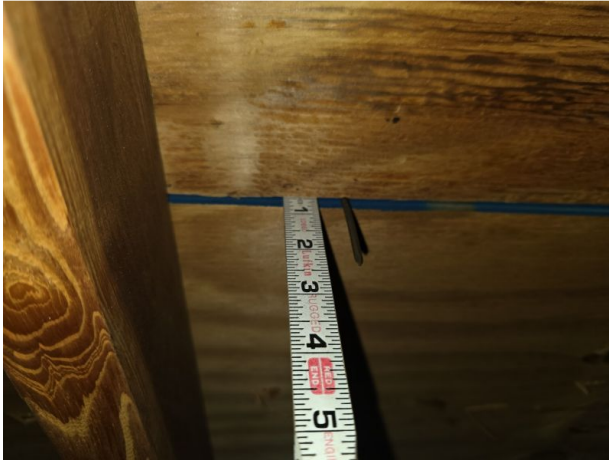
### ROOF TO DECK ATTACHMENT

- ☒ C. Plywood/OSB roof sheathing with a minimum thickness of 7/16" attached to the roof truss/rafter (spaced a maximum of 24" o.c.) by 8d common nails spaced a maximum of 6" in the field. OR Dimensional lumber/Tongue & Groove decking with a minimum of 2 nails per board (or 1 nail per board if each board is equal to or less than 6" in width). OR Any system of screws, nails, adhesives, other deck fastening system or truss/rafter spacing that is shown to have an equivalent or greater resistance than 8d common nails spaced a maximum of 6" in the field (max 24" truss/rafter spacing) or has a mean ultimate uplift resistance of at least 182 psf.

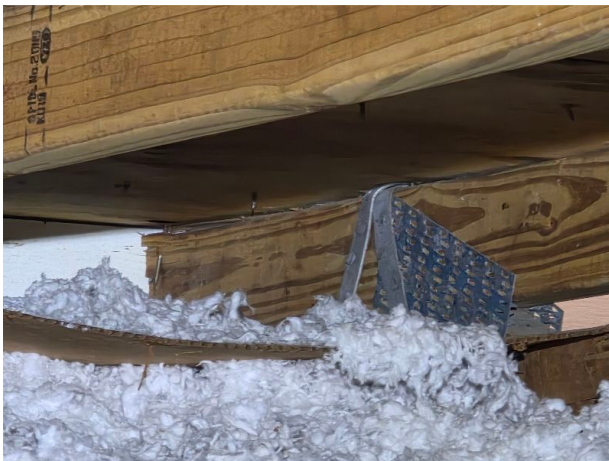
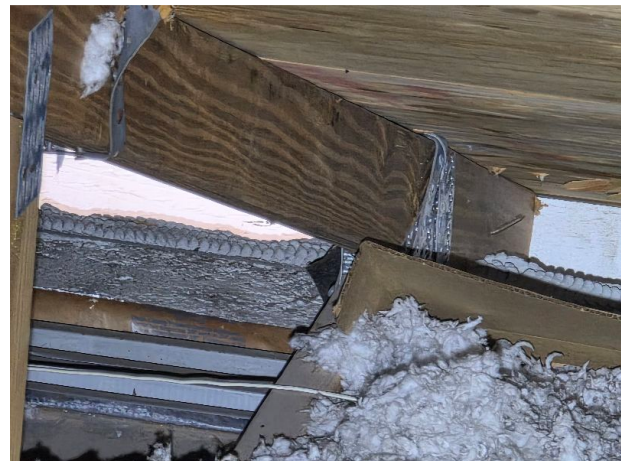
### ROOF TO WALL ATTACHMENT

- ☒ Metal Connectors consisting of two (2) separate straps, one on either side of the truss/rafter where each strap wraps over the truss/rafter and is secured with a minimum of two (2) nails on one side, and a minimum of one (1) nail on the opposing side, OR
- ☐ Metal connectors consisting of a single strap that wraps over the truss/rafter, are secured to the side of the wall and/or bottom of the top plate with a minimum of three (3) nails on each side, OR
- ☐ Purpose-made metal connector(s) or structural fastener(s) with a substantiated wind allowable uplift capacity of 891 lbs. or greater installed per the manufacturer's installation specifications (requires site-specific documentation).
