## Uniform Mitigation Verification Inspection Form

### Windstorm Mitigation Inspection

**9927-9951 NW 56TH PL CORAL SPRINGS, FL. 33076**

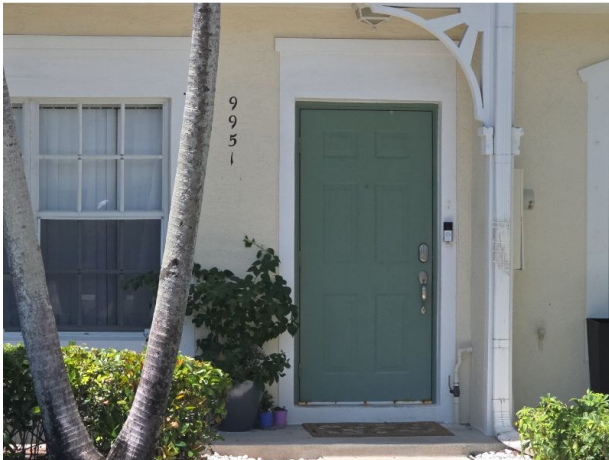
#### UNGLAZED OPENINGS

Entry doors are impact rated and approved(NOA #02-0408.04)

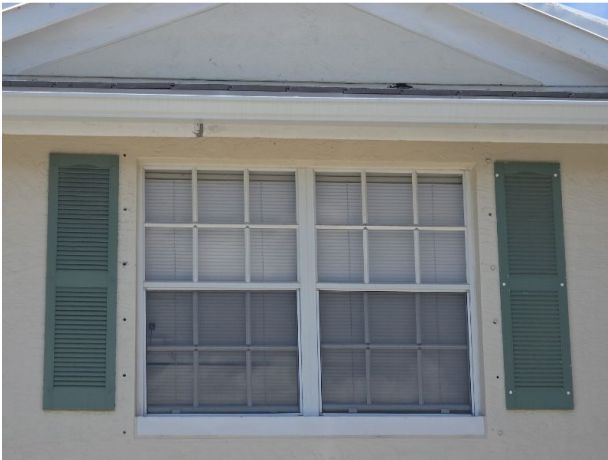
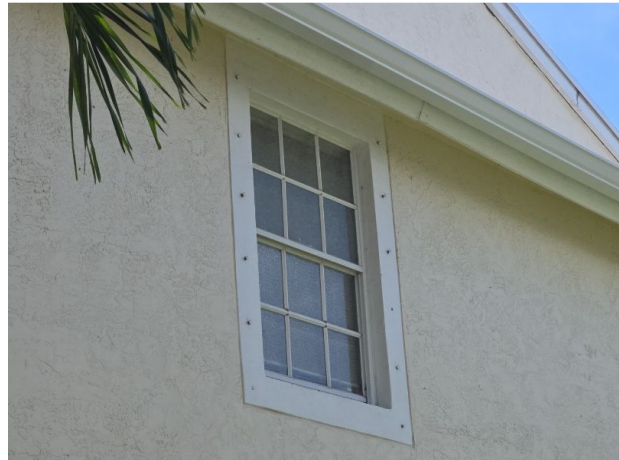
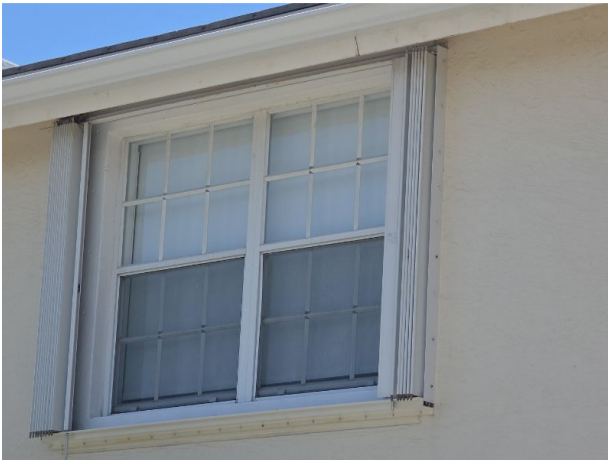
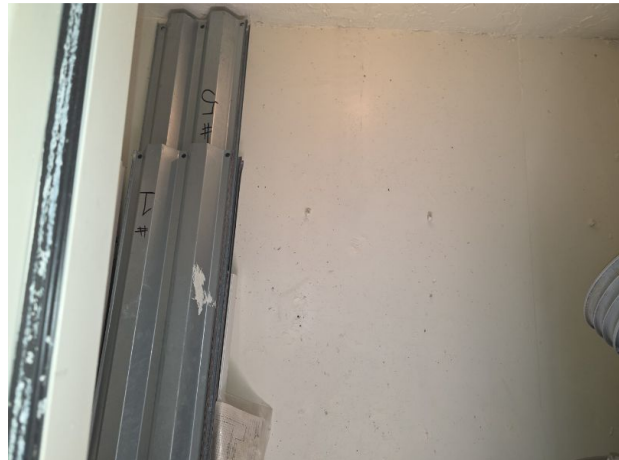
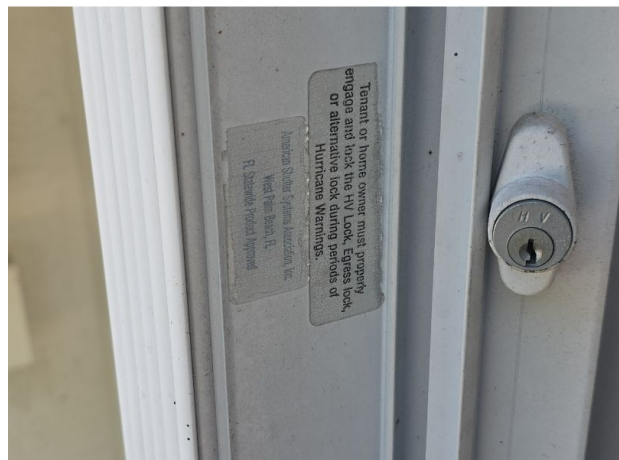
#### GLAZED OPENINGS

Glazed openings are protected with a combination of approved storm panels and approved accordion shutters.

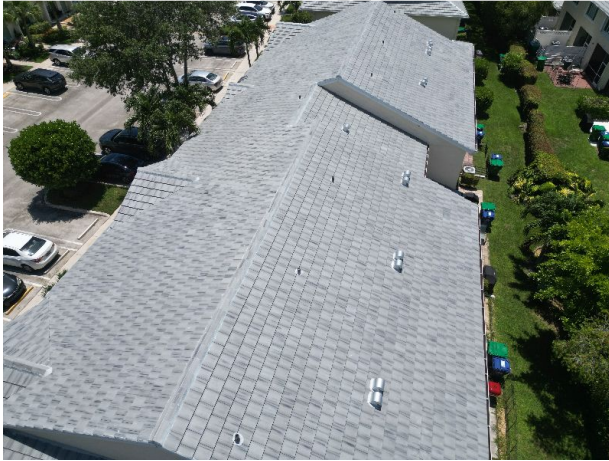
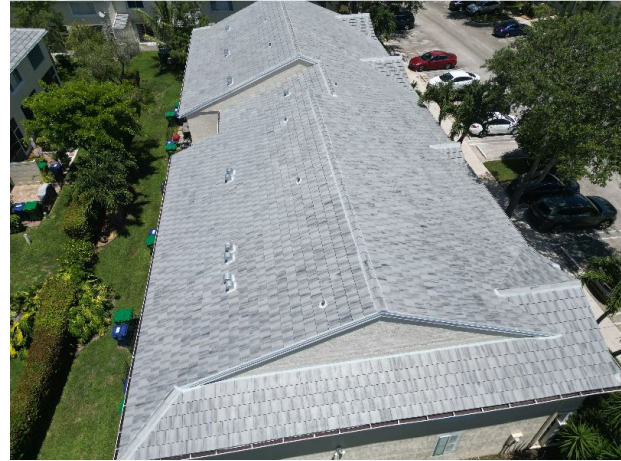
### ROOF COVERING

| 4.1 Roof Covering Type: | Permit Application Date | FBC / MDC Product Approval # | Year of Original Installation or Replacement | No Information Provided for Compliance |
|---|---|---|---|---|
| <input checked="" type="checkbox"/> Concrete/Clay Tile | <b>10/29/2025</b> | <b>25-001252</b> | <b>.</b> | <input type="checkbox"/> |

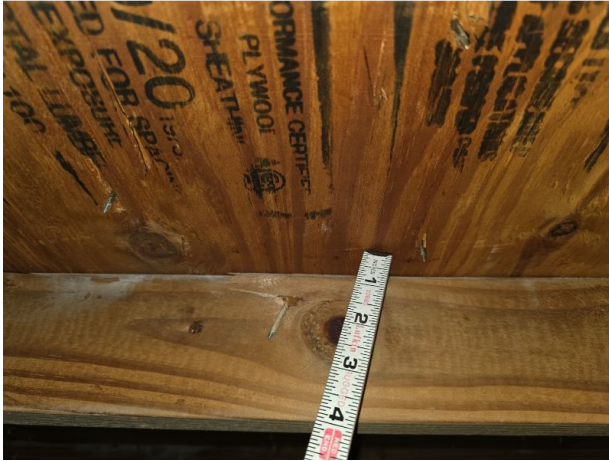
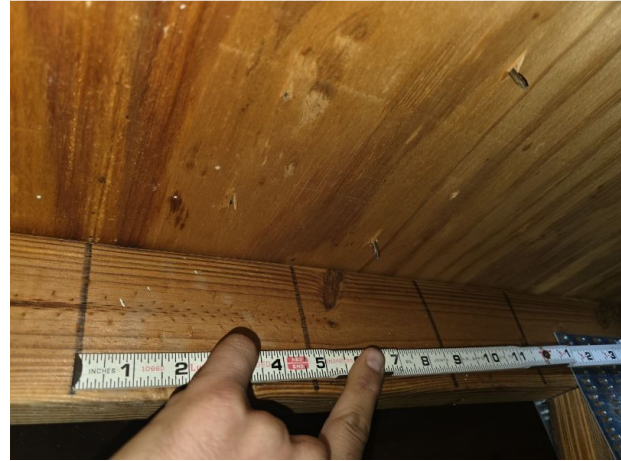
### ROOF TO DECK ATTACHMENT

- ☒ C. Plywood/OSB roof sheathing with a minimum thickness of 7/16" attached to the roof truss/rafter (spaced a maximum of 24" o.c.) by 8d common nails spaced a maximum of 6" in the field. OR Dimensional lumber/Tongue & Groove decking with a minimum of 2 nails per board (or 1 nail per board if each board is equal to or less than 6" in width). OR Any system of screws, nails, adhesives, other deck fastening system or truss/rafter spacing that is shown to have an equivalent or greater resistance than 8d common nails spaced a maximum of 6" in the field (max 24" truss/rafter spacing) or has a mean ultimate uplift resistance of at least 182 psf.

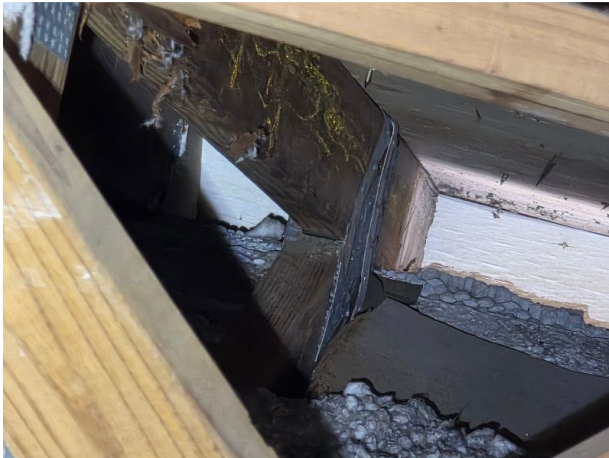
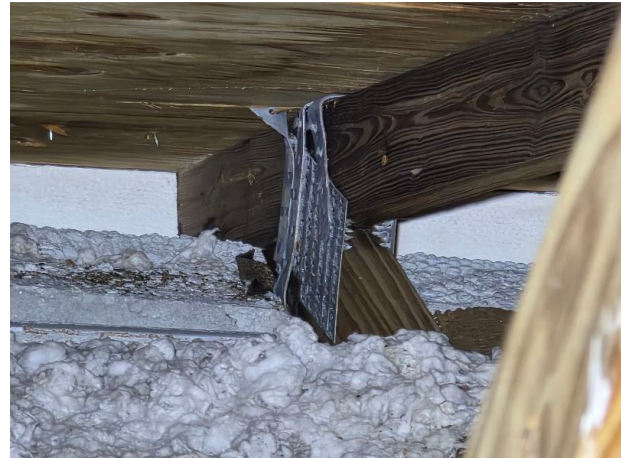
### ROOF TO WALL ATTACHMENT

- ☒ Metal Connectors consisting of two (2) separate straps, one on either side of the truss/rafter where each strap wraps over the truss/rafter and is secured with a minimum of two (2) nails on one side, and a minimum of one (1) nail on the opposing side, OR
- ☐ Metal connectors consisting of a single strap that wraps over the truss/rafter, are secured to the side of the wall and/or bottom of the top plate with a minimum of three (3) nails on each side, OR
- ☐ Purpose-made metal connector(s) or structural fastener(s) with a substantiated wind allowable uplift capacity of 891 lbs. or greater installed per the manufacturer's installation specifications (requires site-specific documentation).
