## Uniform Mitigation Verification Inspection Form

### Windstorm Mitigation Inspection

**9933-9961 NW 57TH MANOR CORAL SPRINGS, FL. 33076**

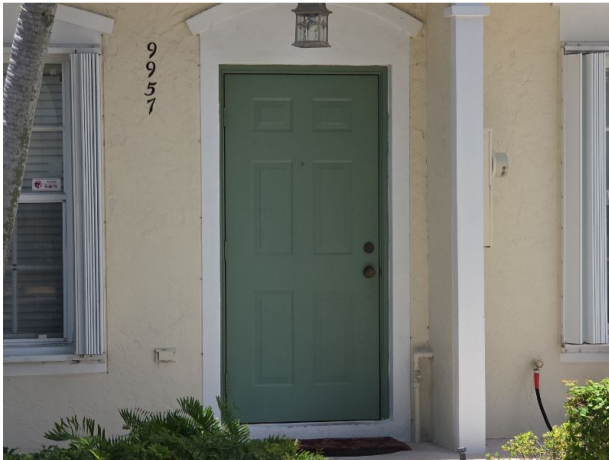
#### UNGLAZED OPENINGS

Entry doors are impact rated and approved(NOA #02-0408.04)

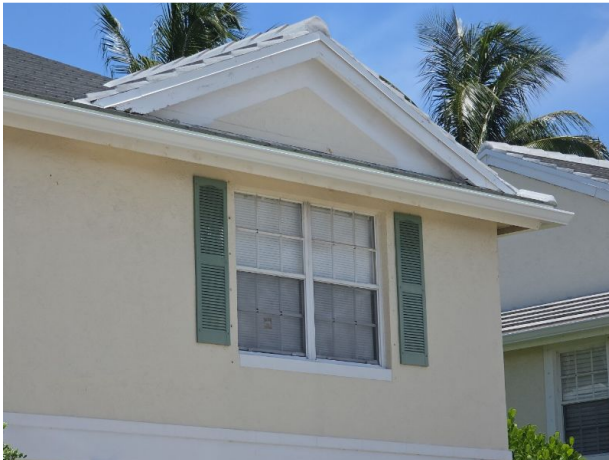
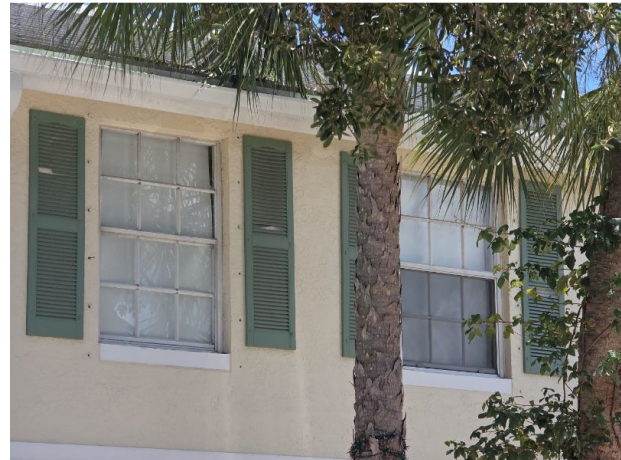
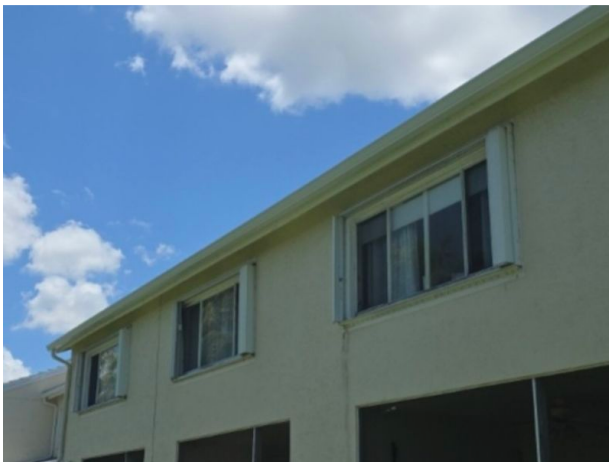
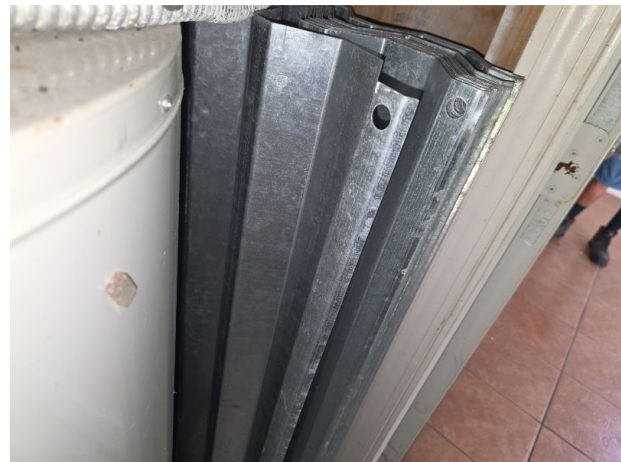
#### GLAZED OPENINGS

Glazed openings are protected with a combination of approved storm panels and approved accordion shutters.

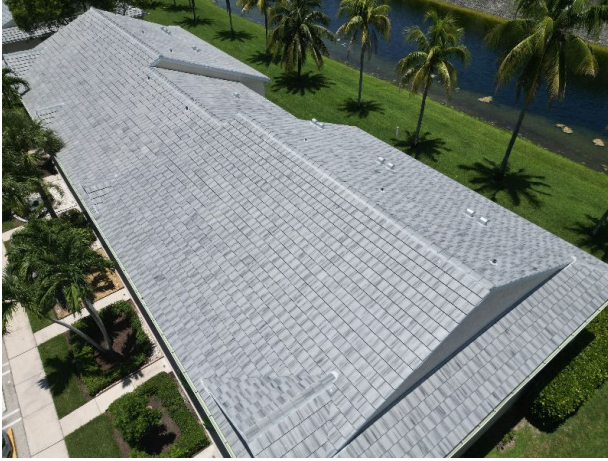
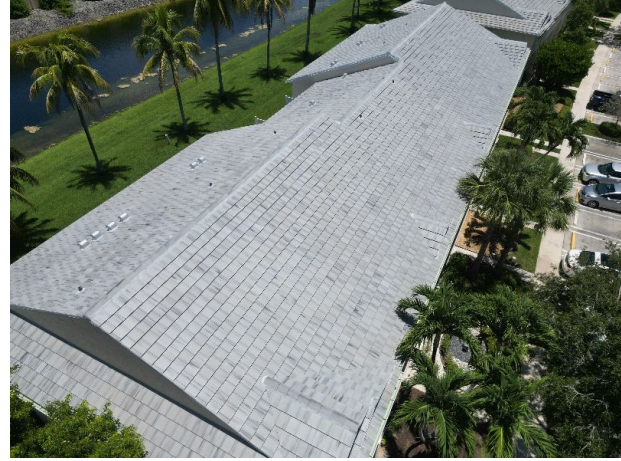
### ROOF COVERING

| 4.1 Roof Covering Type: | Permit<br>Application Date | FBC / MDC Product<br>Approval # | Year of Original Installation<br>or Replacement | No Information<br>Provided for Compliance |
|---|---|---|---|---|
| <input checked="" type="checkbox"/> Concrete/Clay Tile | <b>11/4/2025</b> | <b>25-001272</b> | . | |

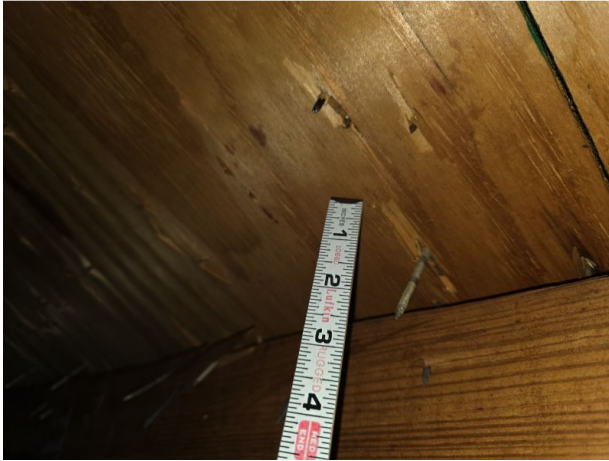
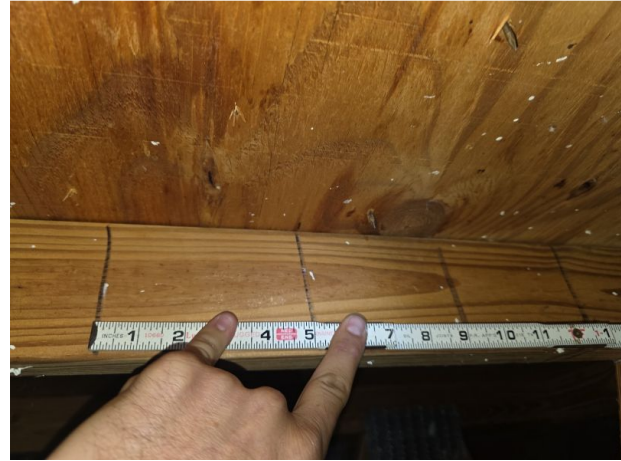
### ROOF TO DECK ATTACHMENT

- ☒ C. Plywood/OSB roof sheathing with a minimum thickness of 7/16" attached to the roof truss/rafter (spaced a maximum of 24" o.c.) by 8d common nails spaced a maximum of 6" in the field. OR Dimensional lumber/Tongue & Groove decking with a minimum of 2 nails per board (or 1 nail per board if each board is equal to or less than 6" in width). OR Any system of screws, nails, adhesives, other deck fastening system or truss/rafter spacing that is shown to have an equivalent or greater resistance than 8d common nails spaced a maximum of 6" in the field (max 24" truss/rafter spacing) or has a mean ultimate uplift resistance of at least 182 psf.

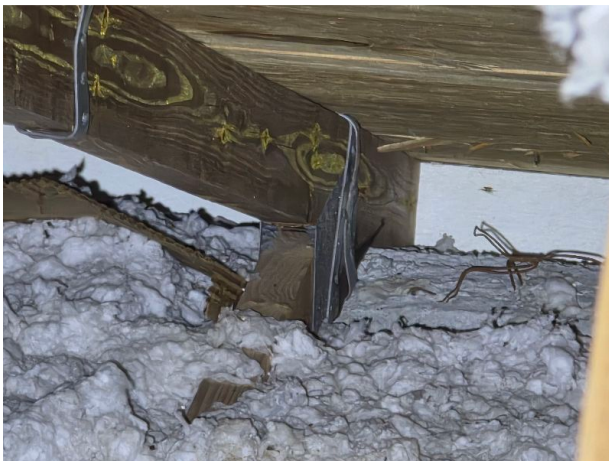
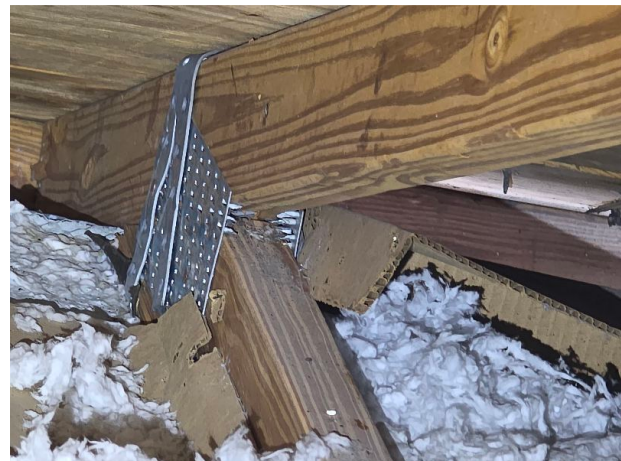
### ROOF TO WALL ATTACHMENT

- ☒ Metal Connectors consisting of two (2) separate straps, one on either side of the truss/rafter where each strap wraps over the truss/rafter and is secured with a minimum of two (2) nails on one side, and a minimum of one (1) nail on the opposing side, OR
- ☐ Metal connectors consisting of a single strap that wraps over the truss/rafter, are secured to the side of the wall and/or bottom of the top plate with a minimum of three (3) nails on each side, OR
- ☐ Purpose-made metal connector(s) or structural fastener(s) with a substantiated wind allowable uplift capacity of 891 lbs. or greater installed per the manufacturer's installation specifications (requires site-specific documentation).
