## Uniform Mitigation Verification Inspection Form

### Windstorm Mitigation Inspection

**9934-9962 NW 56TH PL CORAL SPRINGS, FL. 33076**

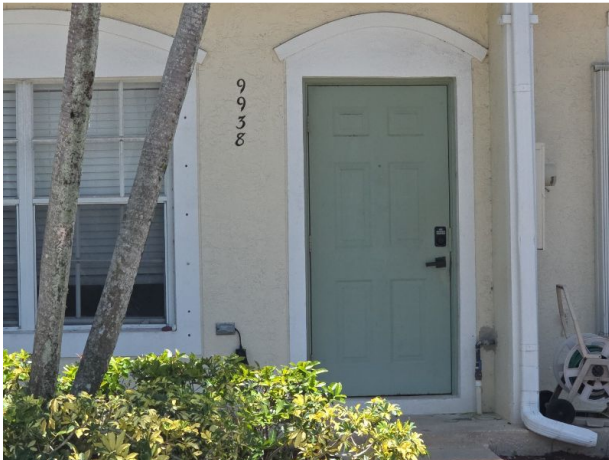
#### UNGLAZED OPENINGS

Entry doors are impact rated and approved(NOA #02-0408.04)

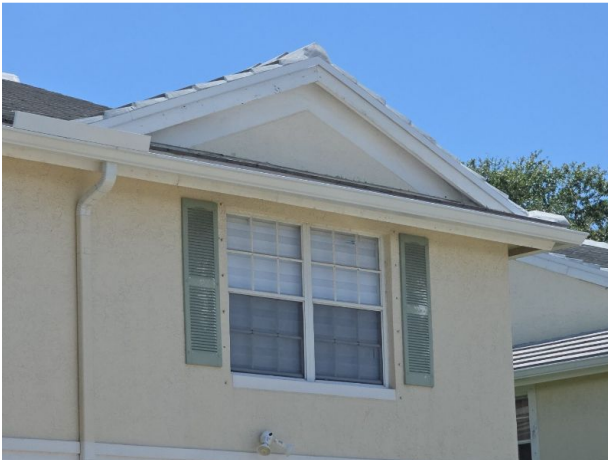
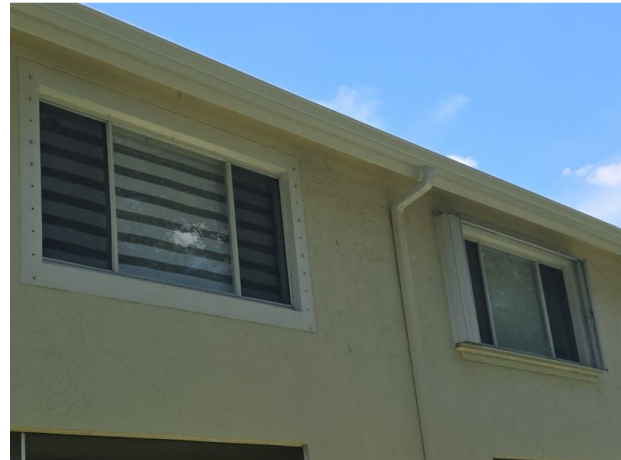
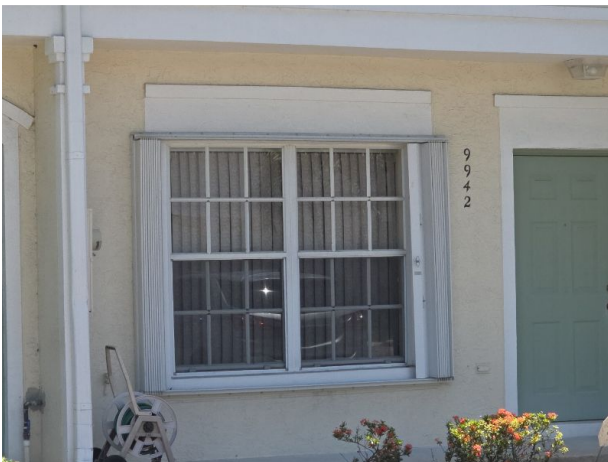
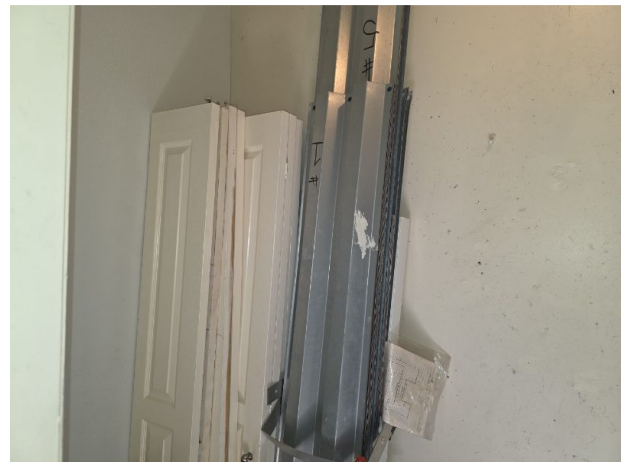
#### GLAZED OPENINGS

Glazed openings are protected with a combination of approved storm panels and approved accordion shutters.

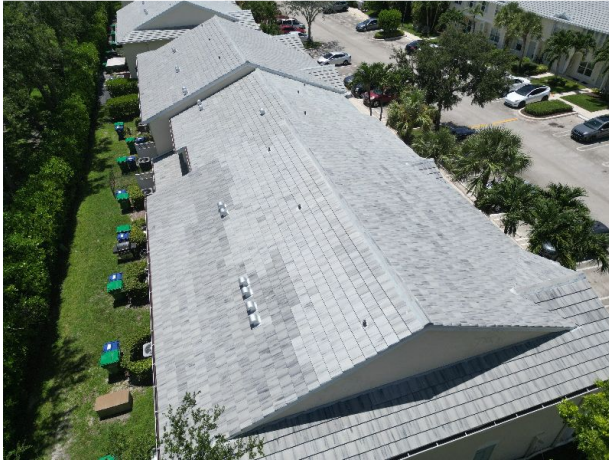
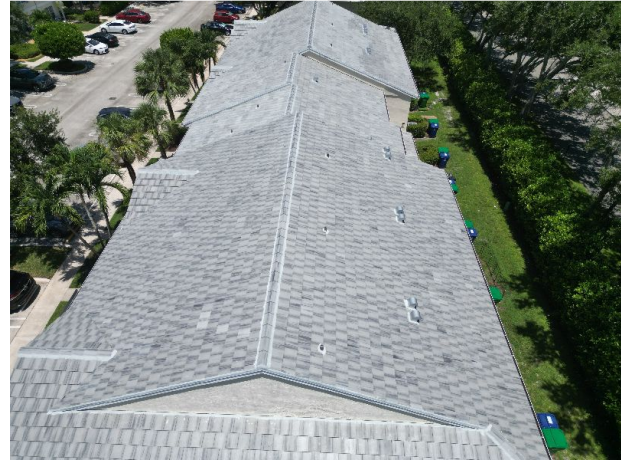
### ROOF COVERING

| 4.1 Roof Covering Type: | Permit<br>Application Date | FBC / MDC Product<br>Approval # | Year of Original Installation<br>or Replacement | No Information<br>Provided for Compliance |
|---|---|---|---|---|
| <input checked="" type="checkbox"/> Concrete/Clay Tile | <b>10/15/2025</b> | <b>25-001204</b> | . | |

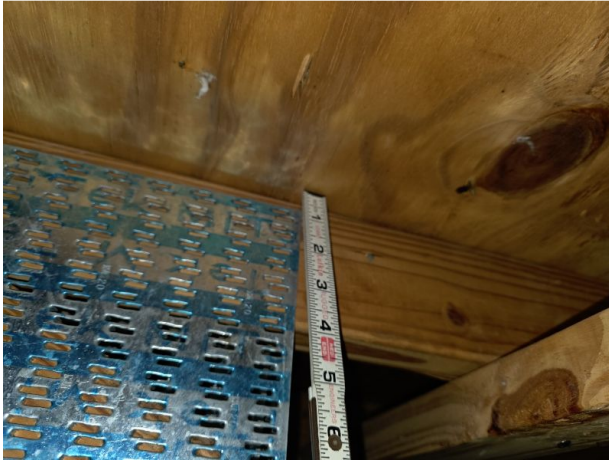
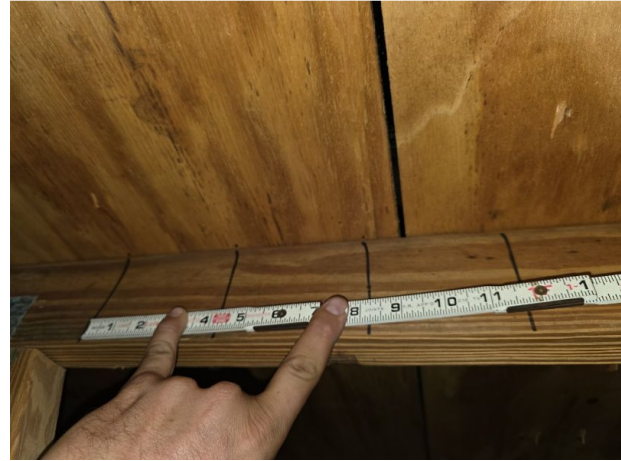
### ROOF TO DECK ATTACHMENT

- ☒ C. Plywood/OSB roof sheathing with a minimum thickness of 7/16" attached to the roof truss/rafter (spaced a maximum of 24" o.c.) by 8d common nails spaced a maximum of 6" in the field. OR Dimensional lumber/Tongue & Groove decking with a minimum of 2 nails per board (or 1 nail per board if each board is equal to or less than 6" in width). OR Any system of screws, nails, adhesives, other deck fastening system or truss/rafter spacing that is shown to have an equivalent or greater resistance than 8d common nails spaced a maximum of 6" in the field (max 24" truss/rafter spacing) or has a mean ultimate uplift resistance of at least 182 psf.

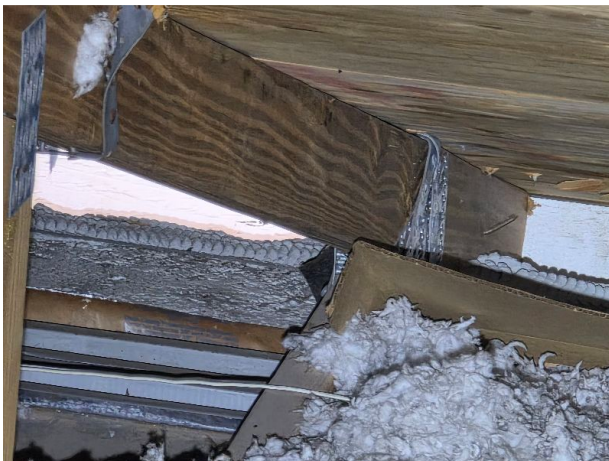
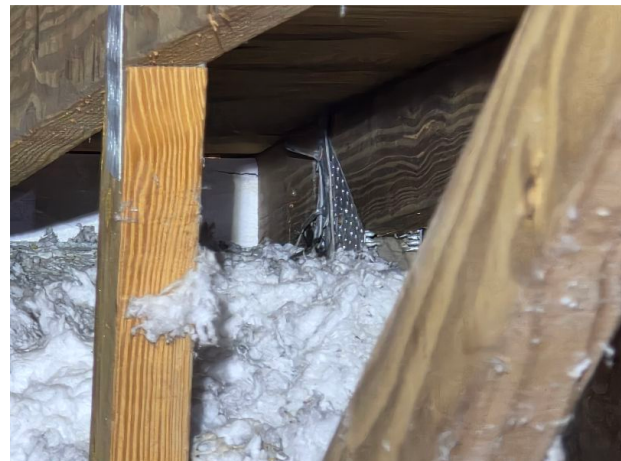
### ROOF TO WALL ATTACHMENT

- ☒ Metal Connectors consisting of two (2) separate straps, one on either side of the truss/rafter where each strap wraps over the truss/rafter and is secured with a minimum of two (2) nails on one side, and a minimum of one (1) nail on the opposing side, OR
- ☐ Metal connectors consisting of a single strap that wraps over the truss/rafter, are secured to the side of the wall and/or bottom of the top plate with a minimum of three (3) nails on each side, OR
- ☐ Purpose-made metal connector(s) or structural fastener(s) with a substantiated wind allowable uplift capacity of 891 lbs. or greater installed per the manufacturer's installation specifications (requires site-specific documentation).
