## Uniform Mitigation Verification Inspection Form

### Windstorm Mitigation Inspection

**9944-9972 NW 57TH MANOR CORAL SPRINGS, FL. 33076**

| INSPECTION DATE: <b>6/30/2026</b> | CONTACT PERSON: | Unit / Bldng |

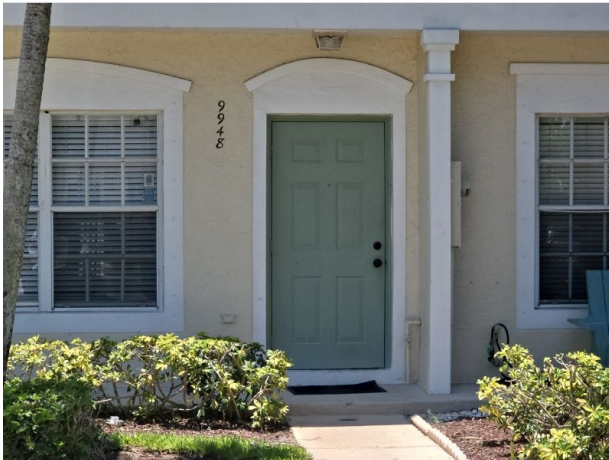
#### UNGLAZED OPENINGS

Entry doors are impact rated and approved(NOA #02-0408.04)

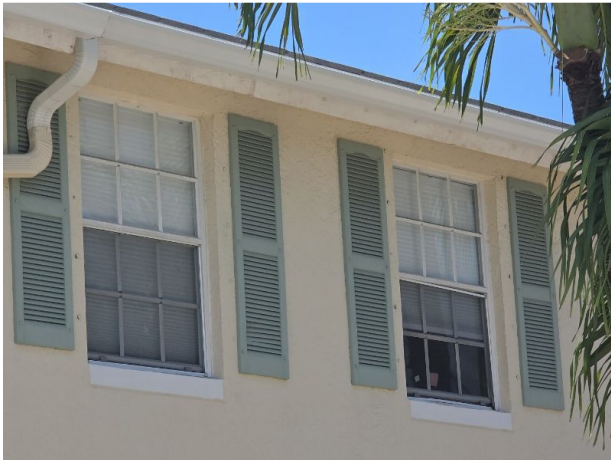
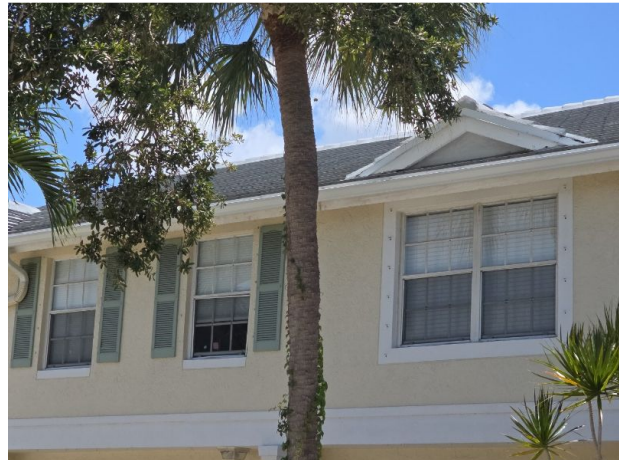
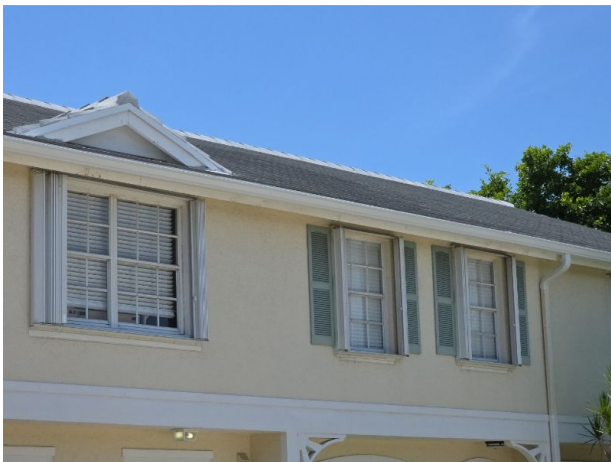
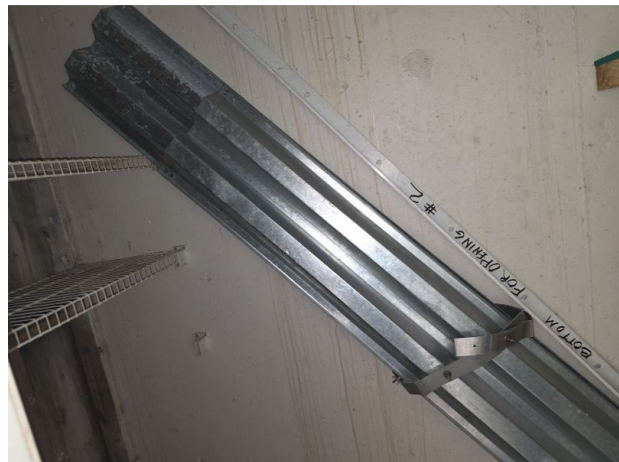
#### GLAZED OPENINGS

Glazed openings are protected with a combination of approved storm panels and approved accordion shutters.

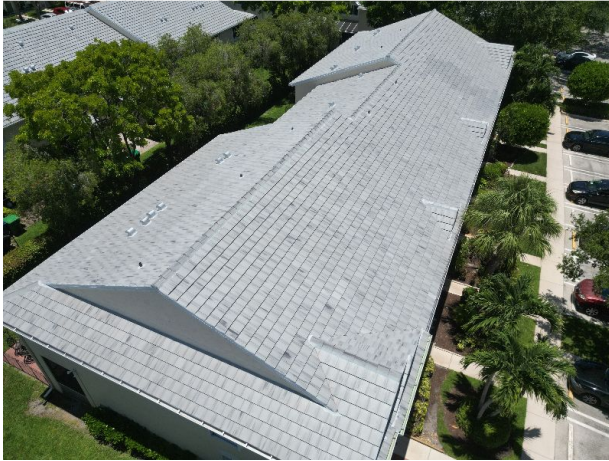
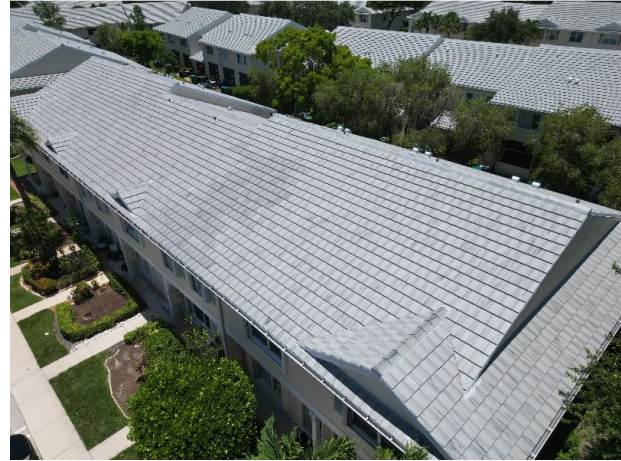
### ROOF COVERING

| 4.1 Roof Covering Type: | Permit Application Date | FBC / MDC Product Approval # | Year of Original Installation or Replacement | No Information Provided for Compliance |
|---|---|---|---|---|
| <input checked="" type="checkbox"/> Concrete/Clay Tile | <b>10/21/2025</b> | <b>25-001212</b> | . | |

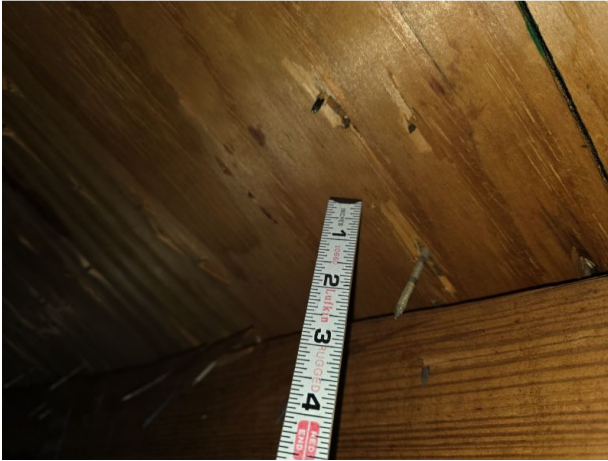
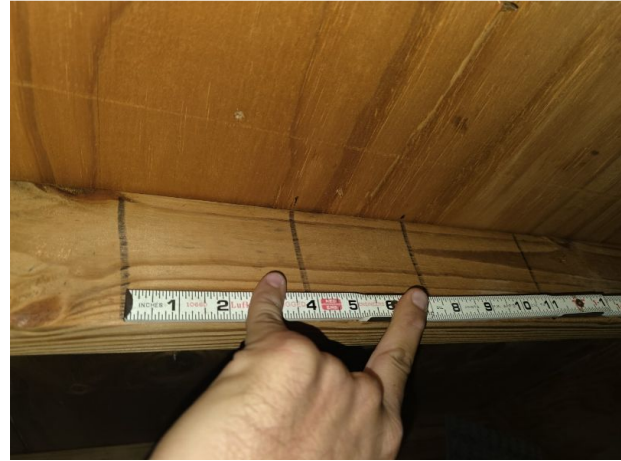
### ROOF TO DECK ATTACHMENT

- ☒ C. Plywood/OSB roof sheathing with a minimum thickness of 7/16" attached to the roof truss/rafter (spaced a maximum of 24" o.c.) by 8d common nails spaced a maximum of 6" in the field. OR Dimensional lumber/Tongue & Groove decking with a minimum of 2 nails per board (or 1 nail per board if each board is equal to or less than 6" in width). OR Any system of screws, nails, adhesives, other deck fastening system or truss/rafter spacing that is shown to have an equivalent or greater resistance than 8d common nails spaced a maximum of 6" in the field (max 24" truss/rafter spacing) or has a mean ultimate uplift resistance of at least 182 psf.

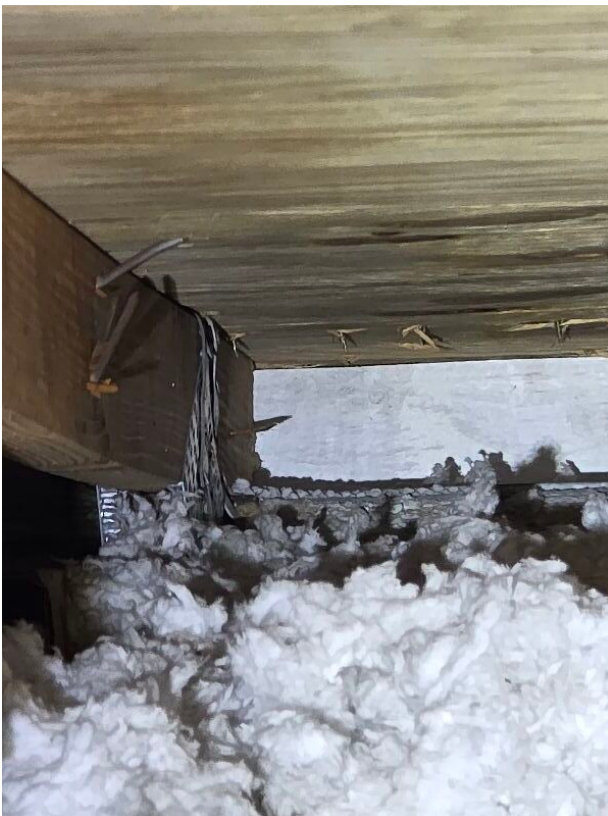
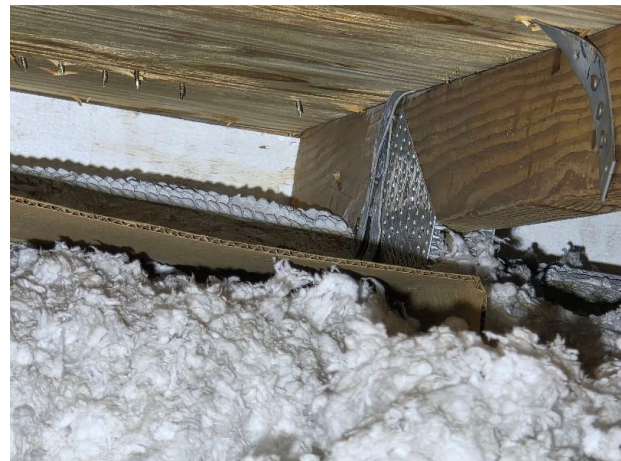
### ROOF TO WALL ATTACHMENT

☒ **D. Double Wraps**

- ☒ Metal Connectors consisting of two (2) separate straps, one on either side of the truss/rafter where each strap wraps over the truss/rafter and is secured with a minimum of two (2) nails on one side, and a minimum of one (1) nail on the opposing side, OR
- ☐ Metal connectors consisting of a single strap that wraps over the truss/rafter, are secured to the side of the wall and/or bottom of the top plate with a minimum of three (3) nails on each side, OR
- ☐ Purpose-made metal connector(s) or structural fastener(s) with a substantiated wind allowable uplift capacity of 891 lbs. or greater installed per the manufacturer's installation specifications (requires site-specific documentation).
