## Uniform Mitigation Verification Inspection Form

### Windstorm Mitigation Inspection

**9955-9983 NW 56TH PL CORAL SPRINGS, FL. 33076**

| INSPECTION DATE: <b>6/30/2026</b> | CONTACT PERSON: | Unit / Bldng |

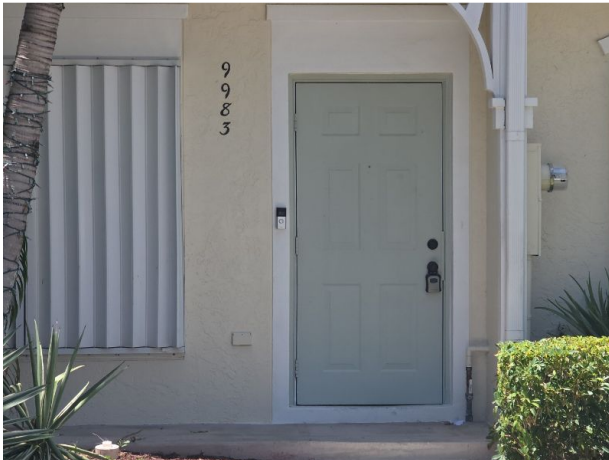
#### UNGLAZED OPENINGS

Entry doors are impact rated and approved(NOA #02-0408.04)

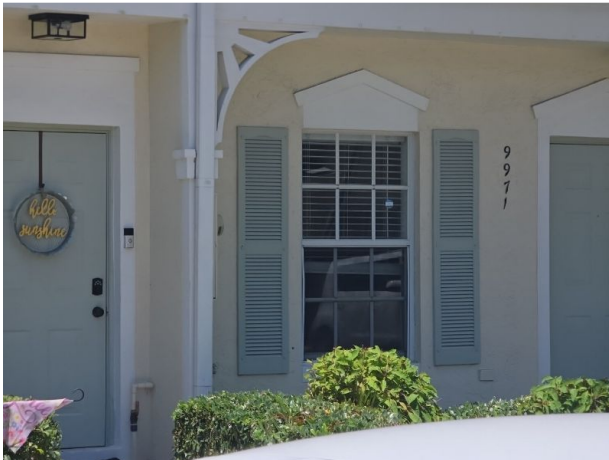
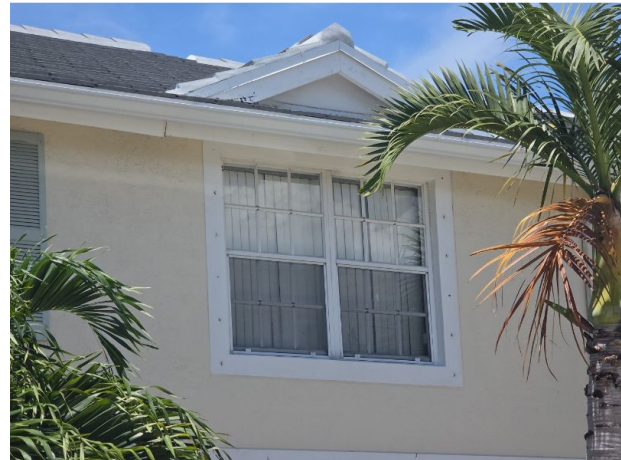
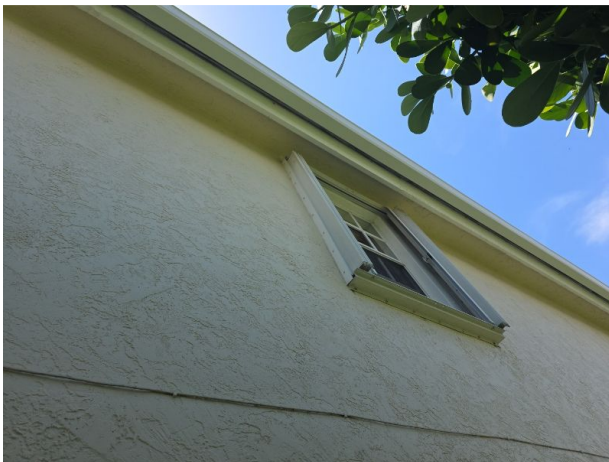
#### GLAZED OPENINGS

Glazed openings are protected with a combination of approved storm panels and approved accordion shutters.

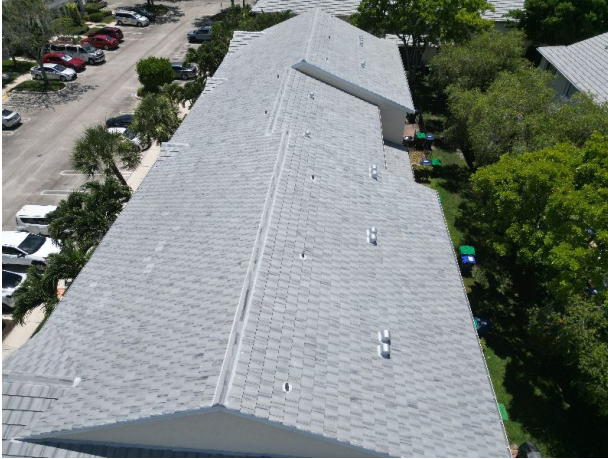
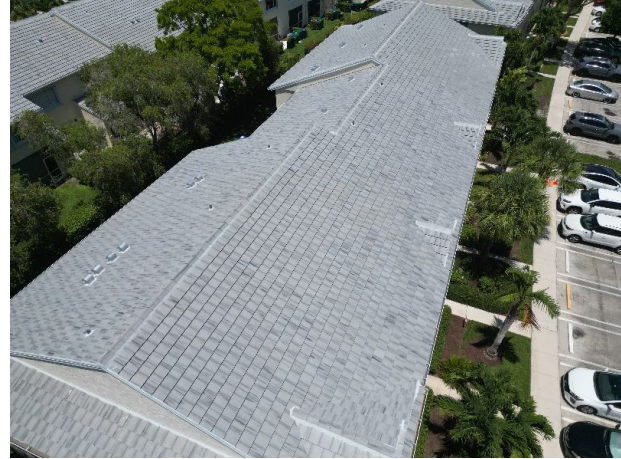
### ROOF COVERING

| 4.1 Roof Covering Type: | Permit Application Date | FBC / MDC Product Approval # | Year of Original Installation or Replacement | No Information Provided for Compliance |
|---|---|---|---|---|
| <input checked="" type="checkbox"/> Concrete/Clay Tile | <b>10/29/2025</b> | <b>25-001251</b> | <b>.</b> | _____ |
