## Uniform Mitigation Verification Inspection Form

### Windstorm Mitigation Inspection

**9965-9993 NW 57TH MANOR CORAL SPRINGS, FL. 33076**

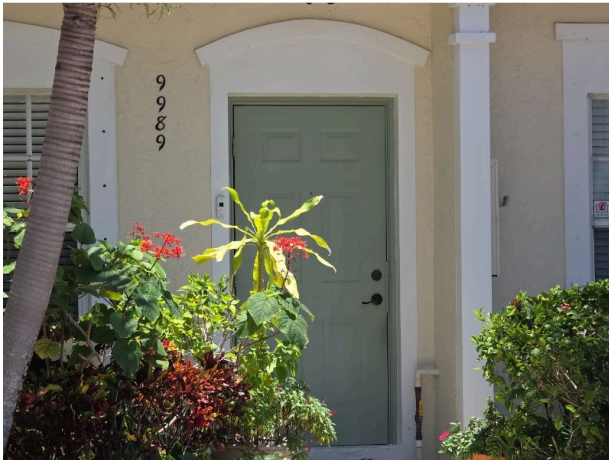
#### UNGLAZED OPENINGS

Entry doors are impact rated and approved(NOA #02-0408.04)

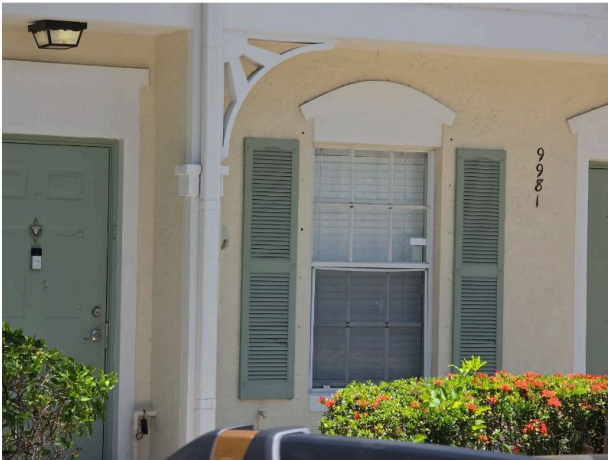
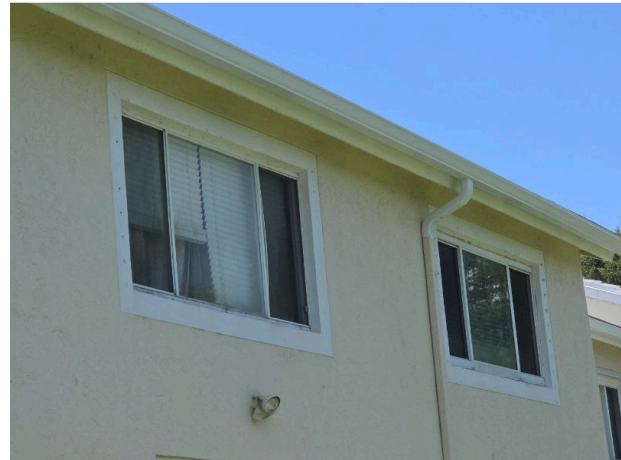
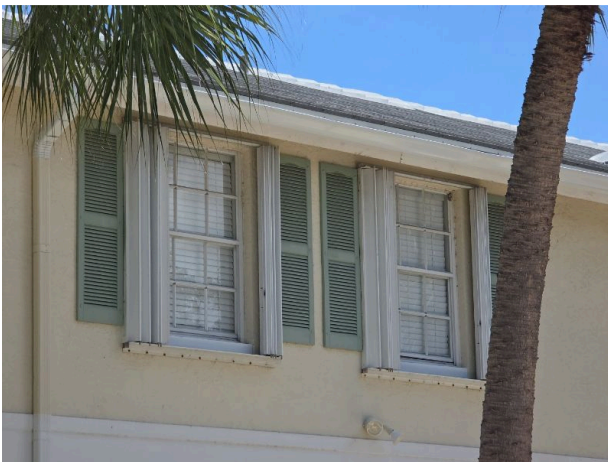
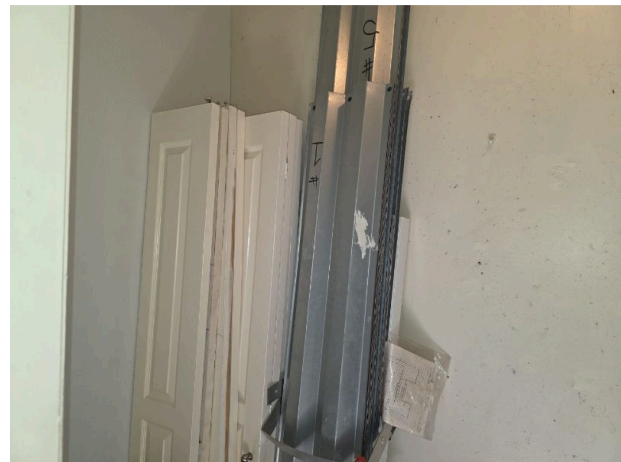
#### GLAZED OPENINGS

Glazed openings are protected with a combination of approved storm panels and approved accordion shutters.

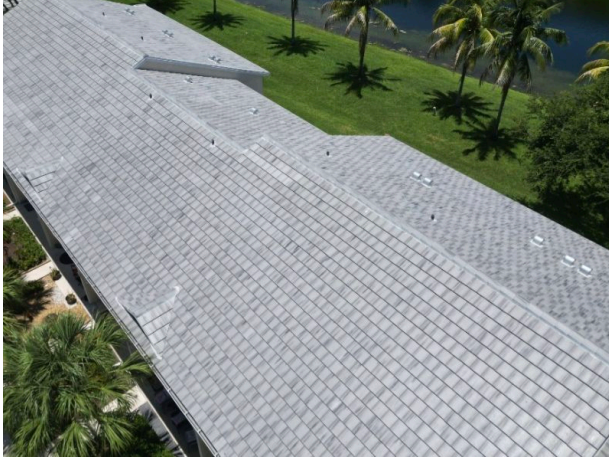
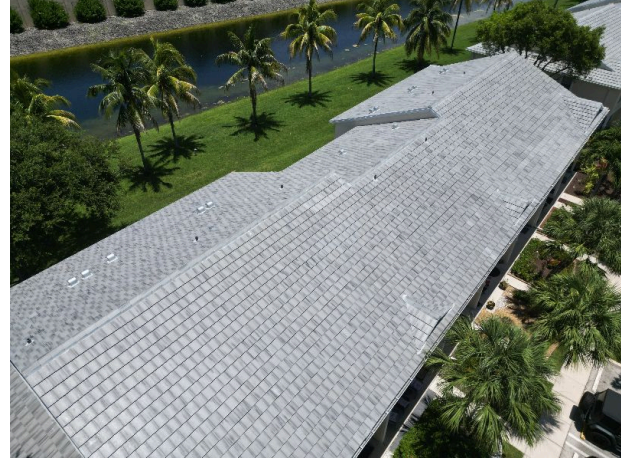
### ROOF COVERING

| 4.1 Roof Covering Type: | Permit Application Date | FBC / MDC Product Approval # | Year of Original Installation or Replacement | No Information Provided for Compliance |
|---|---|---|---|---|
| <input checked="" type="checkbox"/> Concrete/Clay Tile | <b>10/29/2025</b> | <b>25-001248</b> | . | |

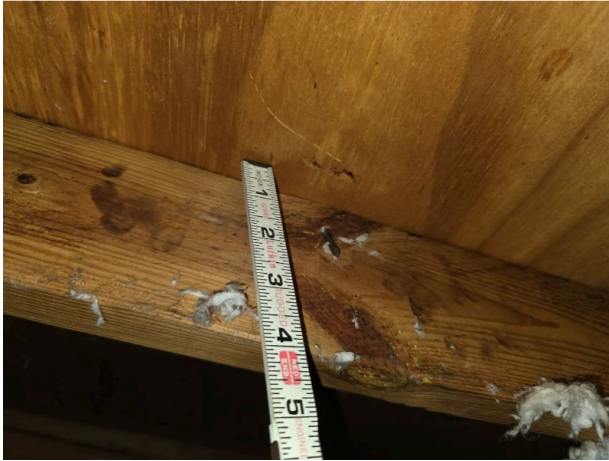
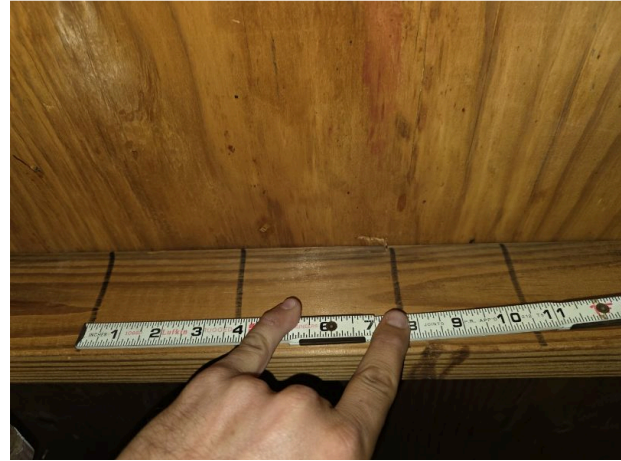
### ROOF TO DECK ATTACHMENT

- ☒ C. Plywood/OSB roof sheathing with a minimum thickness of 7/16" attached to the roof truss/rafter (spaced a maximum of 24" o.c.) by 8d common nails spaced a maximum of 6" in the field. OR Dimensional lumber/Tongue & Groove decking with a minimum of 2 nails per board (or 1 nail per board if each board is equal to or less than 6" in width). OR Any system of screws, nails, adhesives, other deck fastening system or truss/rafter spacing that is shown to have an equivalent or greater resistance than 8d common nails spaced a maximum of 6" in the field (max 24" truss/rafter spacing) or has a mean ultimate uplift resistance of at least 182 psf.
