## Uniform Mitigation Verification Inspection Form

### Windstorm Mitigation Inspection

**9966-9994 NW 56TH PL CORAL SPRINGS, FL. 33076**

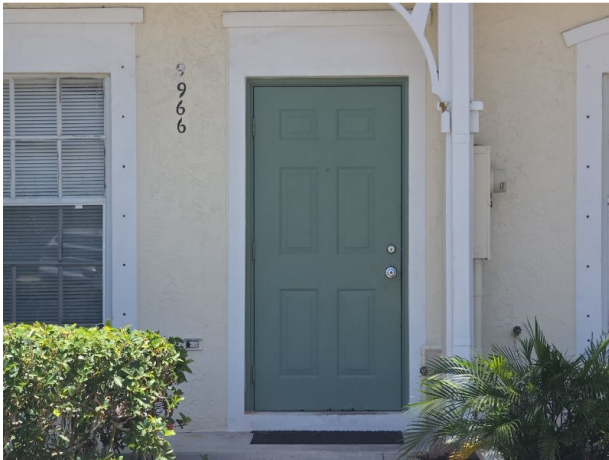
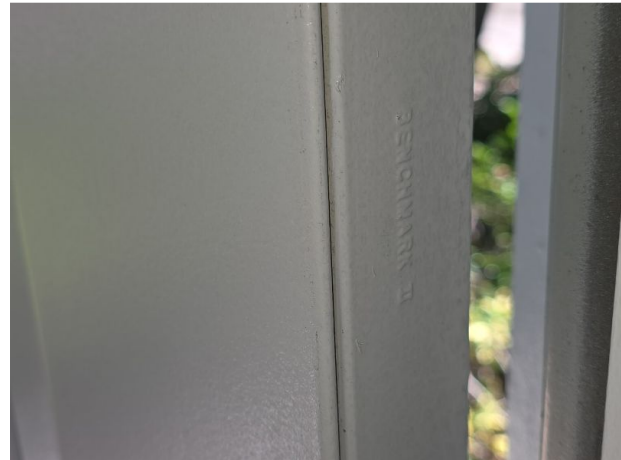
#### UNGLAZED OPENINGS

Entry doors are impact rated and approved(NOA #02-0408.04)

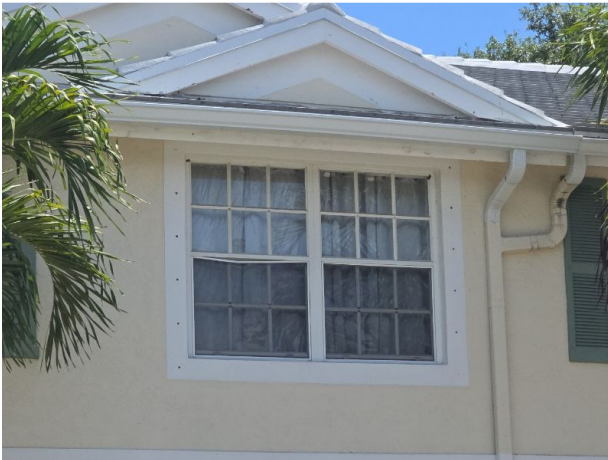
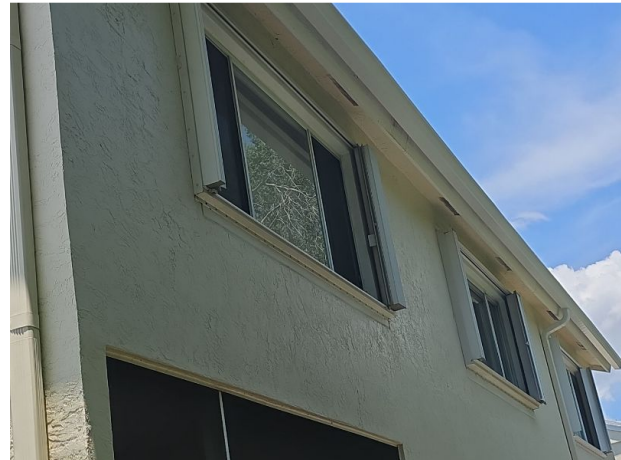
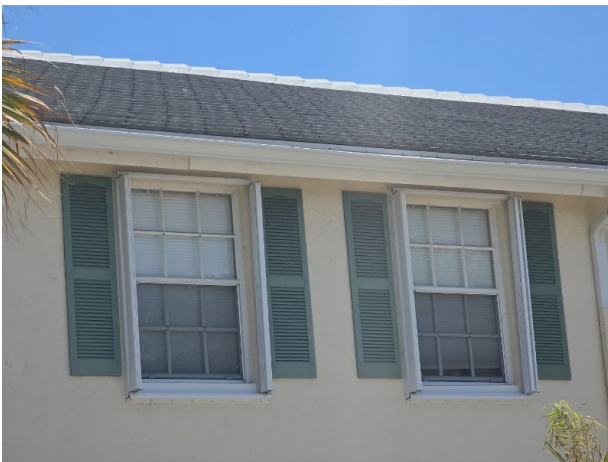
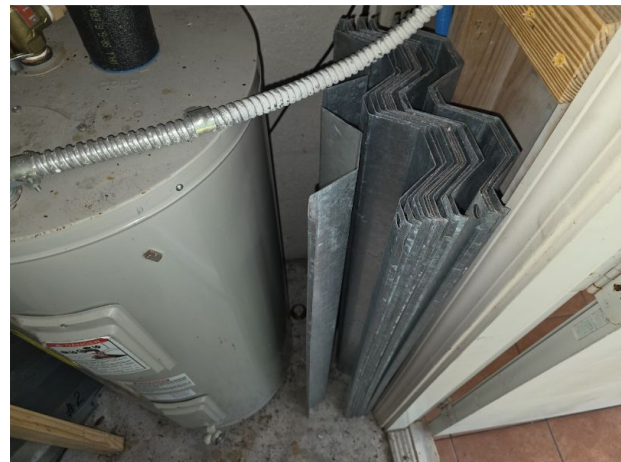
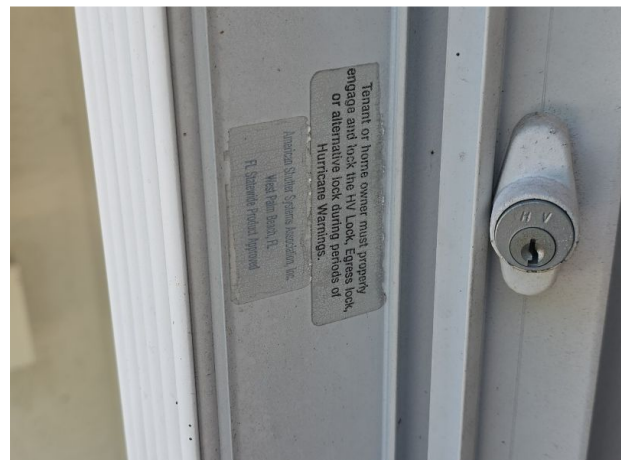
#### GLAZED OPENINGS

Glazed openings are protected with a combination of approved storm panels and approved accordion shutters.

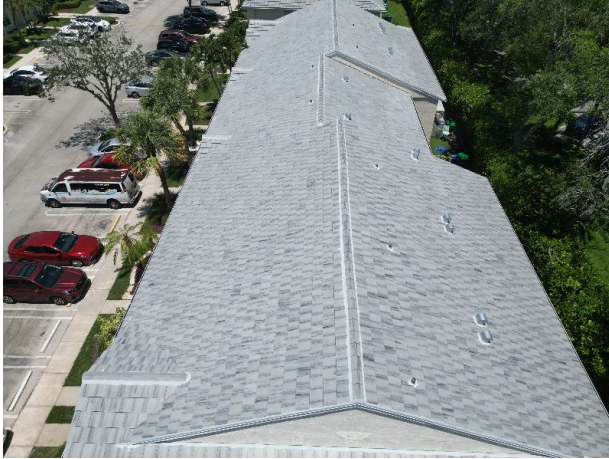
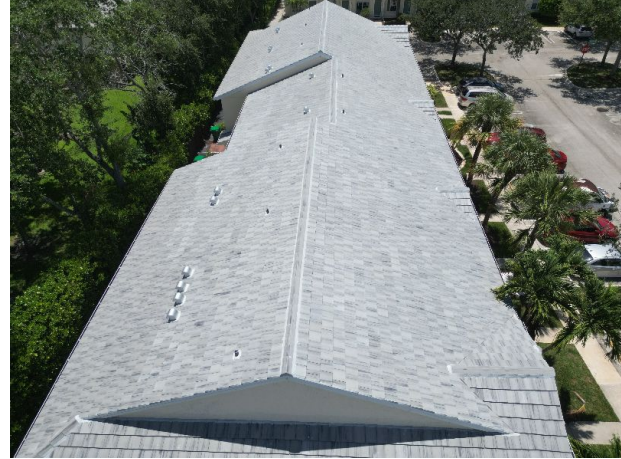
### ROOF COVERING

| 4.1 Roof Covering Type: | Permit<br>Application Date | FBC / MDC Product<br>Approval # | Year of Original Installation<br>or Replacement | No Information<br>Provided for Compliance |
|---|---|---|---|---|
| <input checked="" type="checkbox"/> Concrete/Clay Tile | <b>10/8/2025</b> | <b>25-001207</b> | . | |

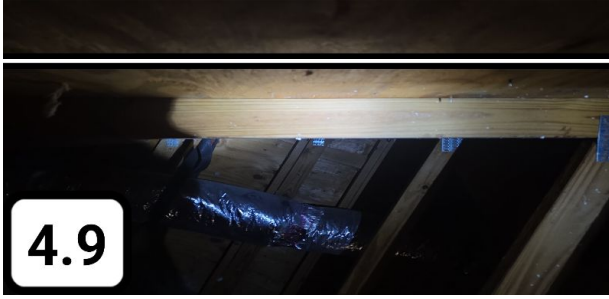
### ROOF SLOPE

☐ Greater than or equal to (≥ 6:12) ☒ Less than (< 6:12).

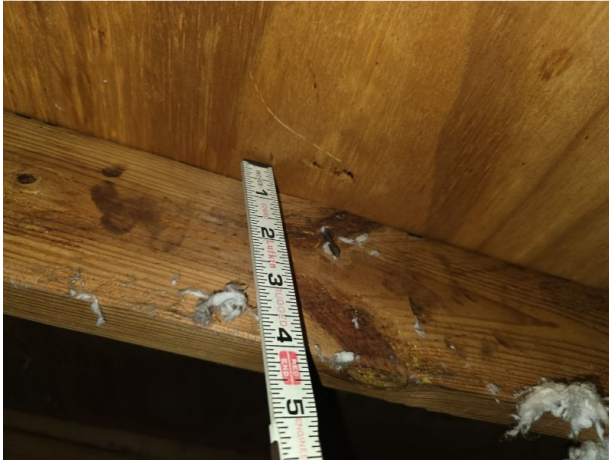
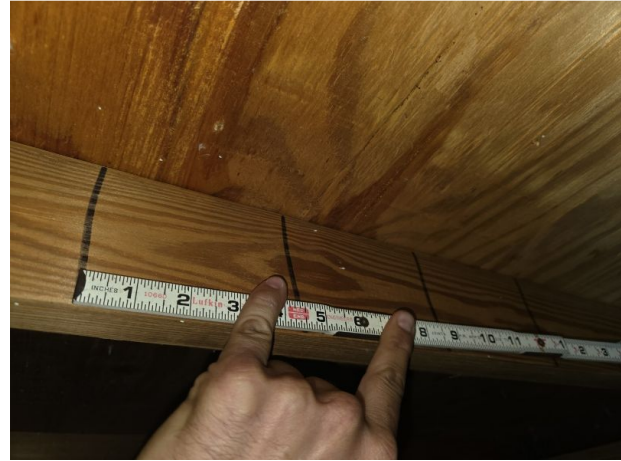
### ROOF TO DECK ATTACHMENT

- ☒ C. Plywood/OSB roof sheathing with a minimum thickness of 7/16" attached to the roof truss/rafter (spaced a maximum of 24" o.c.) by 8d common nails spaced a maximum of 6" in the field. OR Dimensional lumber/Tongue & Groove decking with a minimum of 2 nails per board (or 1 nail per board if each board is equal to or less than 6" in width). OR Any system of screws, nails, adhesives, other deck fastening system or truss/rafter spacing that is shown to have an equivalent or greater resistance than 8d common nails spaced a maximum of 6" in the field (max 24" truss/rafter spacing) or has a mean ultimate uplift resistance of at least 182 psf.

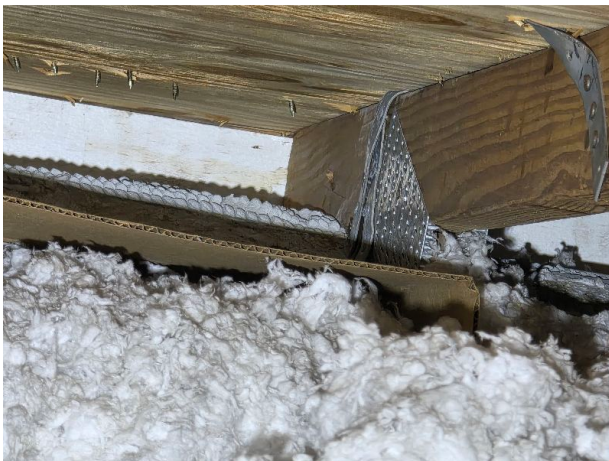
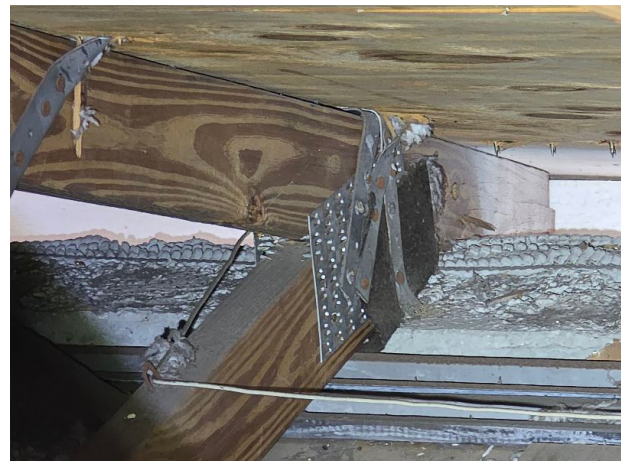
### ROOF TO WALL ATTACHMENT

☒ **D. Double Wraps**

- ☒ Metal Connectors consisting of two (2) separate straps, one on either side of the truss/rafter where each strap wraps over the truss/rafter and is secured with a minimum of two (2) nails on one side, and a minimum of one (1) nail on the opposing side, OR
- ☐ Metal connectors consisting of a single strap that wraps over the truss/rafter, are secured to the side of the wall and/or bottom of the top plate with a minimum of three (3) nails on each side, OR
- ☐ Purpose-made metal connector(s) or structural fastener(s) with a substantiated wind allowable uplift capacity of 891 lbs. or greater installed per the manufacturer's installation specifications (requires site-specific documentation).
